# Inspection Report

**Property Address:**  
1234 Masters Cir  
Baytown TX 77523

# PROPERTY INSPECTION REPORT FORM

John Doe	11/15/2025
Name of Client	Date of Inspection
1234 Masters Clr, Baytown, TX 77523	
Address of Inspected Property	
Amber Diehl TREC # 26115	TREC 26115
Name of Inspector	TREC License #
Name of Sponsor (if applicable)	
TREC License #

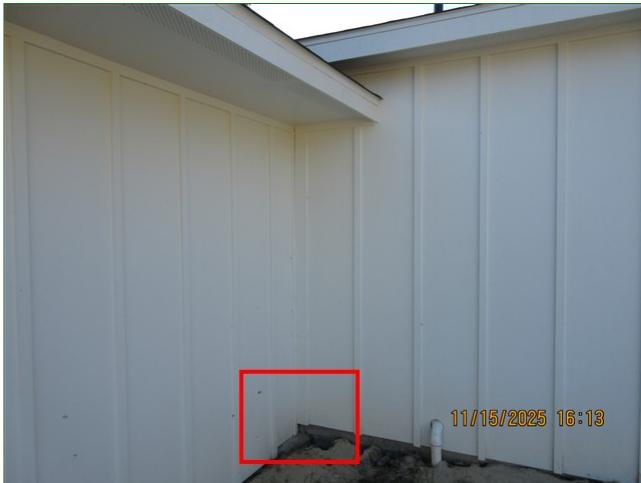
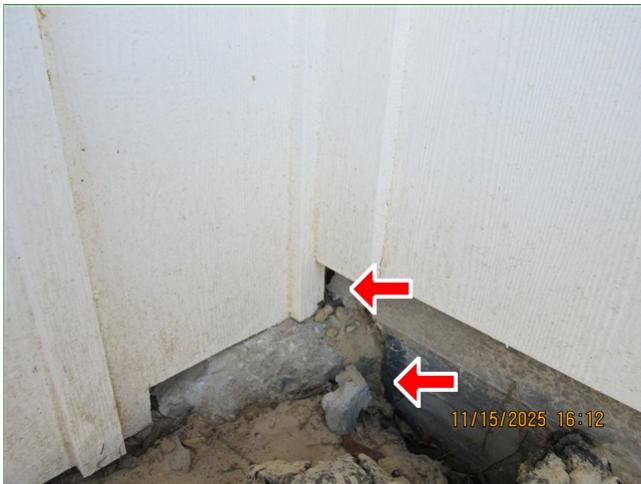
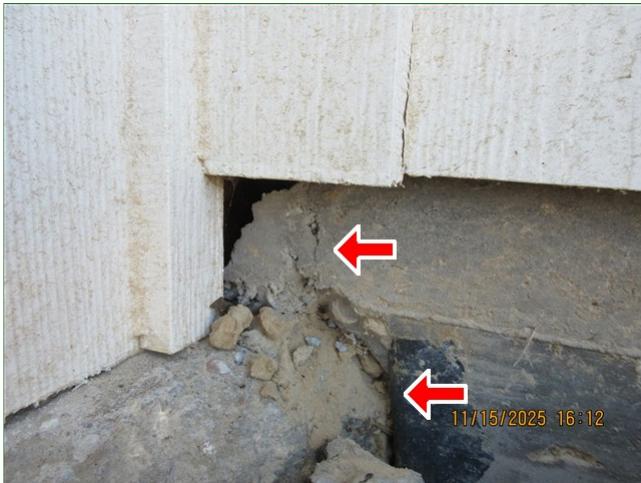
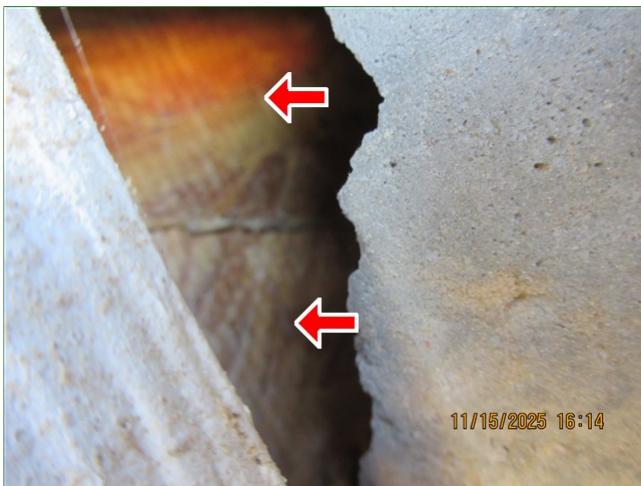
(2) Evidence of separate concrete slabs were observed on the back side of the home at the time of the inspection. The buyer did inform the inspector that a new concrete slab had been poured for the addition to the remodel. This is for your information.

A. Item 1 (Picture) Back of home, foundation, evidence of separate concrete slabs

A. Item 2 (Picture) Back of home, foundation, evidence of separate concrete slabs

A. Item 3 (Picture) Back of home, foundation, evidence of separate concrete slabs

A. Item 4 (Picture) Back of home, foundation, evidence of separate concrete slabs

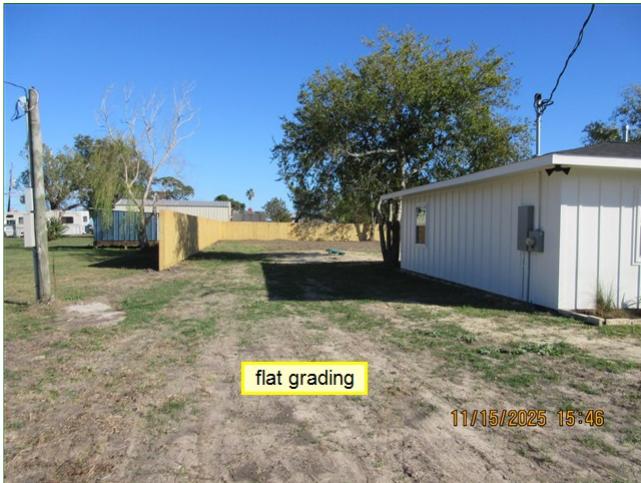
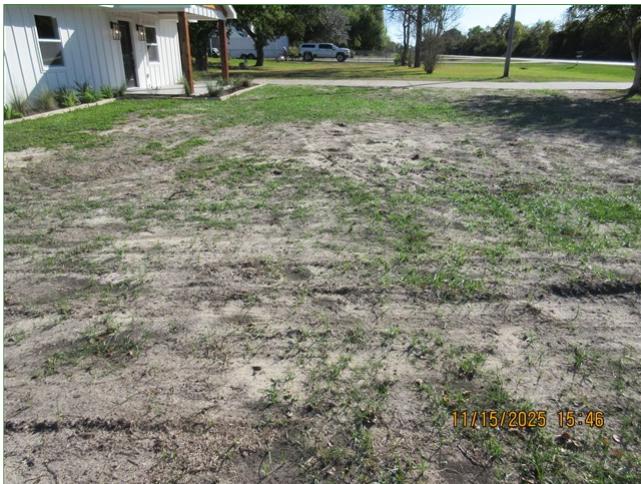
(1) Flat and negative grading was observed at the time of the inspection. The grading should slope away from the home or there should be another system used to properly drain water away from the foundation to protect from puddles of water forming near the foundation.

B. Item 1 (Picture) Left of home, flat grading

B. Item 2 (Picture) Front of home, flat grading

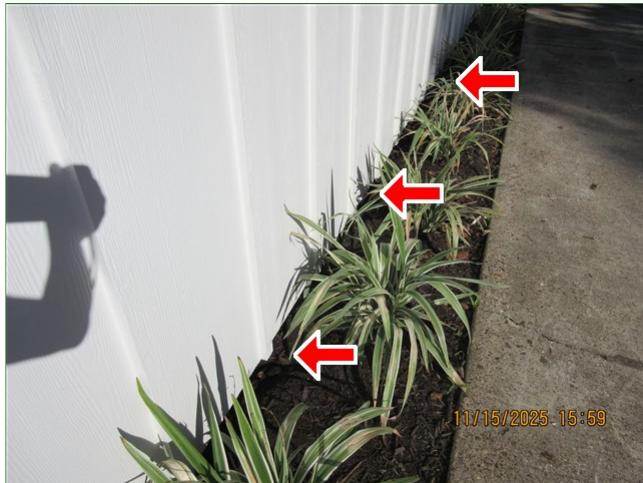
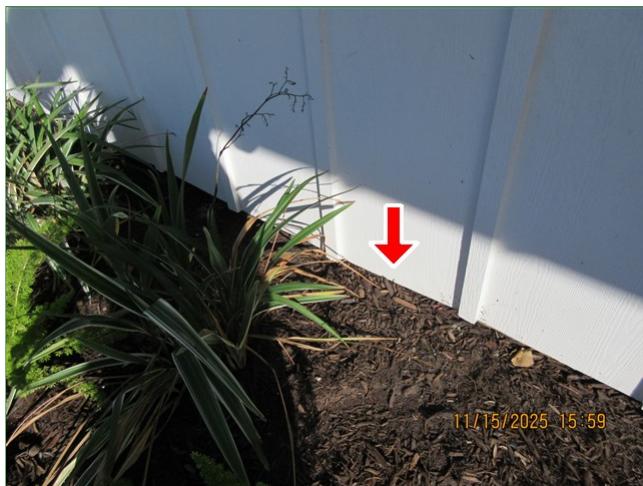
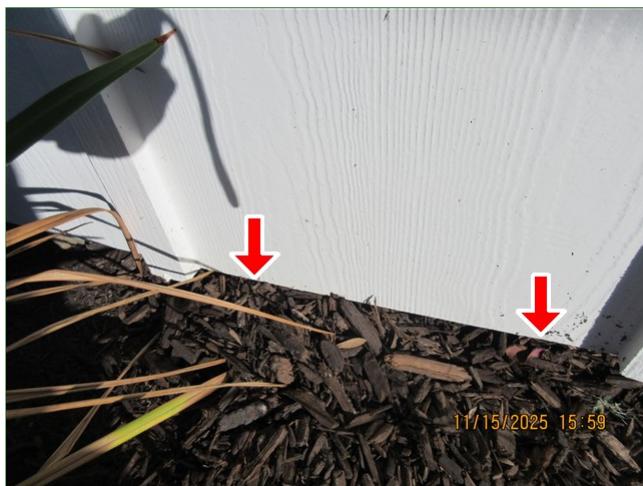
(2) High soil/ mulch levels were observed in multiple locations around the homes foundation, at the time of the inspection. There should be a minimum 6- 8inches of clearance between the bottom of the exterior siding and the ground. In the inspectors opinion, these areas may be more prone to moisture intrusion and/ or retaining moisture against the foundation wall. The inspector recommends further evaluation by a qualified professional.

B. Item 3 (Picture) Right of home, high soil/ mulch levels

B. Item 4 (Picture) Right of home, high soil/ mulch levels

B. Item 5 (Picture) Right of home, high soil/ mulch levels

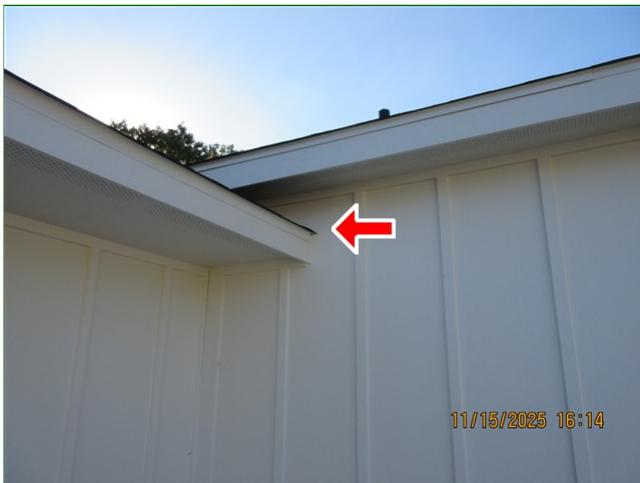
(3) No kick-out flashing was observed at the roof to wall connection at the time of the inspection. The inspector recommends a professional roofer install kick out flashing to protect the siding from potential early deterioration and moisture intrusion.

B. Item 6 (Picture) Back of home, roof to wall connection, no kick out flashing

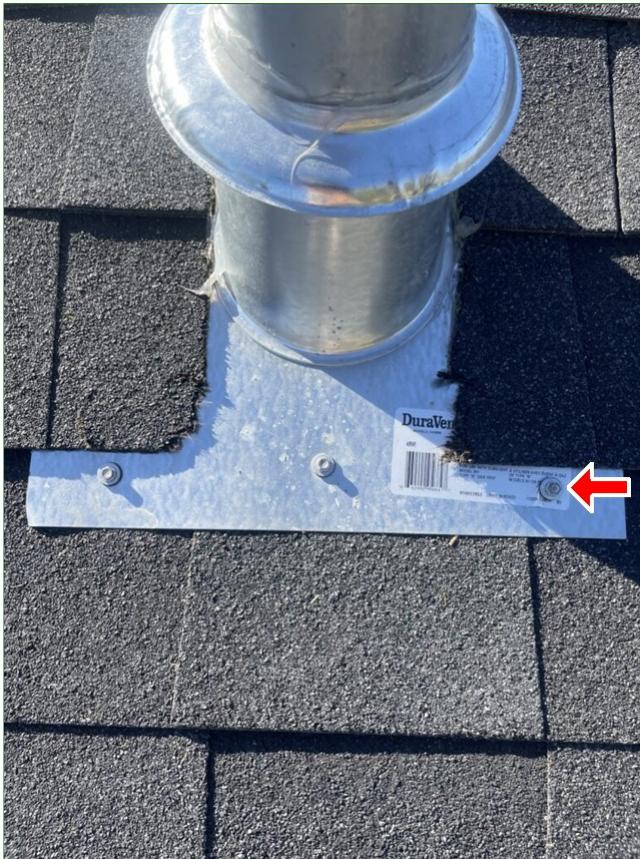
- Tree branches were observed overhanging the roof in the back left corner.
- No sealant/ caulk was observed on multiple nail and screw heads. No nail or screw heads should be exposed. Sealant/ caulk is a temporary fix. This is for your information. The inspector recommends a professional contractor or sealant applicator apply new sealant at each expansion joint as part of routine maintenance.

C. Item 1 (Picture) Roof, through roof flashing, exposed nails

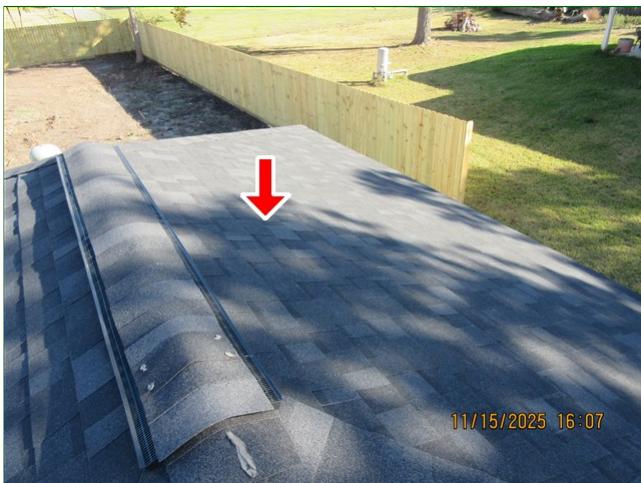
- Soft spots were observed in multiple locations while walking on the roof of the garage at the time of the inspection. The inspector recommends further evaluation to determine if the roof decking is damaged.
- The inspector had very limited access into the attic space at the time of the inspection. As a result the inspector could not properly inspect the attic space and any equipment or components in the attic space. This is for your information.
- Separation at multiple roof rafter to ridge connections were observed at the time of the inspection. The inspector recommends further evaluation by a structural engineer to determine the severity.
- No visible rafter ties were observed.
- What appear to be cut structural members were observed in the attic at the time of the inspection. The

D. Item 1 (Picture) Garage, roof decking, soft spots

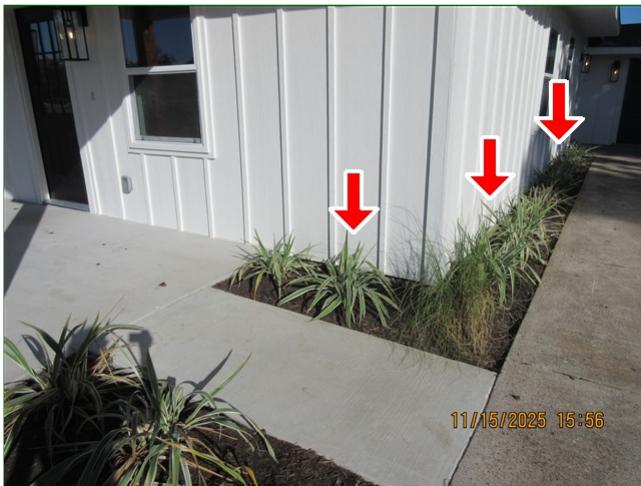
- Vegetation was observed in direct contact with the exterior siding on multiple sides of the home and attached garage at the time of the inspection. Vegetation against exterior siding is more prone to accumulating moisture and may decrease the service life of the siding materials. This is for your information.
- Separation in sealant was observed in multiple locations of the exterior fascia boards, soffit boards, and wall butt joints at the time of the inspection. The inspector recommends a professional contractor or sealant applicator apply new sealant at each expansion joint as part of routine maintenance to protect from

E. Item 1 (Picture) Front and right sides of home, vegetation in direct contact with siding

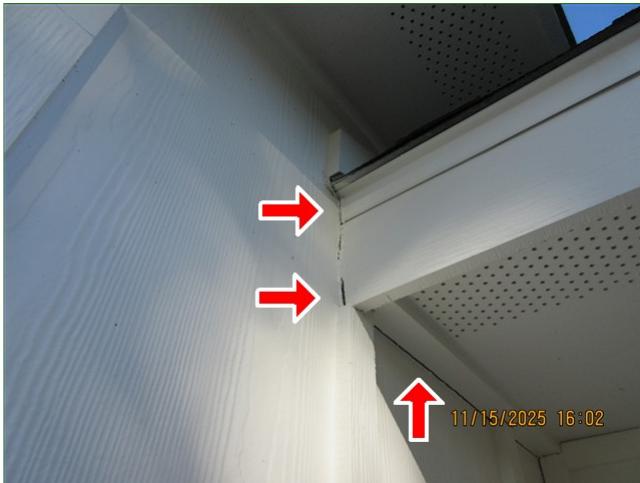
E. Item 3 (Picture) Damaged/ deteriorated sealant was observed in multiple locations of the exterior fascia and soffit board joints at the time of the inspection. The inspector recommends a professional contractor or sealant applicator apply new sealant at each expansion joint as part of routine maintenance.

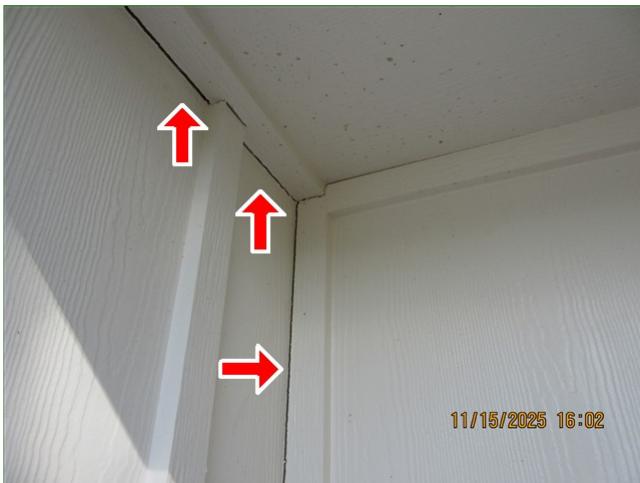
E. Item 4 (Picture) Damaged/ deteriorated sealant was observed in multiple locations of the exterior fascia and soffit board joints at the time of the inspection. The inspector recommends a professional contractor or sealant applicator apply new sealant at each expansion joint as part of routine maintenance.

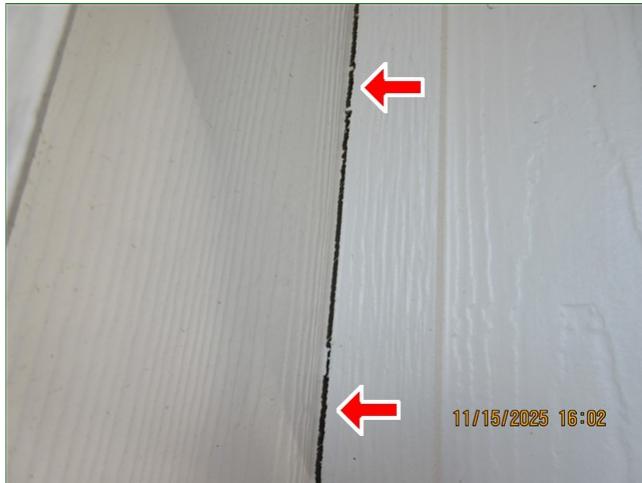
E. Item 5 (Picture) Damaged/ deteriorated sealant was observed in multiple locations of the exterior fascia and soffit board joints at the time of the inspection. The inspector recommends a professional contractor or sealant applicator apply new sealant at each expansion joint as part of routine maintenance.

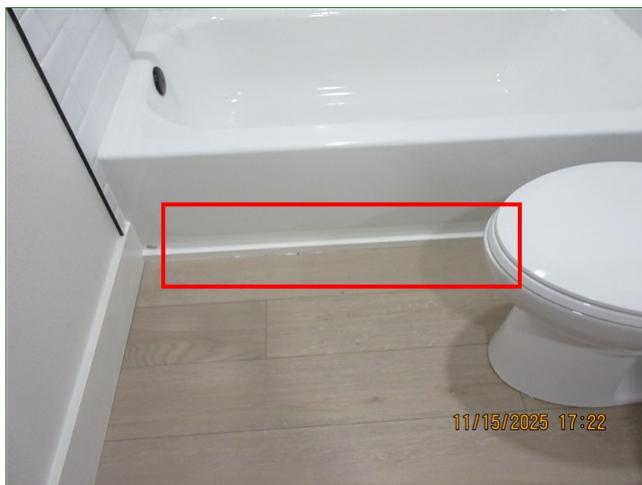
E. Item 6 (Picture) Guest bathroom, base board, no sealant

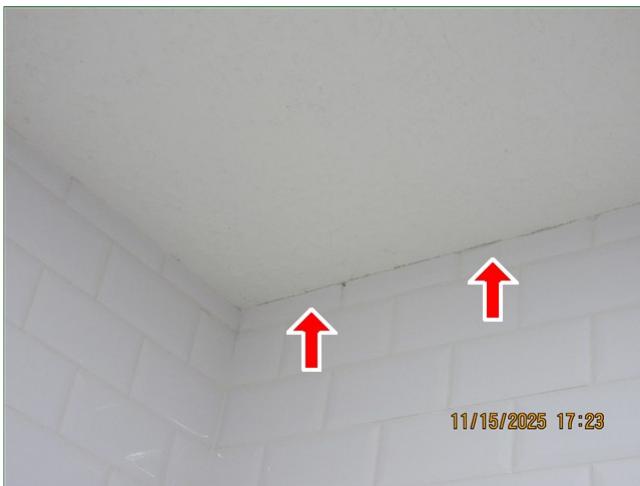
- In the inspectors opinion, poor sealant/ caulk work was done in many locations throughout the interior walls, base boards, and trim boards at the time of the inspection. This is for your information.

E. Item 10 (Picture) Guest bathroom, tile wall, poor caulk/ sealant work

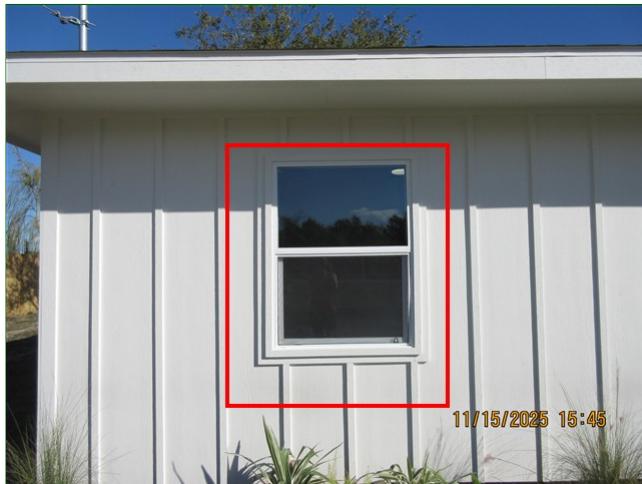
- No flashing was observed at any of the exterior cement fiber siding and window frame butt joints. The inspector recommends further evaluation by a qualified specialist to determine if the siding is properly installed according to manufacturers installation requirements.

E. Item 11 (Picture) Front of home, cement fiber siding & window butt joints, no flashing

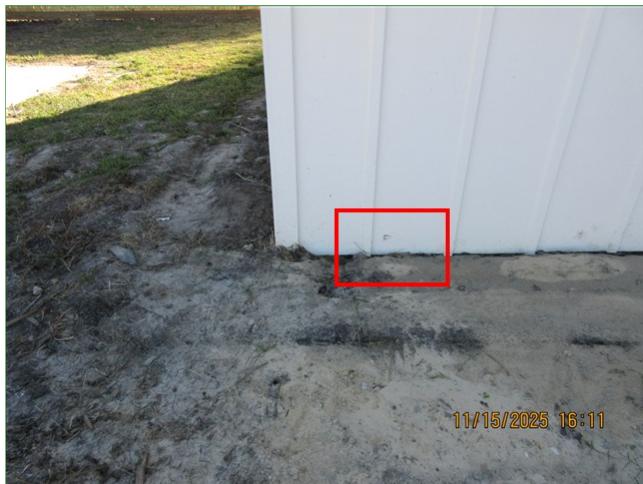
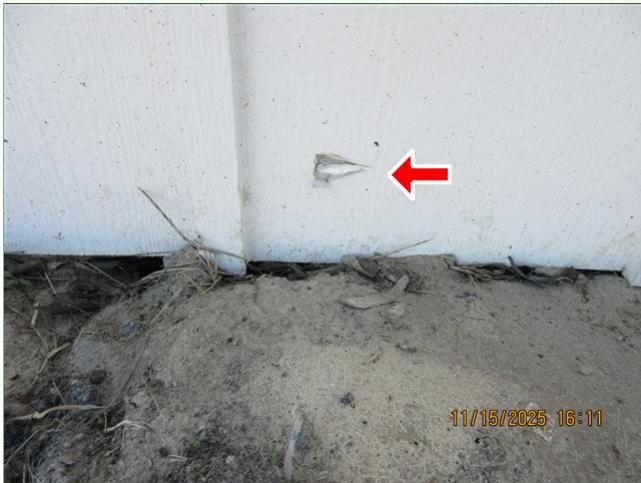
E. Item 15 (Picture) Back of home, siding, damaged

E. Item 16 (Picture) Back of home, siding, damaged

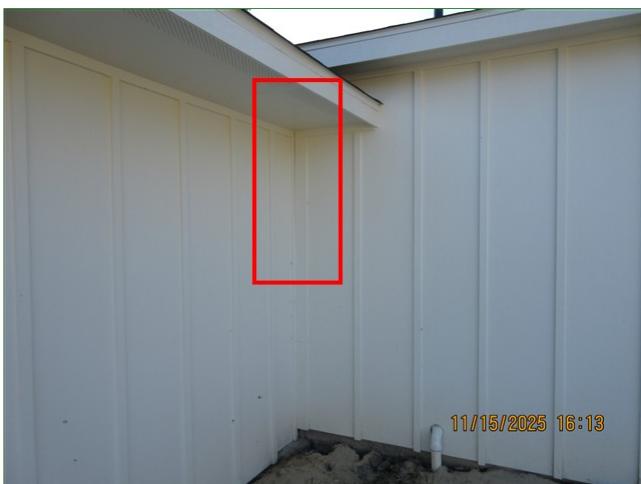
E. Item 17 (Picture) Back of home, siding butt joint, separated

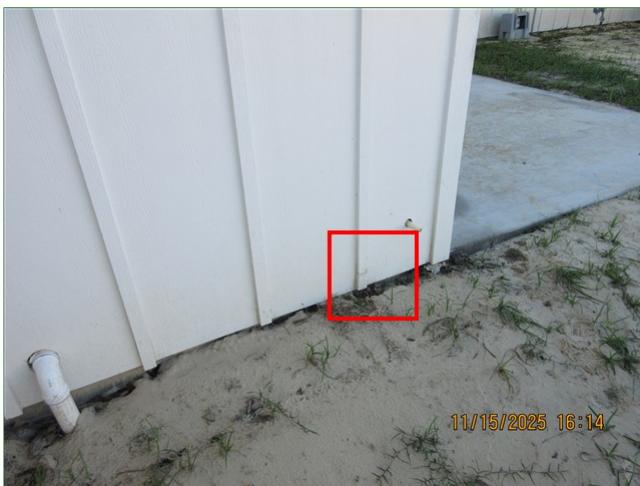
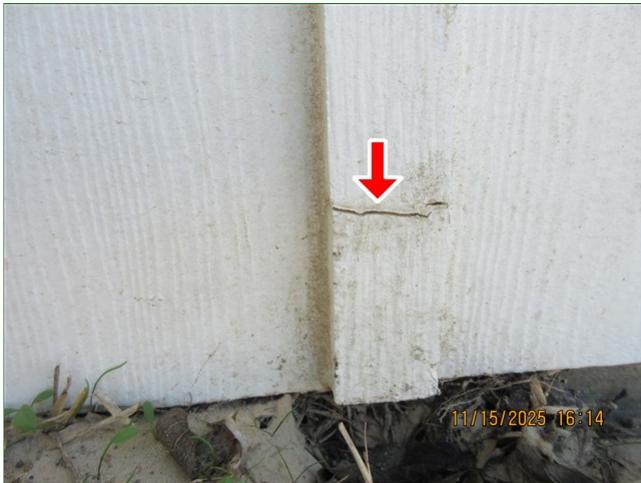
E. Item 21 (Picture) Back of home, siding, damaged

E. Item 22 (Picture) Back of home, siding, damaged

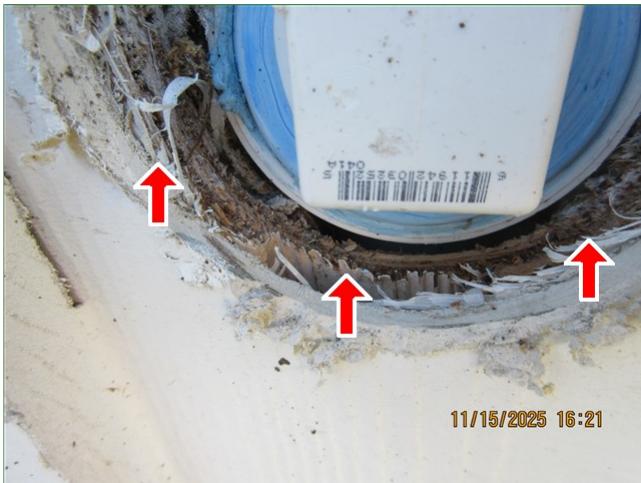
- What appears to be an old or first layer of exterior siding was observed under the new exterior siding at the time of the inspection. Due to the age of the home, the inspector recommends having the possible under layer of siding tested for asbestos. Although it was prohibited from still being manufactured in the late 1900's; asbestos siding is still around and being used. This is for your information.

- No through wall termination flashing or boxes were observed at any of the through wall terminations at the time of the inspection.

E. Item 25 (Picture) Back of home, through wall termination, no flashing, possible 2 layers of exterior siding

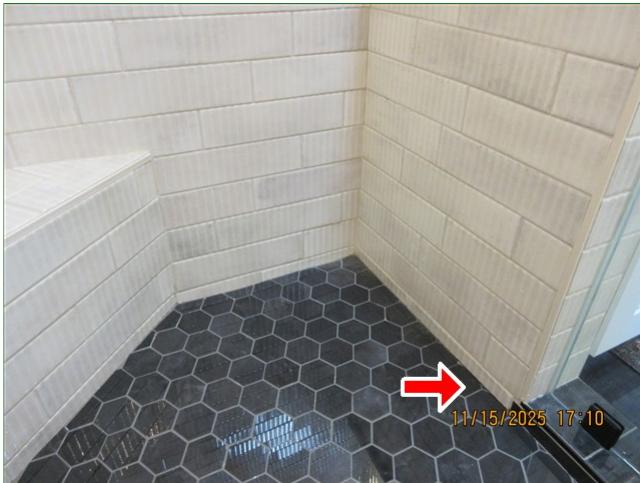
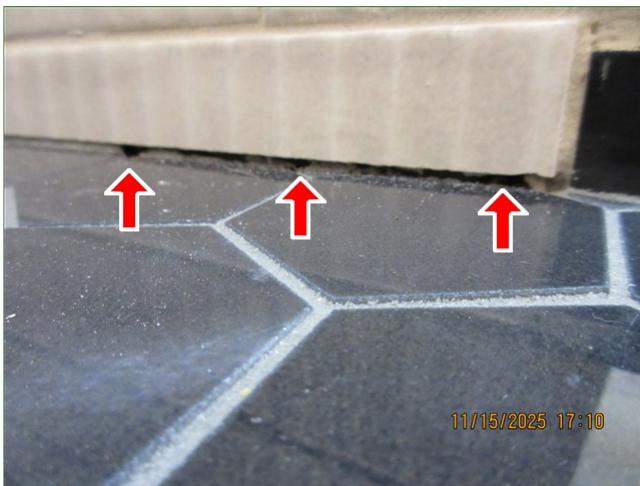
- Missing/ deteriorated grout/ mortar was observed in the master and guest bathroom shower's tile wall to floor connection at the time of the inspection. The inspector recommends correction to protect from moisture intrusion.
- Small leaks were observed at the master bathroom's shower glass wall connection at the time of the inspection.
- No sealant was observed at both the bathroom's shower plumbing fixtures.

E. Item 26 (Picture) Master bathroom, shower tile wall to floor connection, missing grout

E. Item 27 (Picture) Master bathroom, shower tile wall to floor connection, missing grout

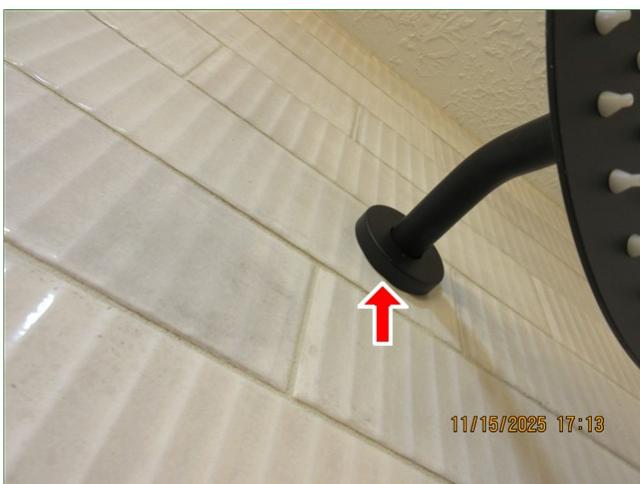
E. Item 28 (Picture) Master bathroom, shower, fixture connections, no sealant

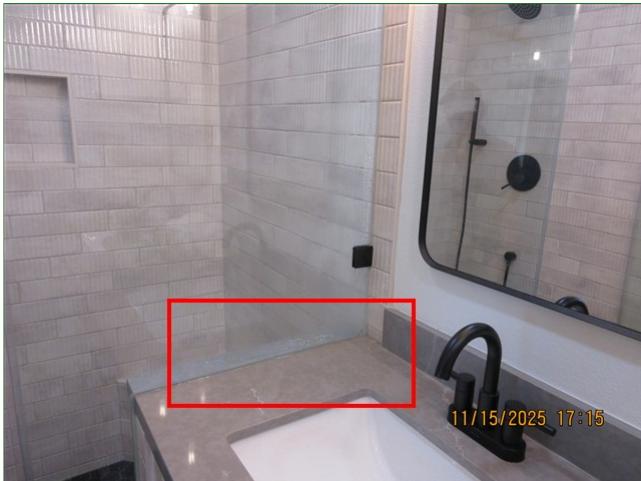
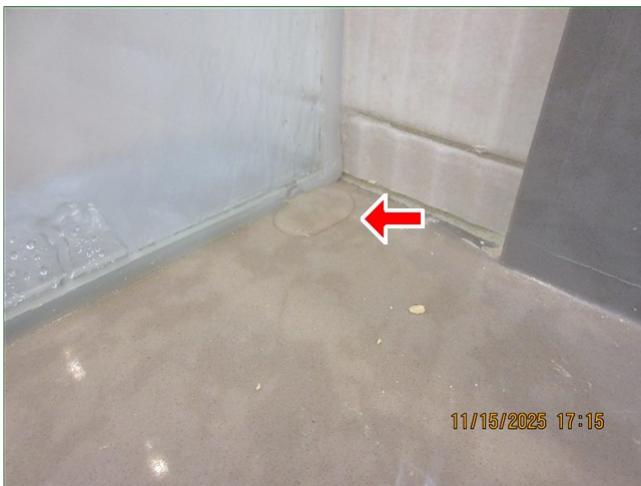
E. Item 29 (Picture) Master bathroom, glass shower wall, missing sealant

E. Item 30 (Picture) Master bathroom, glass shower wall, missing sealant

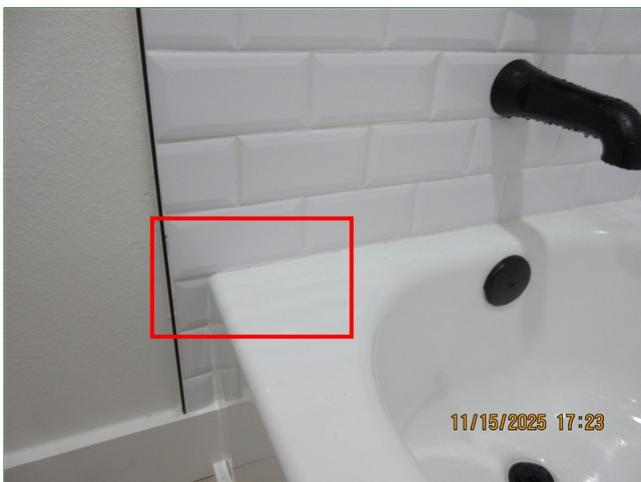
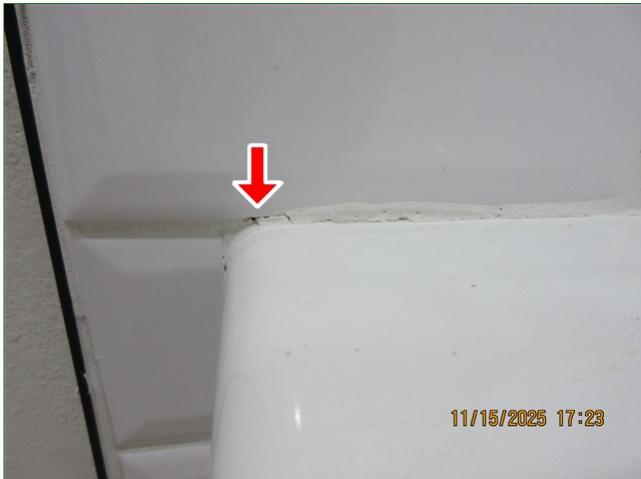
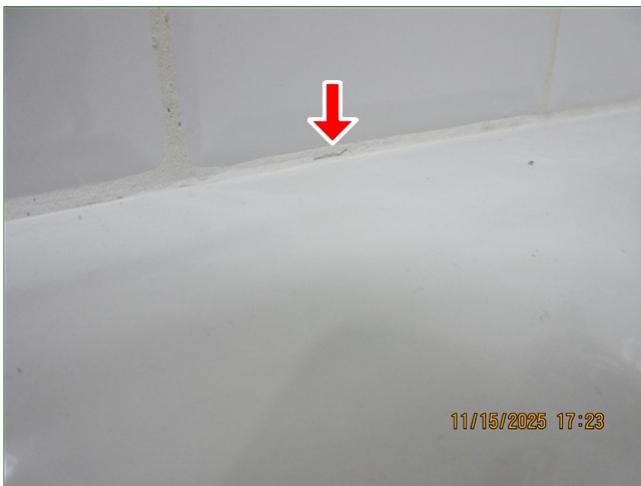
E. Item 31 (Picture) Guest bathroom, tile wall, grout cracked

E. Item 32 (Picture) Guest bathroom, tile wall, grout cracked

E. Item 33 (Picture) Guest bathroom, tile wall, grout cracked

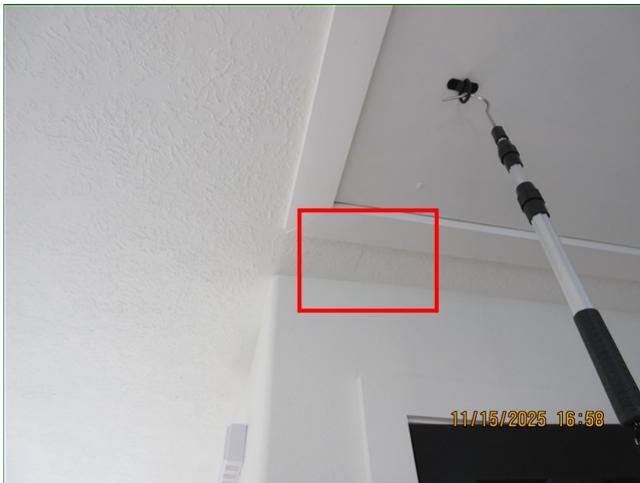
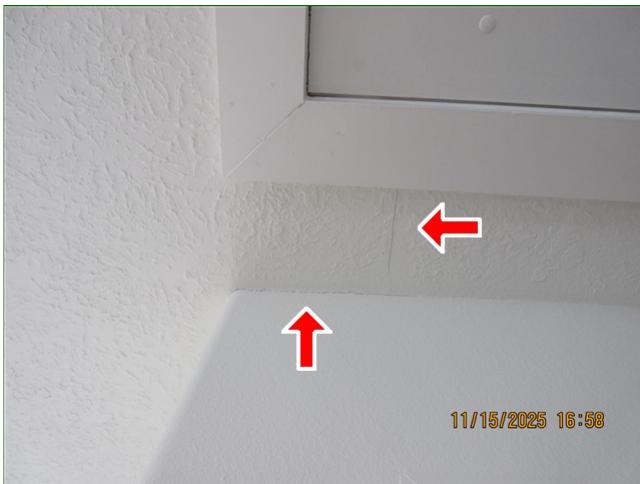
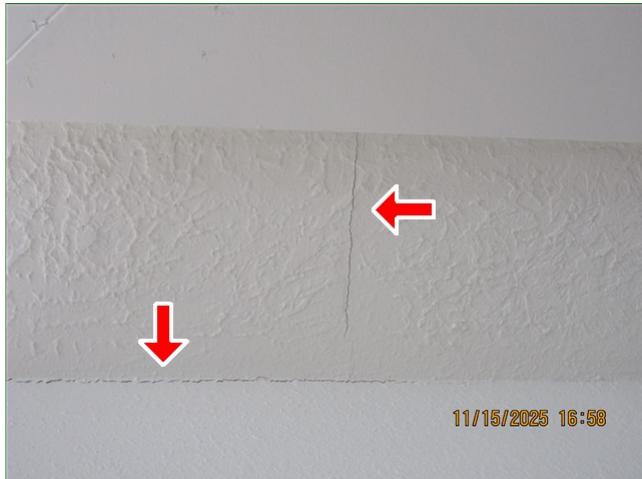
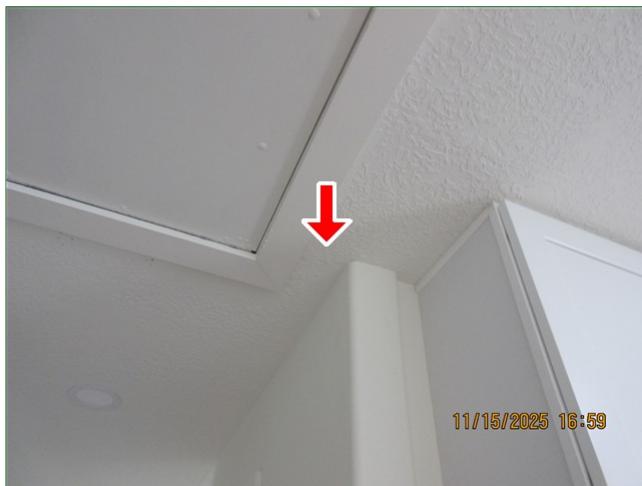
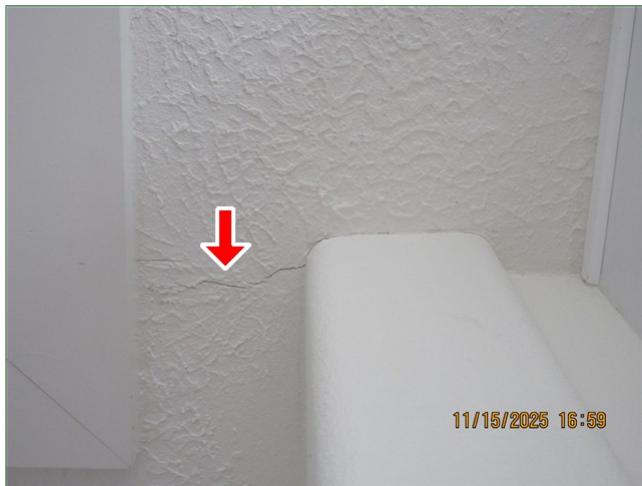
- Minor hairline cracks were observed on the ceiling in multiple locations at the time of the inspection. The clients informed the inspector that the owners recently remodeled. In the inspectors opinion, the cracks appear to be a minor concern at the time of the inspection, however, since they may have reappeared since remodeling and painting, the inspector recommends further evaluation by a structural engineer if you are concerned.

F. Item 1 (Picture) Hallway, ceiling near attic pull down stairs, ceiling, cracked

F. Item 2 (Picture) Hallway, ceiling near attic pull down stairs, ceiling, cracked

F. Item 3 (Picture) Hallway, ceiling near attic pull down stairs, ceiling, cracked

F. Item 4 (Picture) Hallway, ceiling near attic pull down stairs, ceiling, cracked

F. Item 5 (Picture) Hallway, ceiling near attic pull down stairs, ceiling, cracked

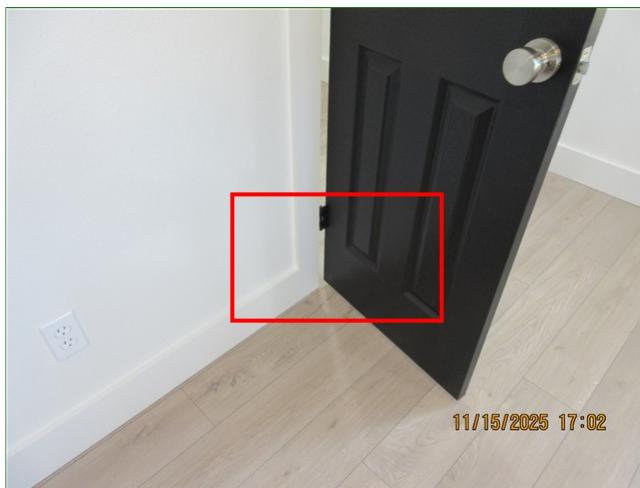
- No door stopper was observed at multiple doors and cabinet doors throughout the home at the time of the inspection. This is for your information.

G. Item 1 (Picture) Master bedroom, no door stopper

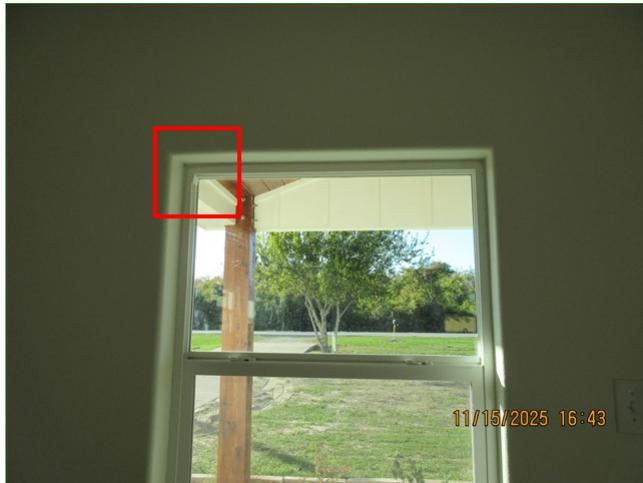
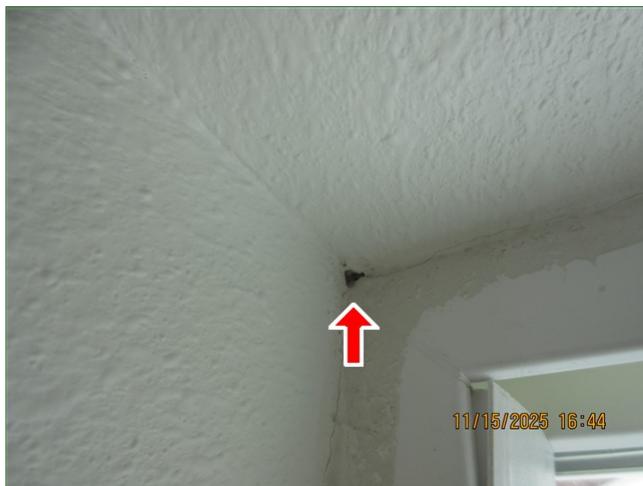
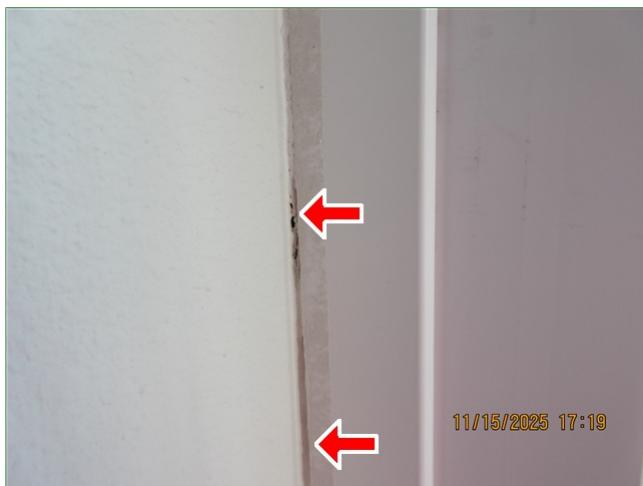
- Missing/ separated caulk/ sealant was observed at multiple window frames casings at the time of the inspection. This is for your information.

H. Item 1 (Picture) Front of home, window, sealant missing/ separated

H. Item 2 (Picture) Front of home, window, sealant missing/ separated

H. Item 3 (Picture) Front of home, window, sealant missing/ separated

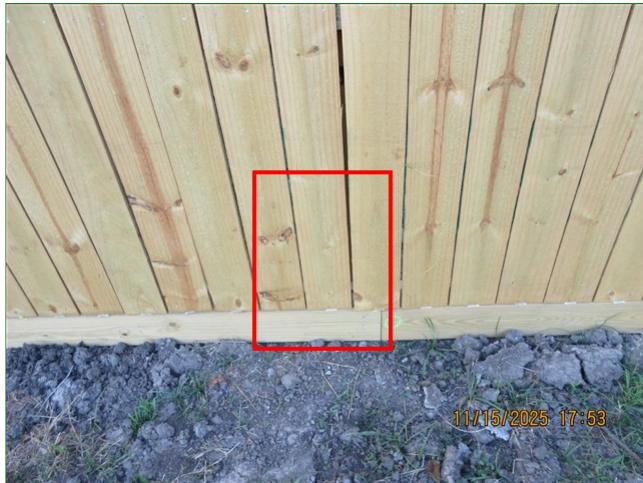
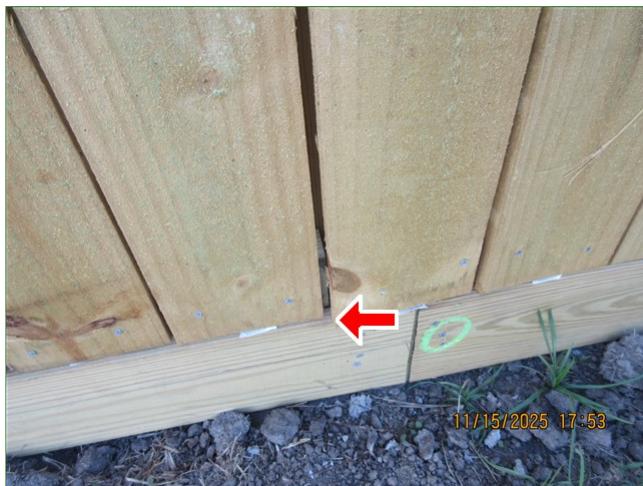
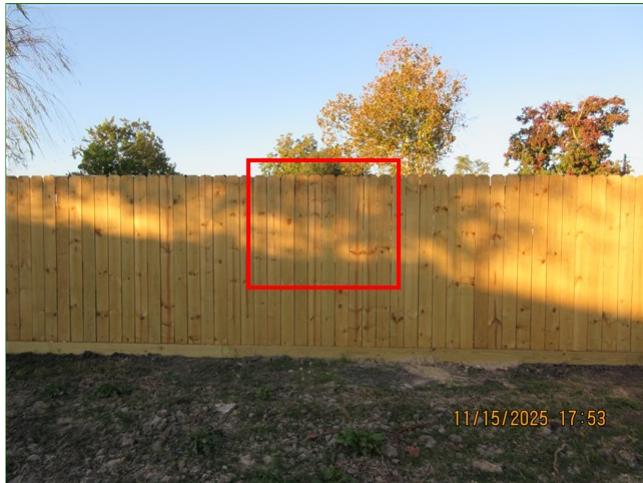
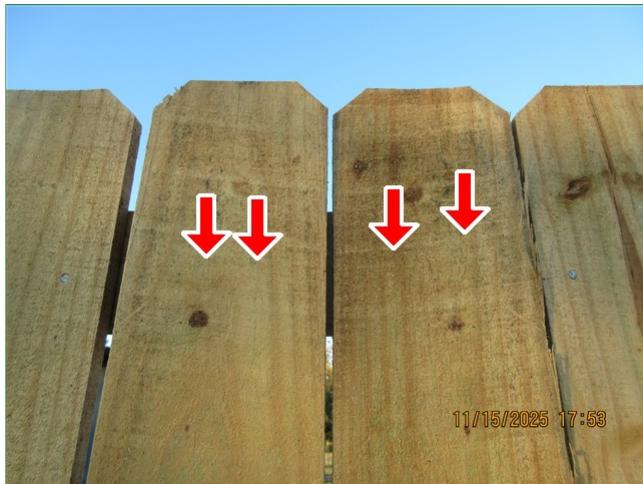
Multiple plank boards were loose on multiple sides of the fence at the time of the inspection. The inspector also noticed the fence felt loose at the time of the inspection. The inspector recommends properly securing the fences wood planks and ensuring sufficient amount of posts have been installed to properly support the fences length span.

L. Item 1 (Picture) Back of home, fence plank boards, loose

L. Item 2 (Picture) Back of home, fence plank boards, loose

L. Item 3 (Picture) Back of home, fence plank boards, loose

L. Item 4 (Picture) Back of home, fence plank boards, loose

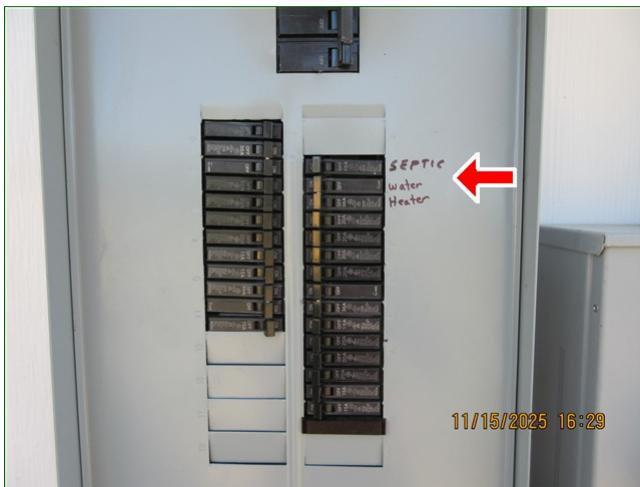
(1) Only 3 circuit breakers were labeled at the main electrical panelboard at the time of the inspection. This is a safety hazard. All circuit breakers should be labeled to assist in safe and proper circuit breaker shut offs.

A. Item 1 (Picture) Left of home, panel board, not labeled

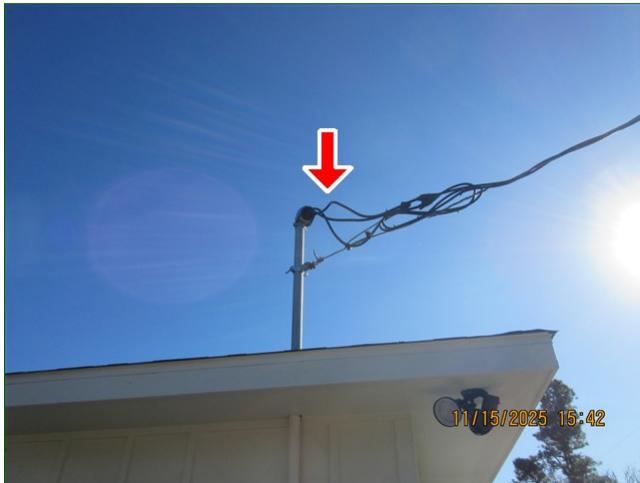
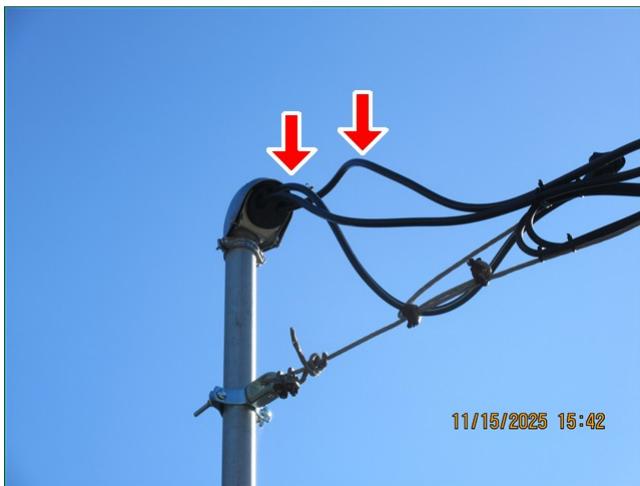
(2) An insufficient drip loop was observed at the main electrical service cable's service mast entrance at the time of the inspection. The inspector recommends speaking to the electric or utility company for further evaluation and correction to protect from moisture intrusion.

A. Item 2 (Picture) Front left of home, main electric service mast, insufficient drip loop

A. Item 3 (Picture) Front left of home, main electric service mast, insufficient drip loop

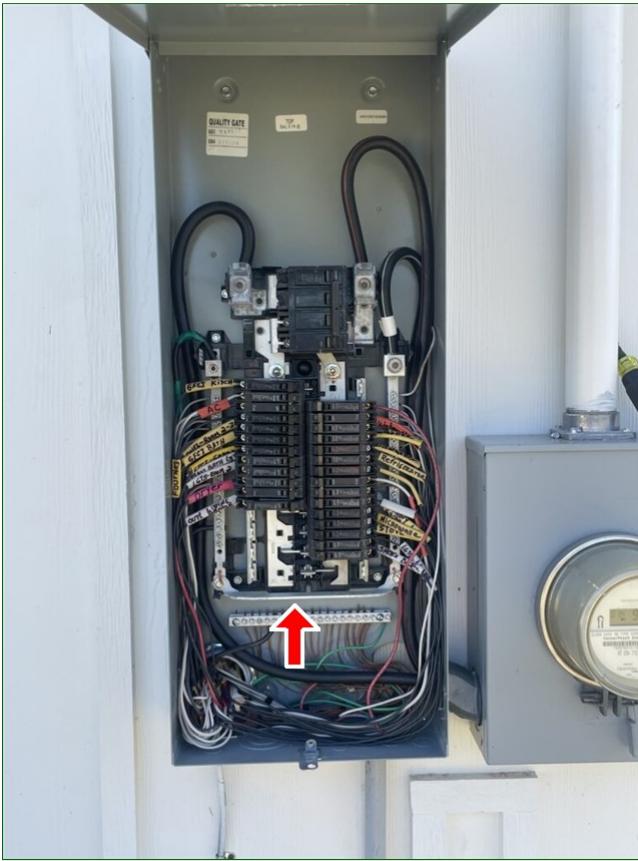
- No Main Bonding Jumper was observed in the main service panelboard at the time of the inspection.
- In the inspectors opinion, improper placement of the crossover tie bar was observed.

A. Item 4 (Picture) Left of home, main service panelboard, crossover tie bar, improper location

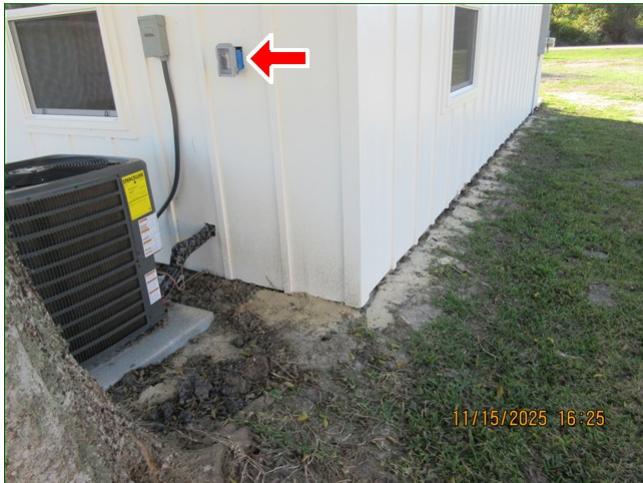
- (1) The inspector recommends all smoke detectors be tested upon moving in to home.
- (2) A loose exterior electrical outlet box was observed on the back side of the home at the time of the inspection. The inspector recommends correction by a qualified specialist to protect from moisture intrusion.

B. Item 1 (Picture) Back of home, electrical outlet box, loose

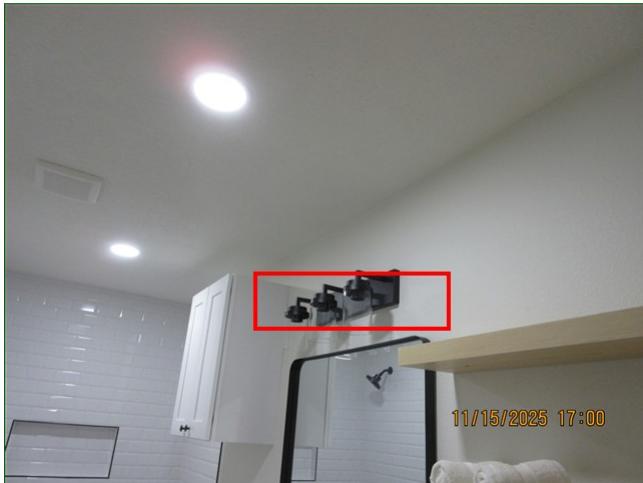
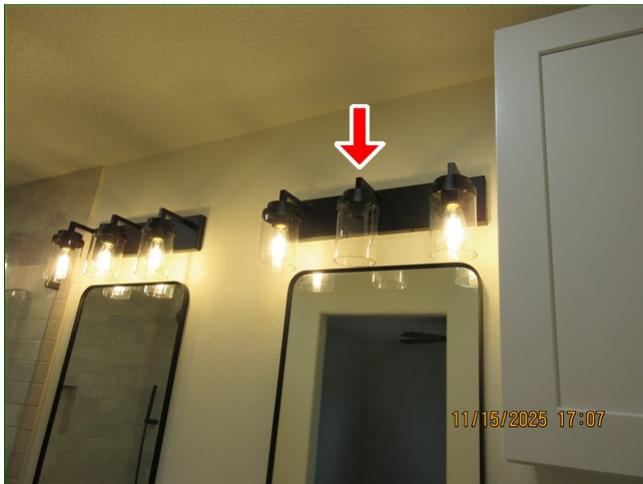
(3) No light bulbs were observed in multiple bathroom light fixtures at the time of the inspection. This is for your information.

B. Item 2 (Picture) Hallway, guest bathroom, no light bulbs

B. Item 3 (Picture) Master bathroom, missing light bulb

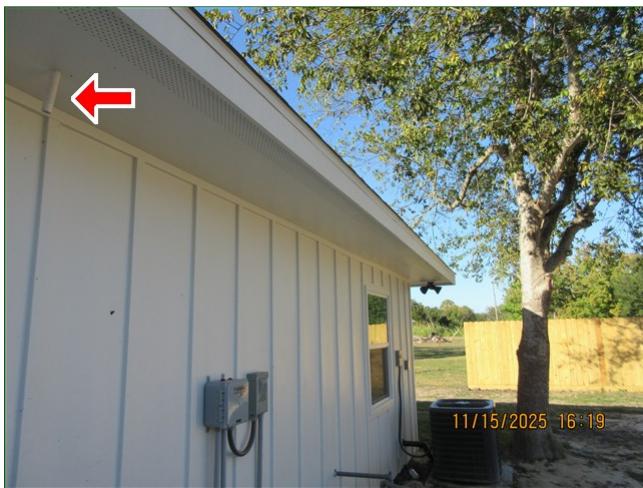
(1) The condensate drain like was observed in an inconspicuous location at the time of the inspection. The condensate drain line should terminate to the outdoors in a readily visible location. This is for your information.

D. Item 1 (Picture) Back of home, condensate drain termination, not in conspicuous location

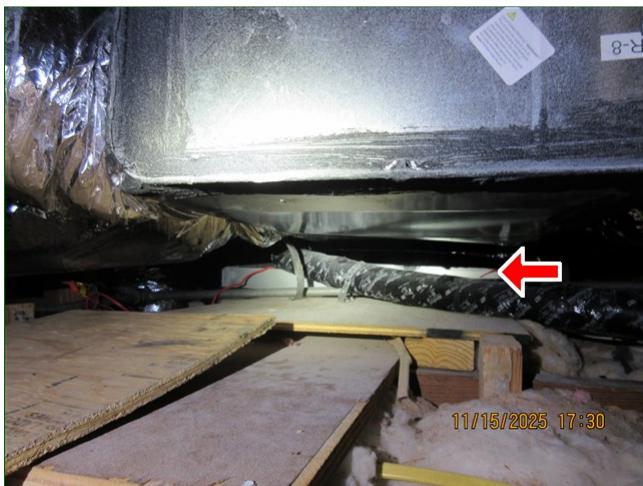
(2) In the inspectors opinion, an insufficient size drip pan was observed underneath the attic HVAC unit at the time of the inspection. There should be a drip pan large enough to catch any condensation or moisture dripping from the unit to protect from moisture damage. The inspector recommends installing a larger drip pan.

D. Item 2 (Picture) Attic, HVAC unit, insufficient drip pan

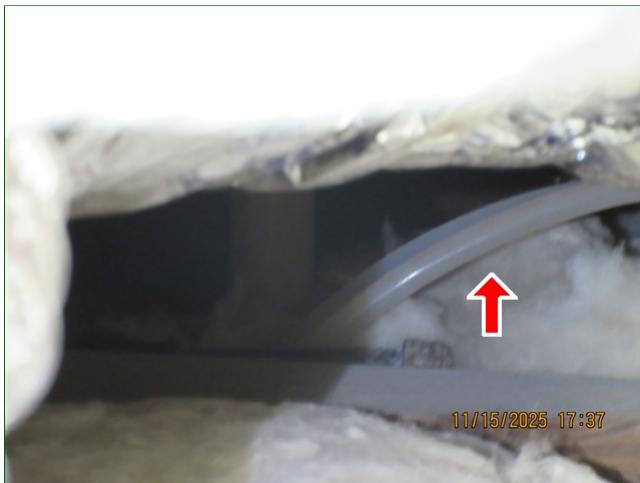
Exposed plumbing supply lines were observed in the attic at the time of the inspection. The inspector recommends speaking to the builder to have the supply pipes properly insulating to protect them from freezing/ bursting during the winter season.

A. Item 1 (Picture) Attic, plumbing supply pipes, exposed

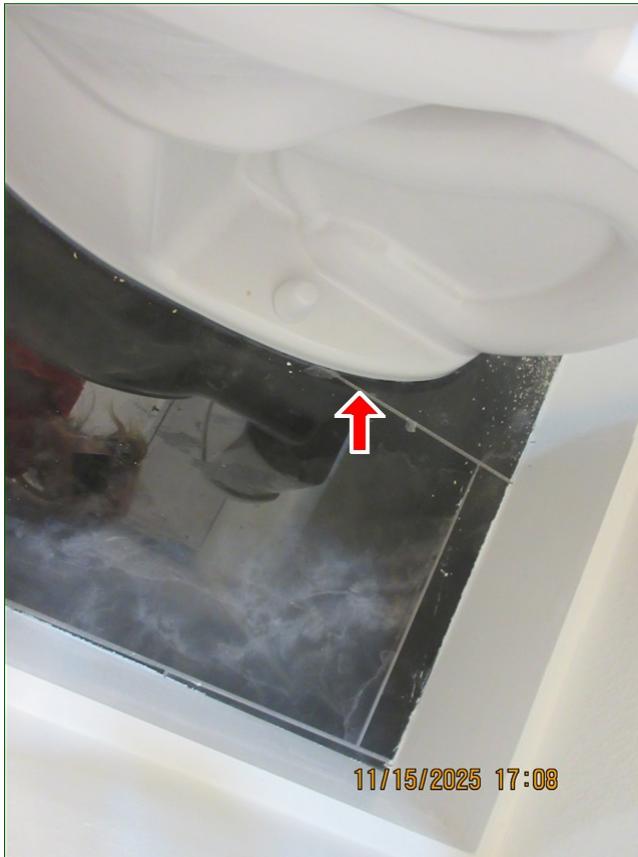
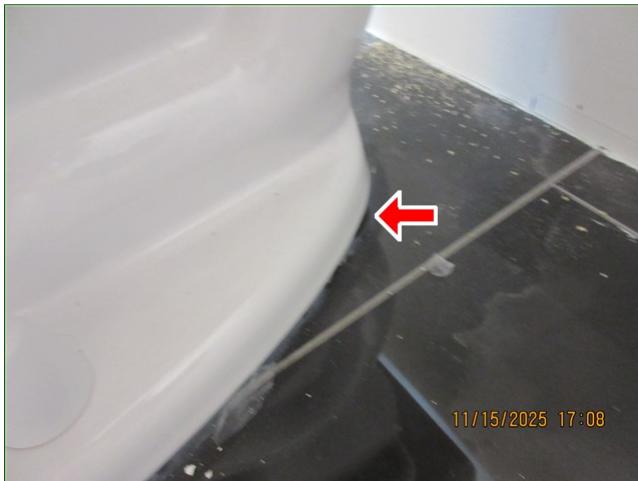
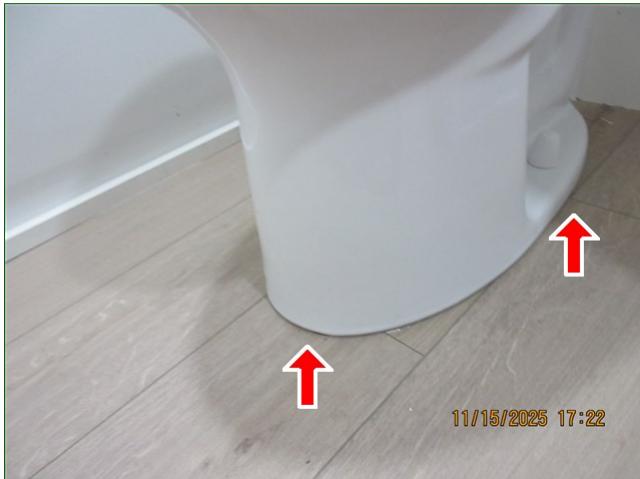
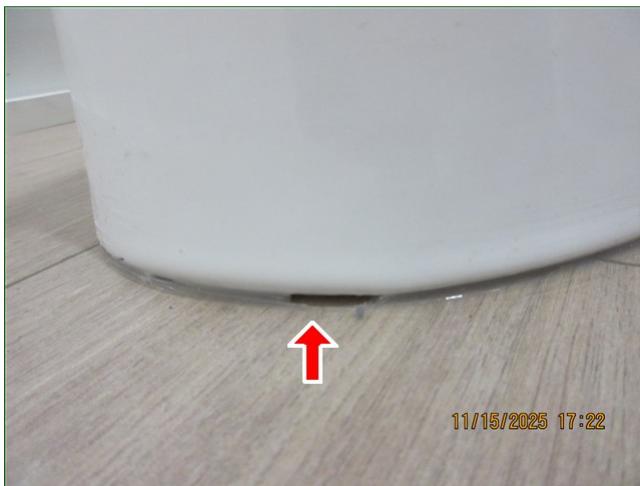
(1) Missing sealant/ caulk was observed at both of the bathroom toilet's floor connection at the time of the inspection. This is for your information.

B. Item 1 (Picture) Master bathroom, toilet floor connection, missing sealant

B. Item 2 (Picture) Master bathroom, toilet floor connection, missing sealant

B. Item 3 (Picture) bathroom, toilet floor connection, missing sealant

B. Item 4 (Picture) bathroom, toilet floor connection, missing sealant
