# Inspection Report

**Property Address:**  
1234 Masters Cir  
Baytown TX 77523

# PROPERTY INSPECTION REPORT FORM

John Doe	11/15/2025
Name of Client	Date of Inspection
1234 Masters Clr, Baytown, TX 77523	
Address of Inspected Property	
Amber Diehl TREC # 26115	TREC 26115
Name of Inspector	TREC License #
Name of Sponsor (if applicable)	
TREC License #

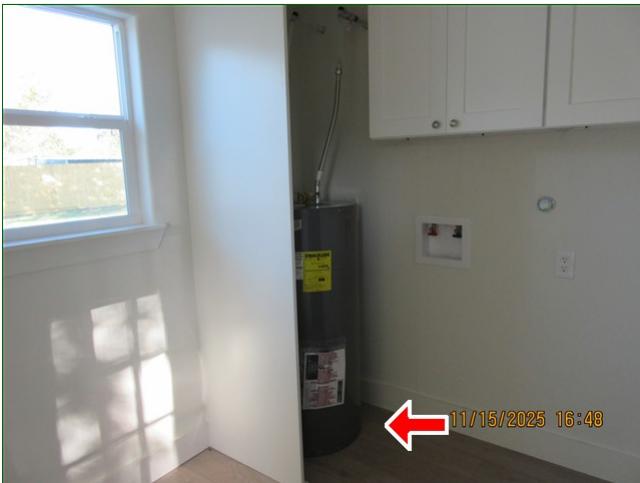
- No overflow drain pipe was installed at the water heater tank at the time of the inspection. The water heater should have an auxiliary drain pipe that terminated to the outdoors.

C. Item 1 (Picture) Utility/ laundry room, water heater tank, no auxiliary drain pan or pipe terminating to outdoors

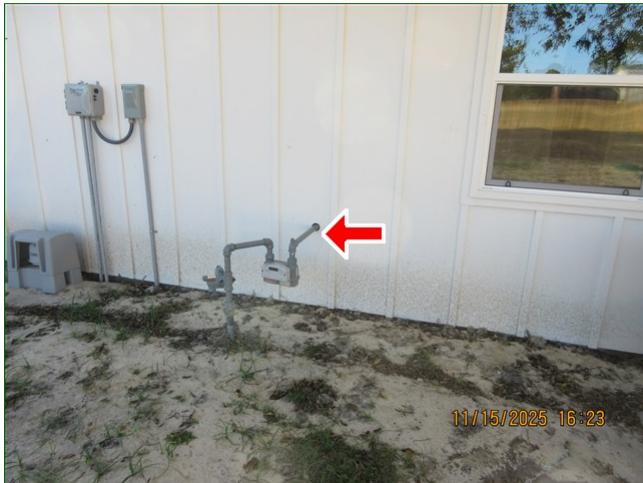
No electrical bonding wiring was observed at the gas meter/ supply pipe at the time of the inspection. The inspector recommends further evaluation by a licensed plumber to verify proper electrical bonding and grounding wires are installed.

E. Item 1 (Picture) Back of home, gas meter, no electrical bonding wired connection clamp

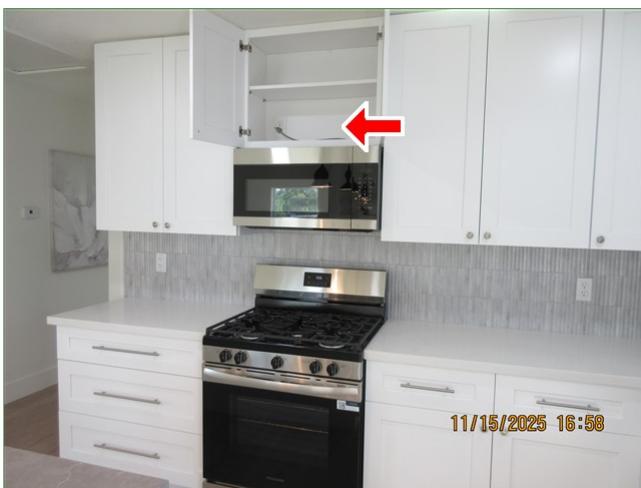
C. Item 1 (Picture) Kitchen, gas fueled oven/ stove, no exhaust vent to outdoors

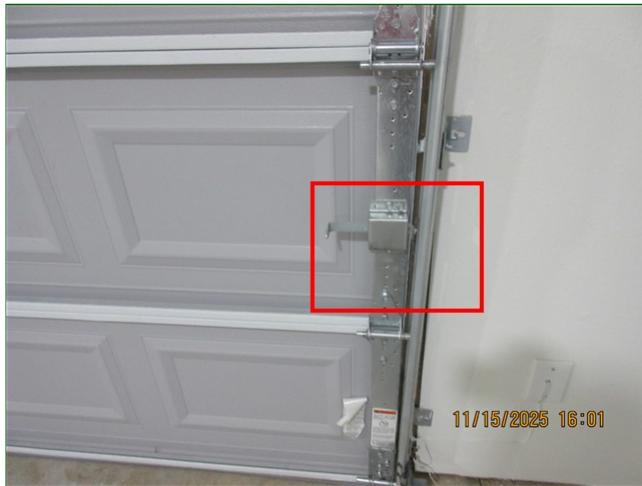
G. Item 1 (Picture) Garage door, manual lock, not disengaged

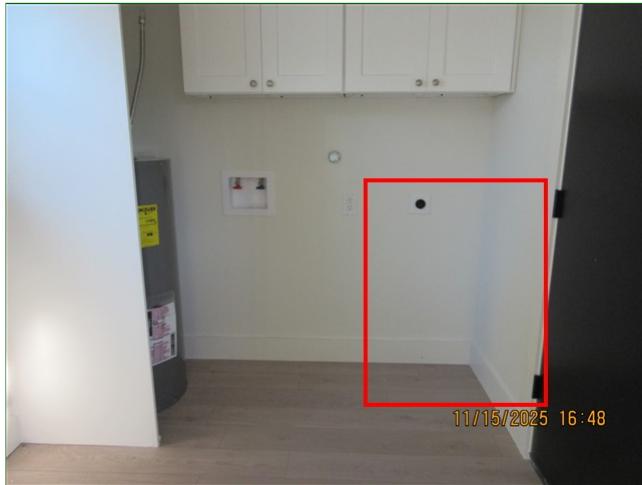
H. Item 1 (Picture) Utility/ laundry room, no dryer vent termination
