Inspection Report

1234 Masters Cir
Waller Tx 77484

PROPERTY INSPECTION REPORT FORM

1.0 DESCRIBE THE STAGE OF COMPLETION

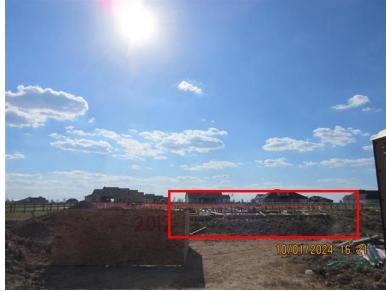
2.0 Item 1 (Picture)
Front of home, grade & elevation

The elevation and grade in regards to the home's footprint appears to be adequate at this stage. Although, due to there being multiple dirt piles present, verifying the slope was not possible. This is for your information.

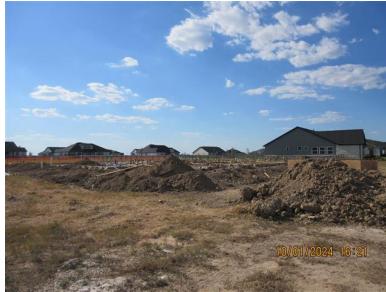
2.1 Item 1 (Picture)
Left side of home. piles of dirt

Evidence of sloping the ground to divert surface run-off was observed at the time of the inspection. There were many big piles of dirt/sand present and is for you information.

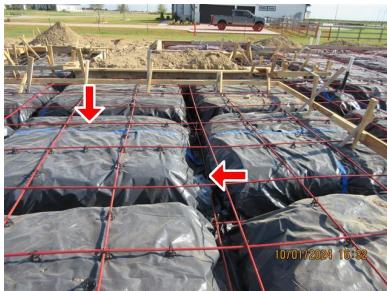
2.3 Item 1 (Picture)
Vapor barrier, tears and gaps/ separation

(1) The prep for slab is complete including gravel/dirt/sand, reinforced mesh wire and moisture barrier. However, the vapor barrier did not seem ready for the concrete to be poured. This is for your information and I recommend speaking to the builder to verify if they will be making adjustments to the vapor barriers joints and penetration locations.

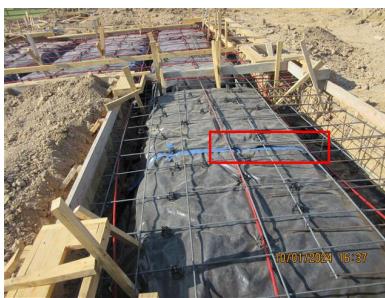
**2.3 Item 7 (Picture)**

Vapor barrier, tears and gaps/ separation

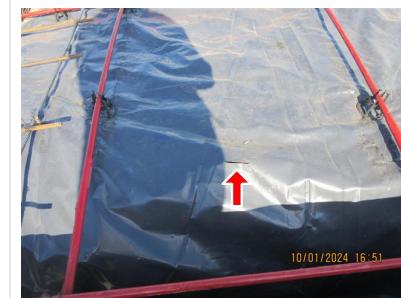
**2.3 Item 9 (Picture)**

Vapor barrier, tears and gaps/ separation

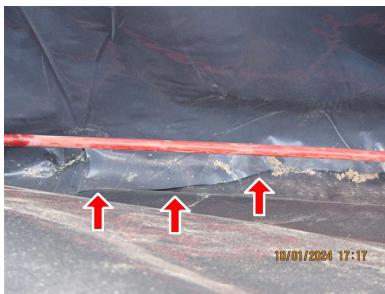
**2.3 Item 10 (Picture)**

Vapor barrier, tears and gaps/ separation

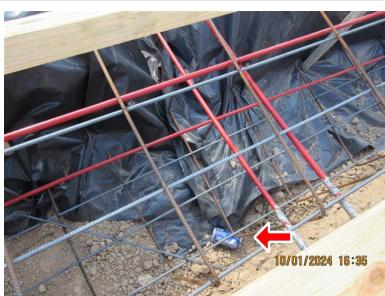
**2.3 Item 11 (Picture)**

(2) Debris/ trash was observed in multiple footings trenches, at the time of the inspection. This is for your information and I recommend speaking to the builder and having the debris/ trash removed prior to pouring the slab.

Exterior footing "wall", trash

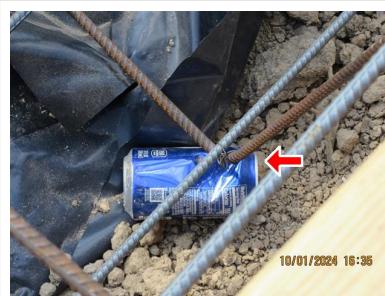
**2.3 Item 12 (Picture)**

Exterior footing "wall", trash

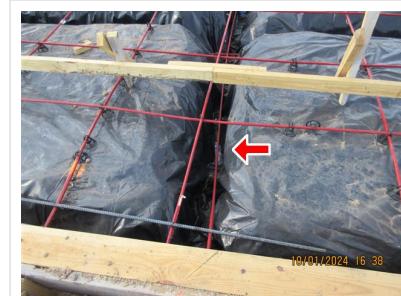
**2.3 Item 13 (Picture)**

Exterior footing "wall", trash

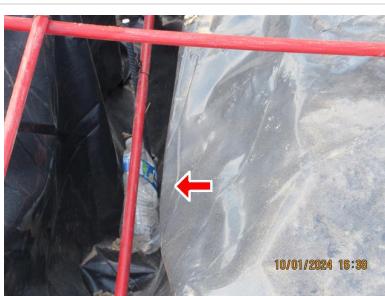
**2.3 Item 14 (Picture)**

Exterior footing "wall", trash

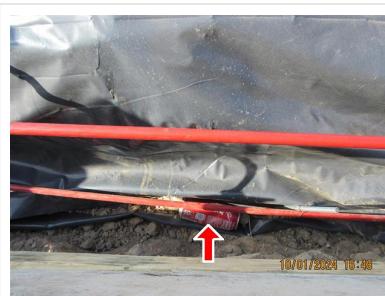
**2.3 Item 15 (Picture)**

Exterior footing "wall", trash

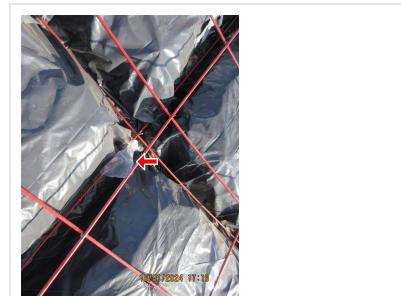
**2.3 Item 16 (Picture)**

Middle of foundation, footing "wall", trash

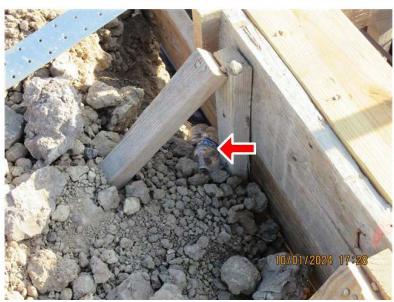
2.3 Item 17 (Picture)

Exterior footing "wall", trash
