# Infrared Inspection Report

*1234 Masters Cir  
Baytown, Texas 77523*

November 15, 2025

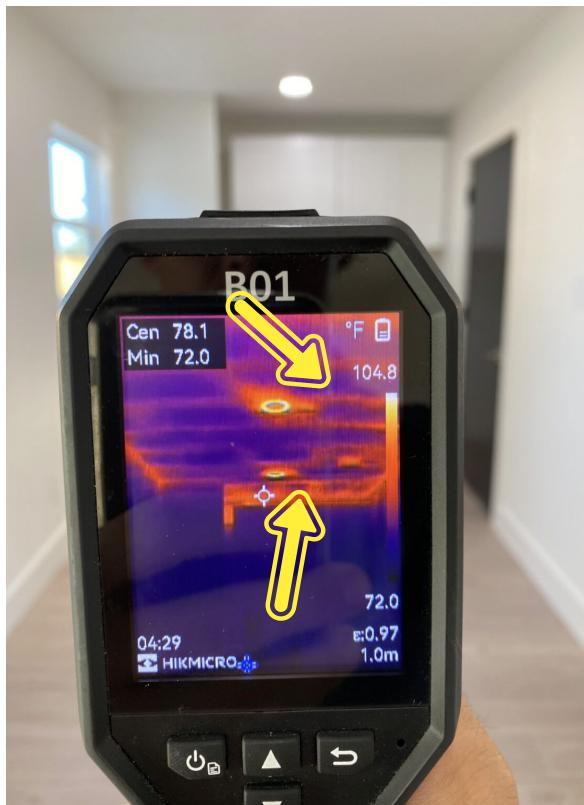
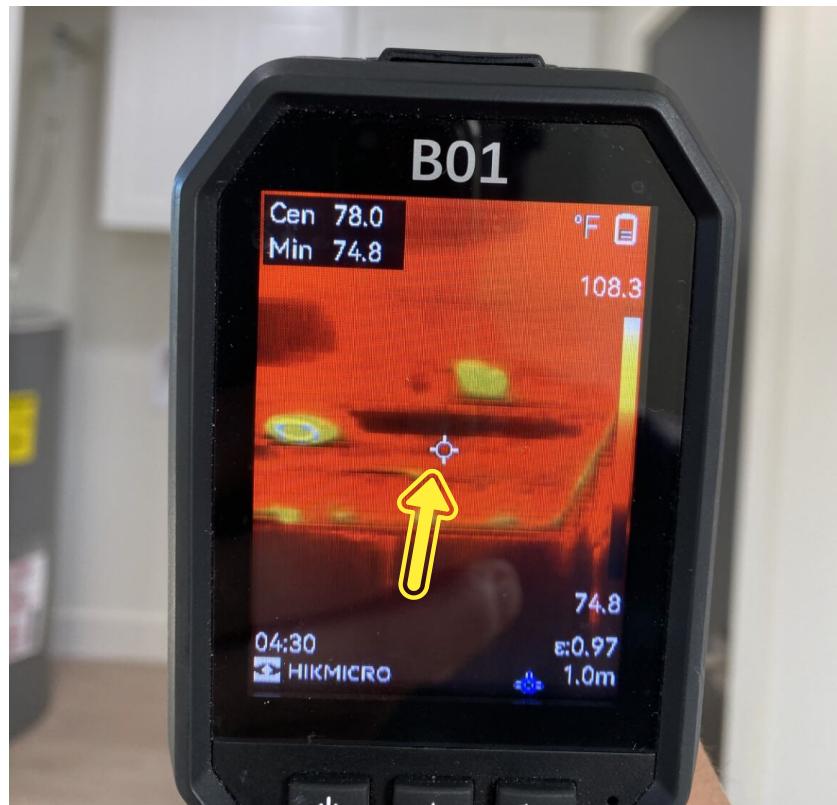
Thermal anomalies were observed in multiple locations of the home, at the time of the inspection. In the inspectors opinion, the anomalies present during the inspection were indicative of potential air infiltration. The inspector recommend further review and properly insulating as needed. The following is a report of our findings at the time of the inspection on Saturday November 15, 2025.

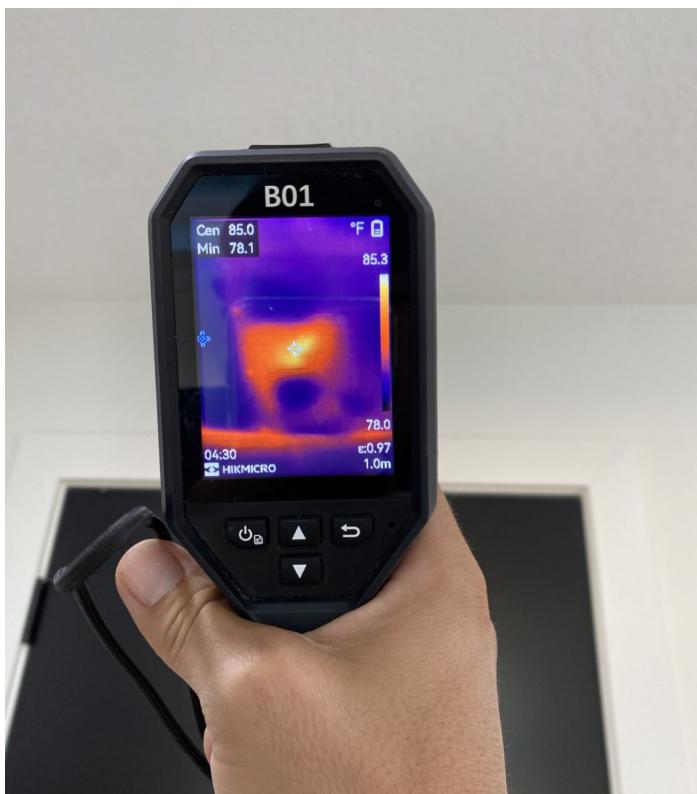
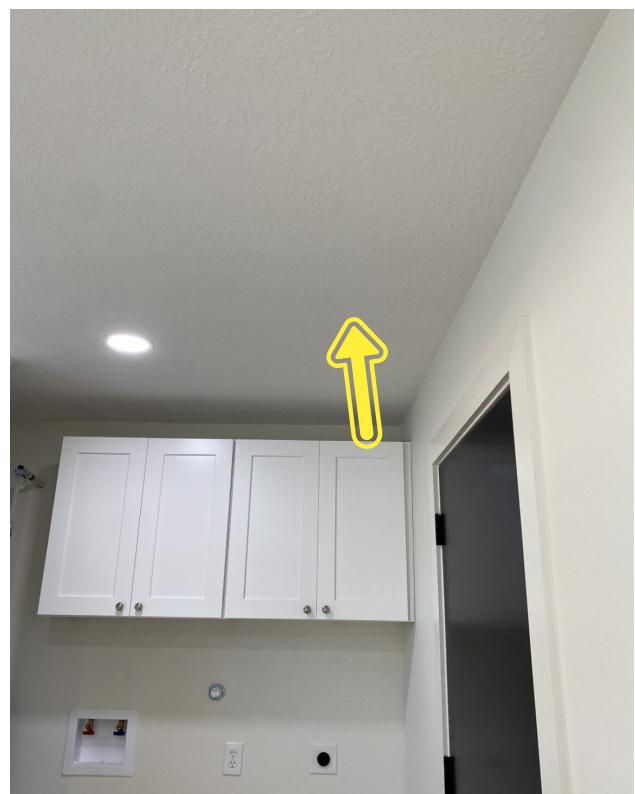
**LOCATION: Mud Room**

Thermal anomalies were observed in multiple locations of the home, at the time of the inspection. In the inspectors opinion, the anomalies present during the inspection were indicative of potential air infiltration at windows and corner joints. The inspector recommend further review and properly insulating as needed. The following is a report of our findings at the time of the inspection on Saturday November 15, 2025.

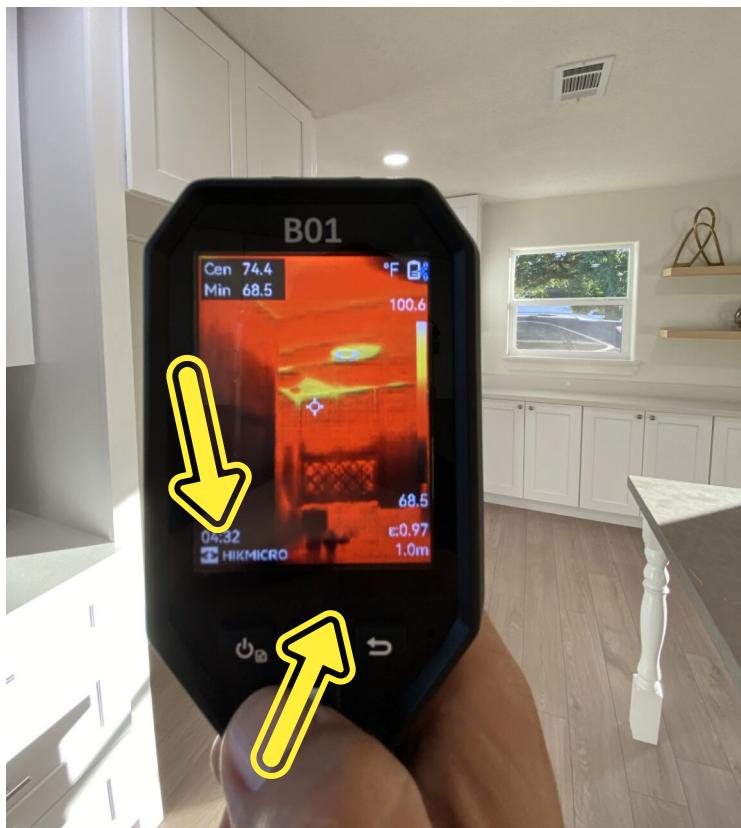
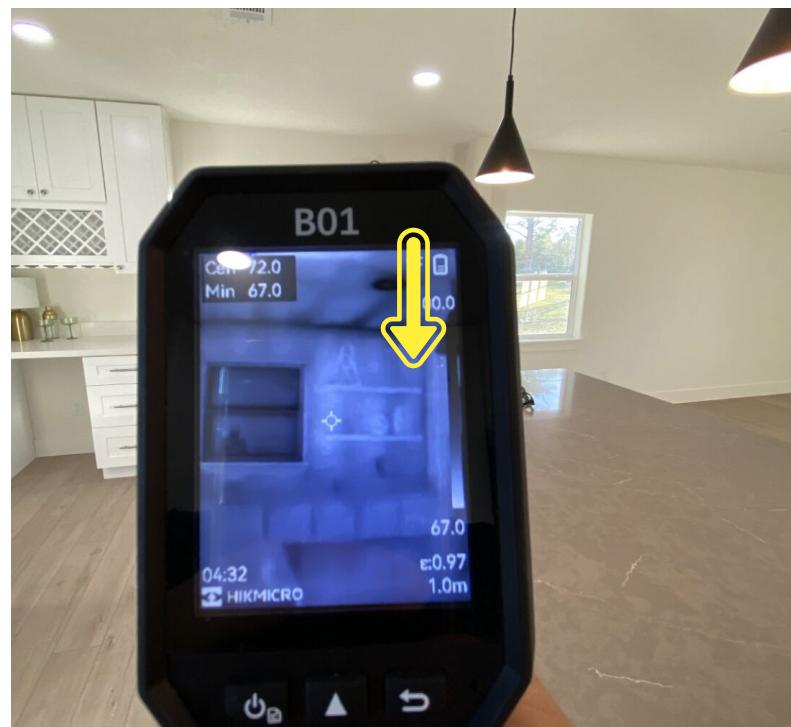
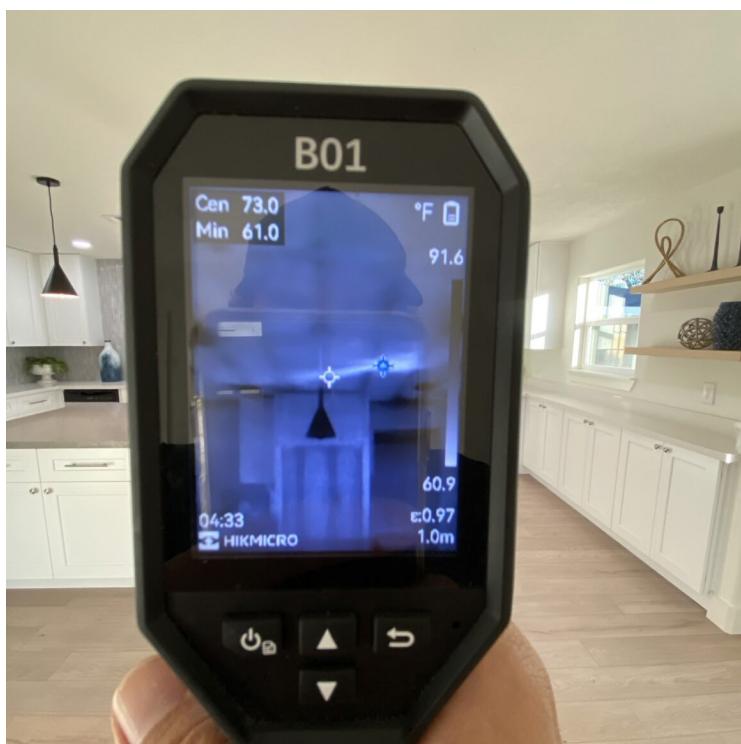
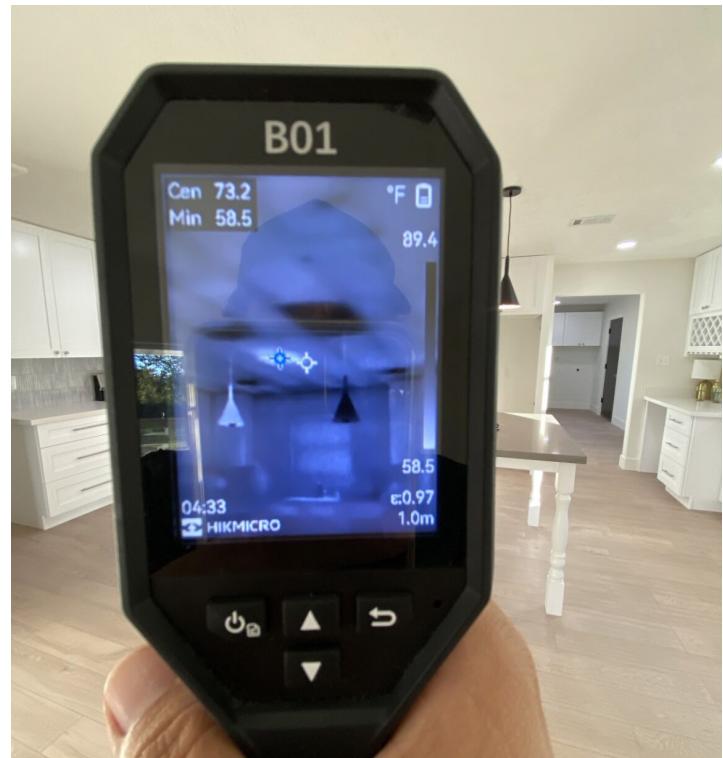
**LOCATION: Kitchen**

Thermal anomalies were observed in multiple locations of the home, at the time of the inspection. In the inspectors opinion, the anomalies present during the inspection were indicative of potential air infiltration at windows and corner joints. The inspector recommend further review and properly insulating as needed. The following is a report of our findings at the time of the inspection on Saturday November 15, 2025.

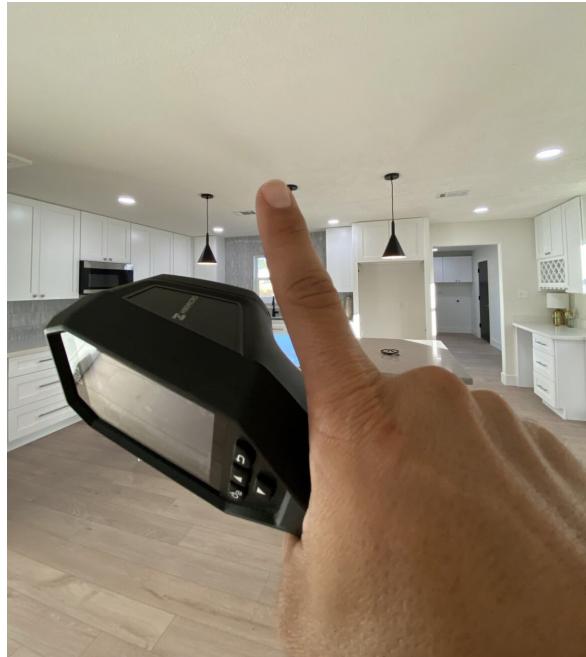
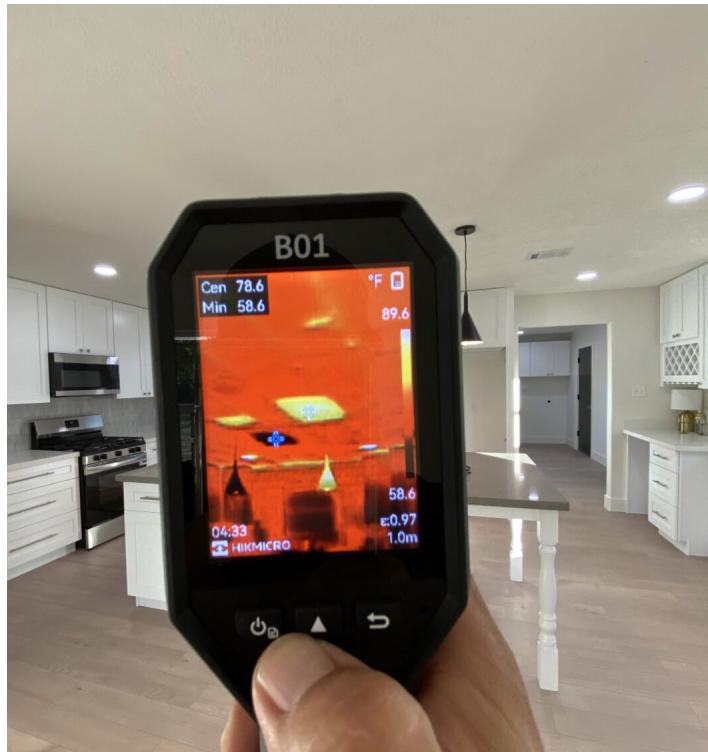
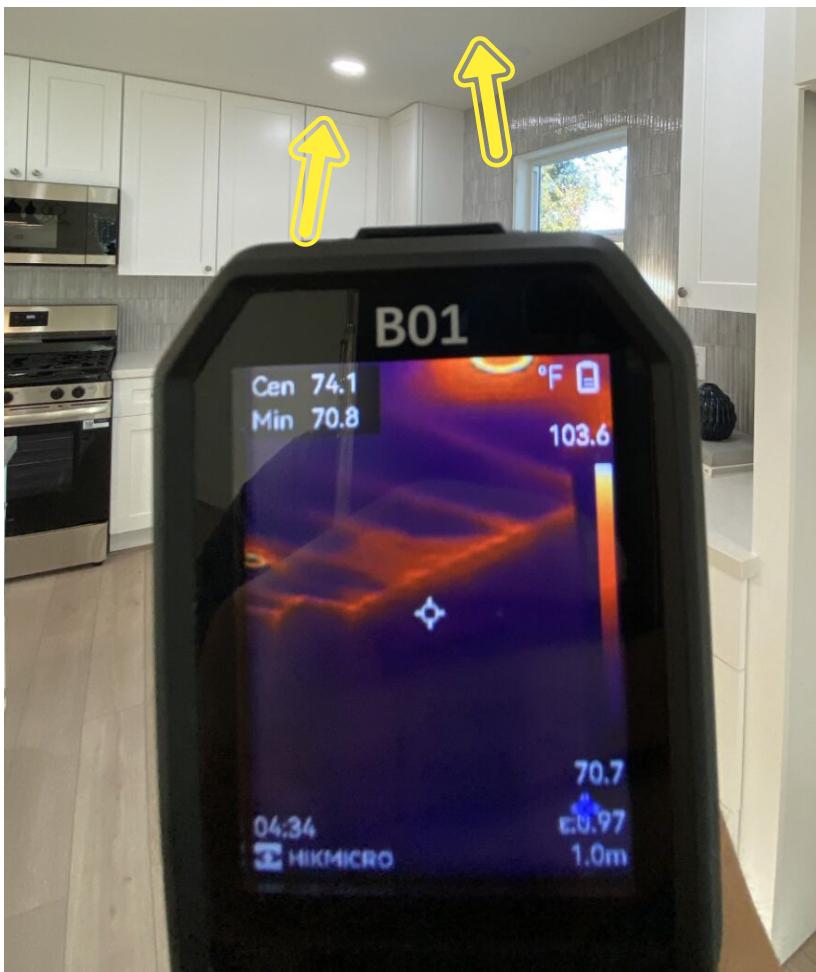
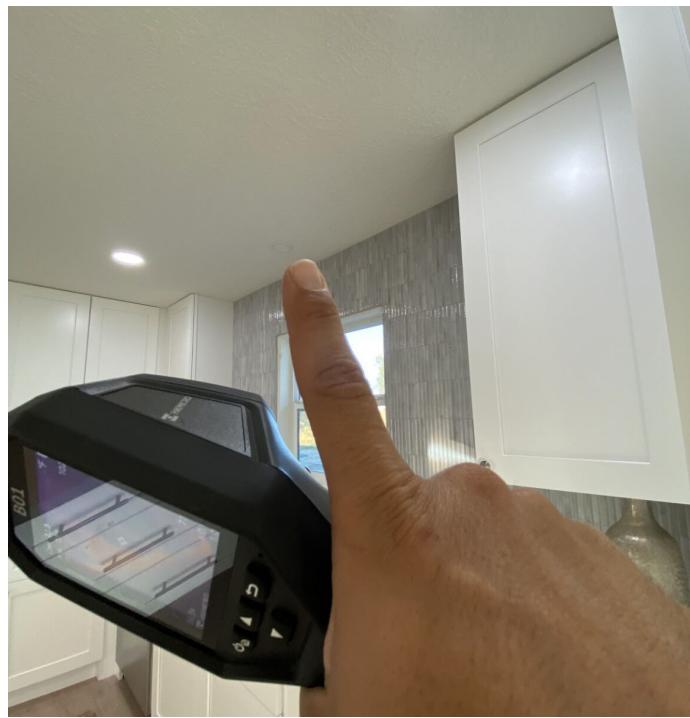
**LOCATION: Kitchen**

Thermal anomalies were observed in multiple locations of the home, at the time of the inspection. In the inspectors opinion, the anomalies present during the inspection were indicative of potential air infiltration at windows and corner joints. The inspector recommend further review and properly insulating as needed. The following is a report of our findings at the time of the inspection on Saturday November 15, 2025.

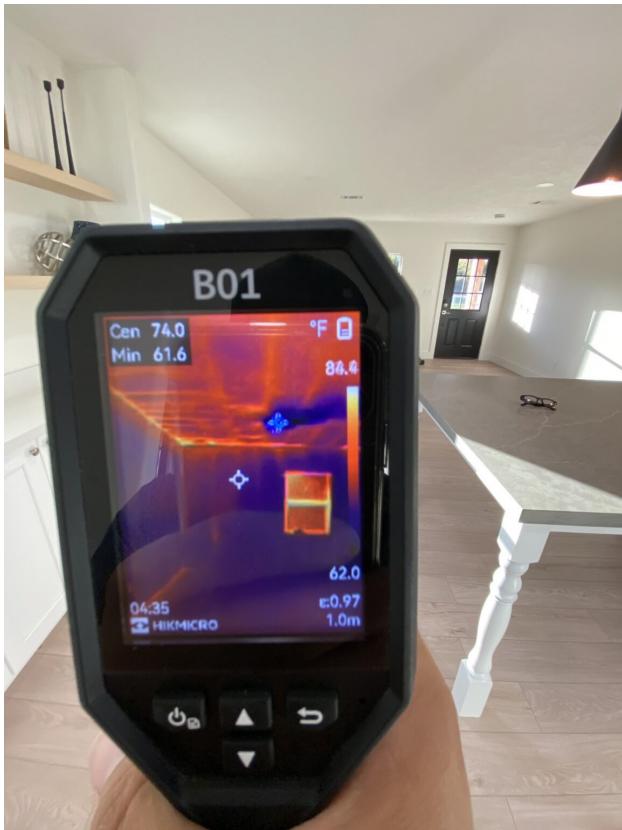
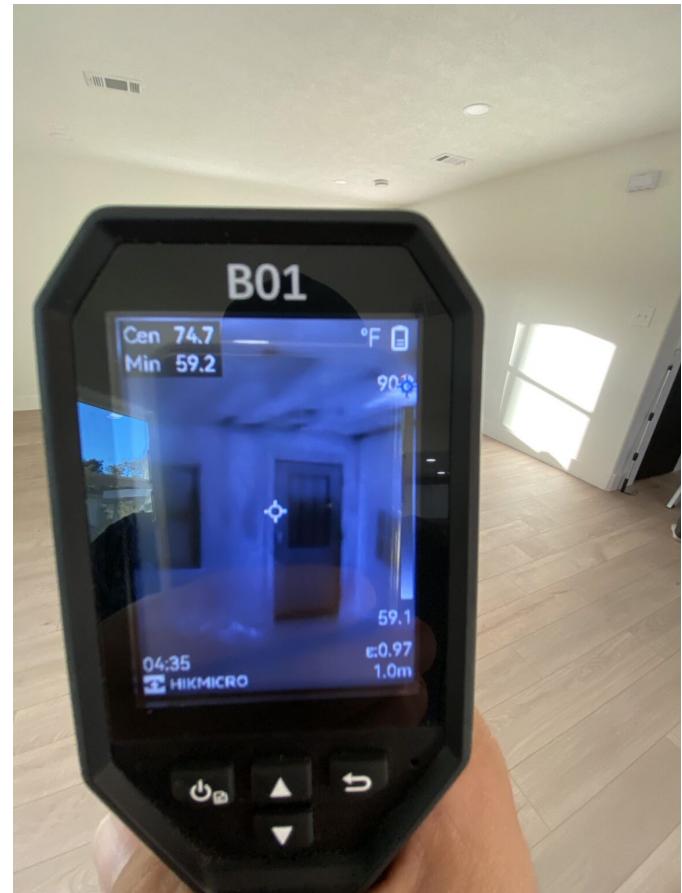
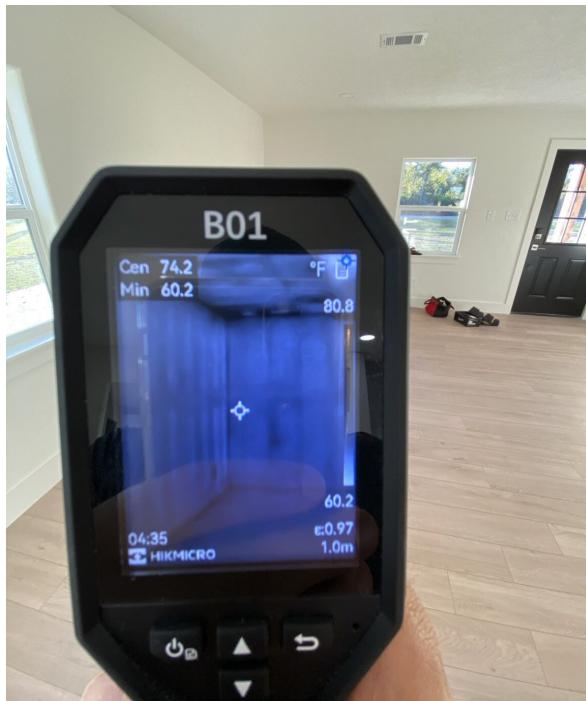
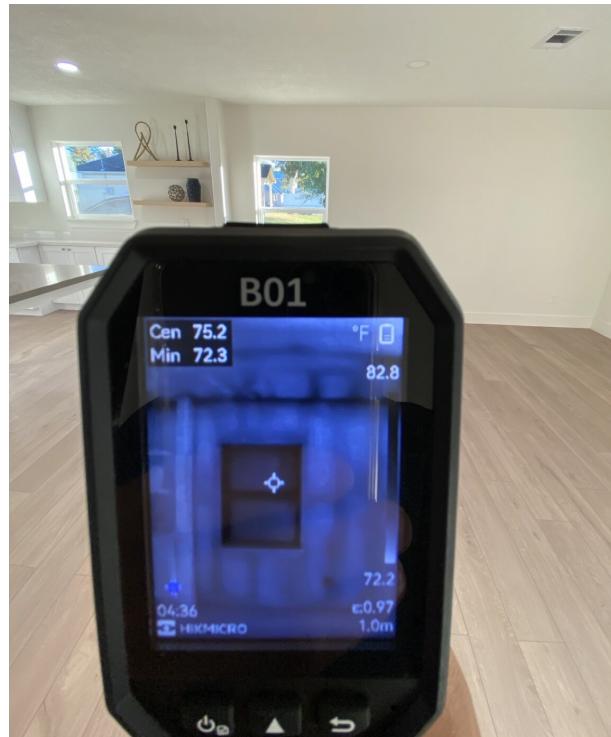
**LOCATION:** Living Room / Front Entry

Thermal anomalies were observed in multiple locations of the home, at the time of the inspection. In the inspectors opinion, the anomalies present during the inspection were indicative of potentially low levels or missing insulation, air infiltration and moisture. The inspector used a moisture meter detector to test for moisture. The moisture meter read low levels of moisture at the time of the inspection. This is for your information. The inspector recommend further review and properly insulating as needed. The following is a report of our findings at the time of the inspection on Monday November 15, 2025.

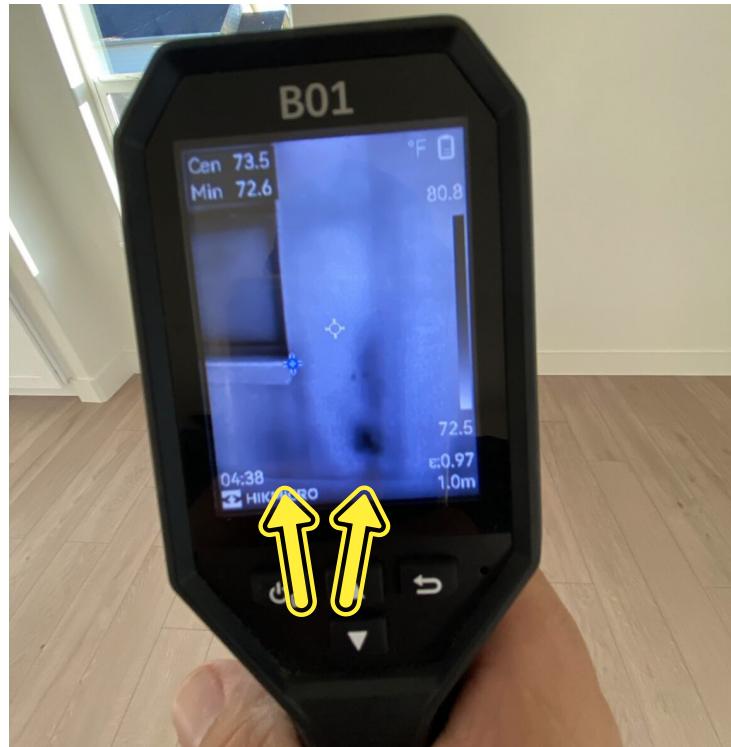
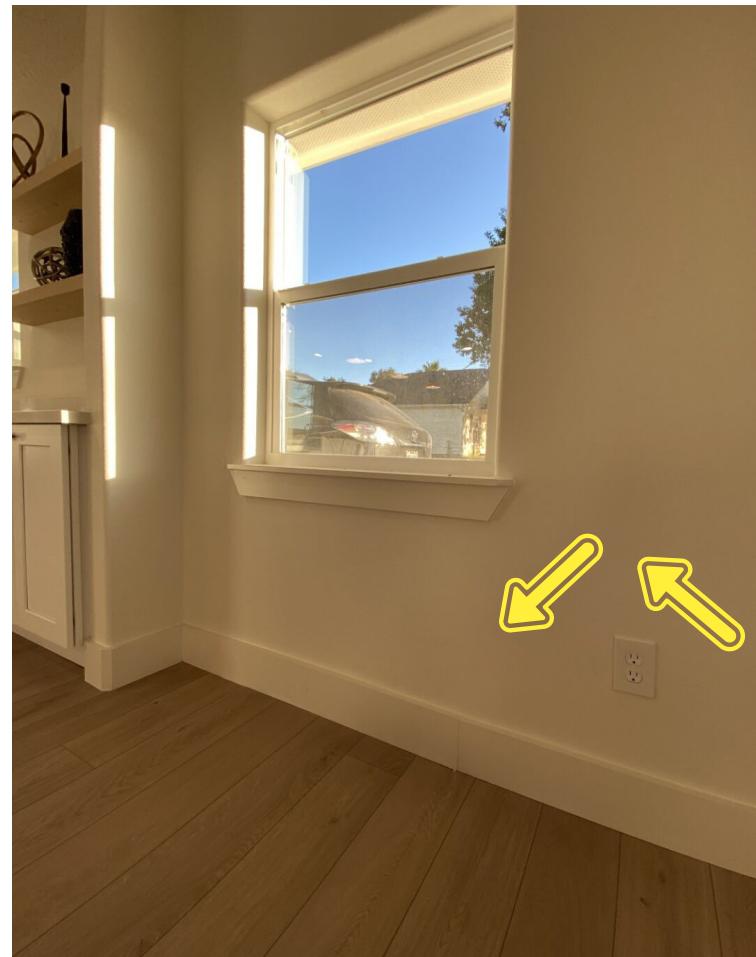
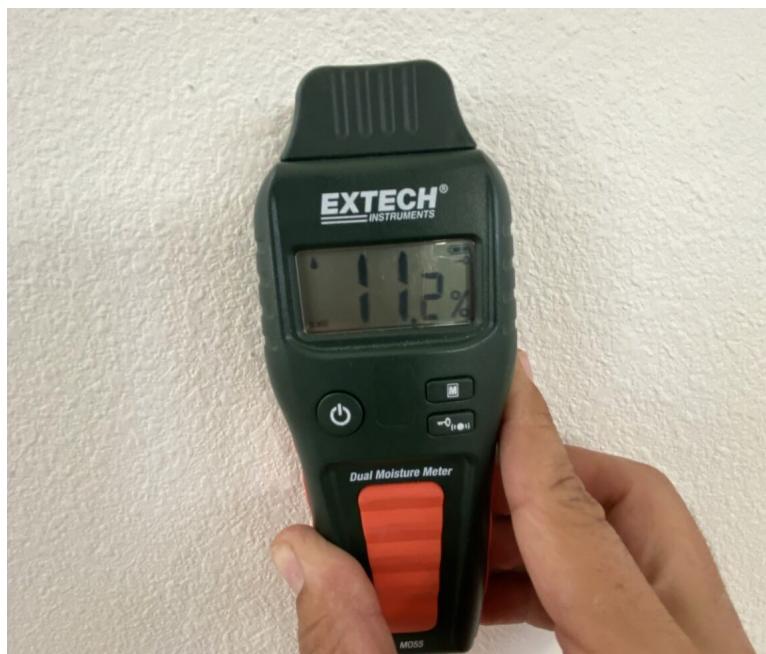
**LOCATION:** Living Room

Thermal anomalies were observed in multiple locations of the home, at the time of the inspection. In the inspectors opinion, the anomalies present during the inspection were indicative of potentially low levels or missing insulation, air infiltration and moisture. The inspector used a moisture meter detector to test for moisture. The moisture meter read low levels of moisture at the time of the inspection. This is for your information. The inspector recommend further review and properly insulating as needed. The following is a report of our findings at the time of the inspection on Monday November 15, 2025.

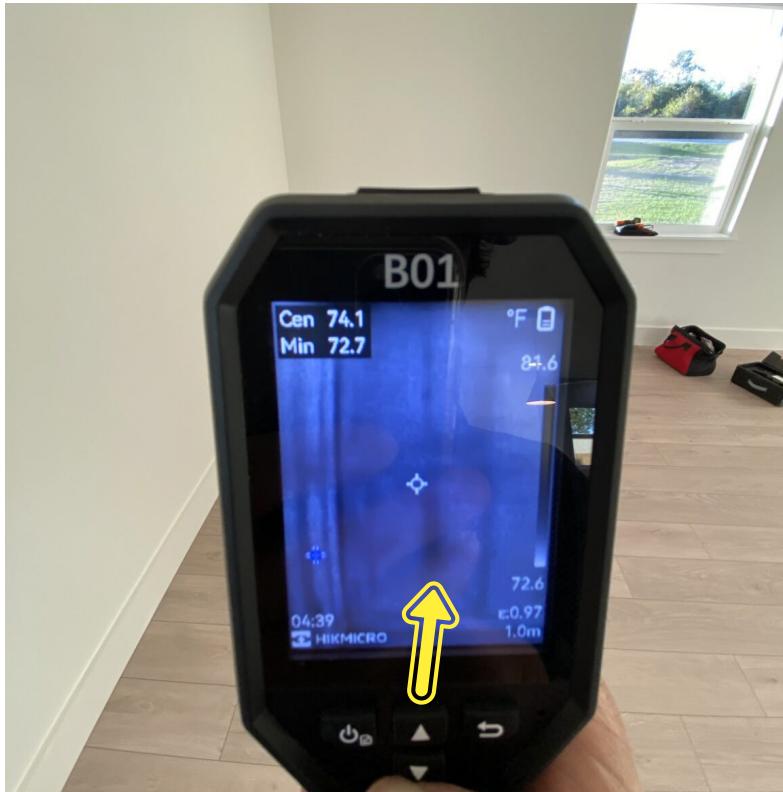
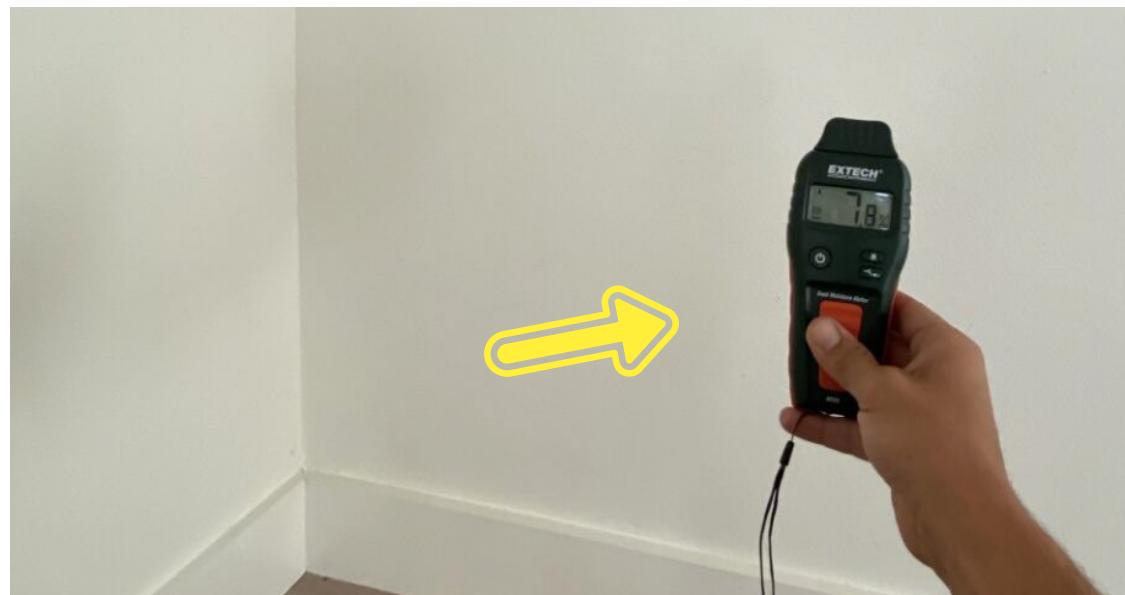
### LOCATION: Living Room

Thermal anomalies were observed in multiple locations of the home, at the time of the inspection. In the inspectors opinion, the anomalies present during the inspection were indicative of potential air infiltration at windows and corner joints. The inspector recommend further review and properly insulating as needed. The following is a report of our findings at the time of the inspection on Monday November 15, 2025.

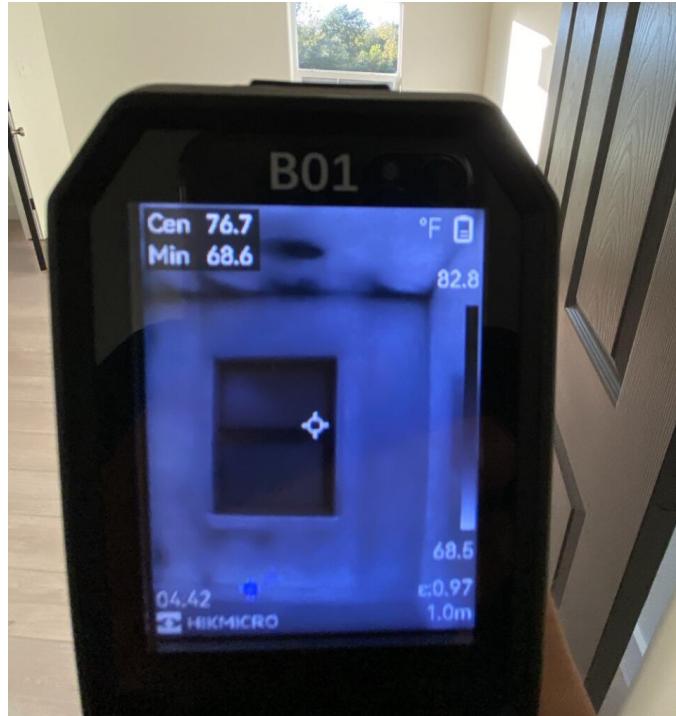
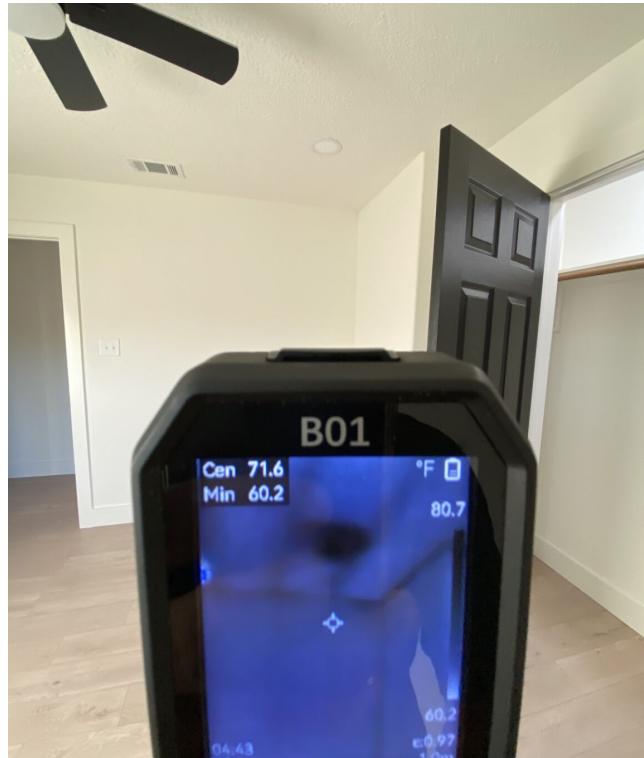
**LOCATION: 1st Guest Room Back**

Thermal anomalies were observed in multiple locations of the home, at the time of the inspection. In the inspectors opinion, the anomalies present during the inspection were indicative of potential air infiltration at windows and corner joints. The inspector recommend further review and properly insulating as needed. The following is a report of our findings at the time of the inspection on Monday November 15, 2025.

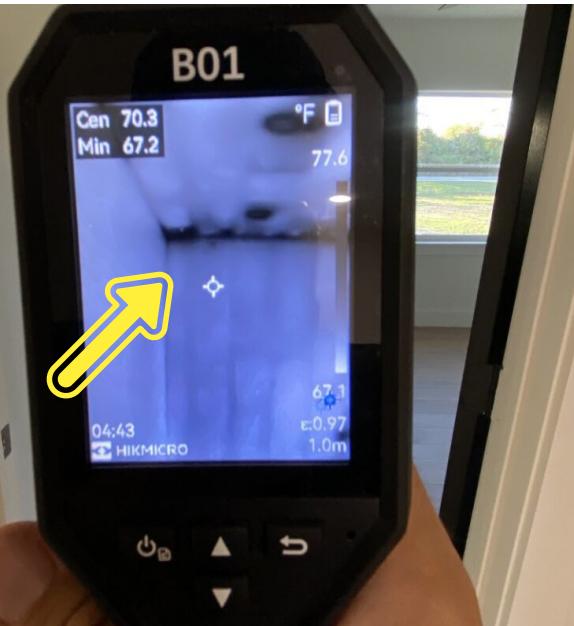
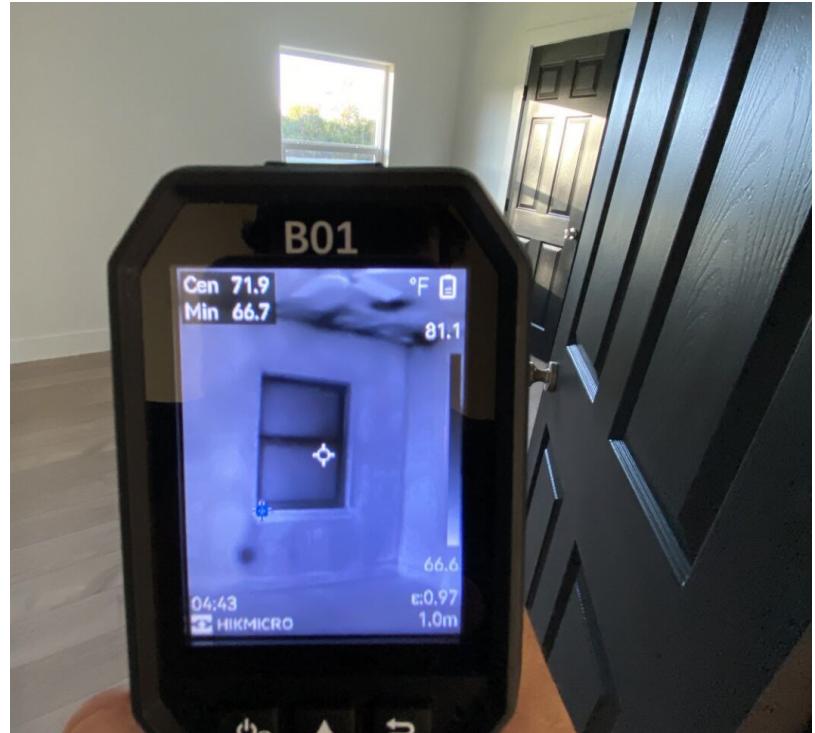
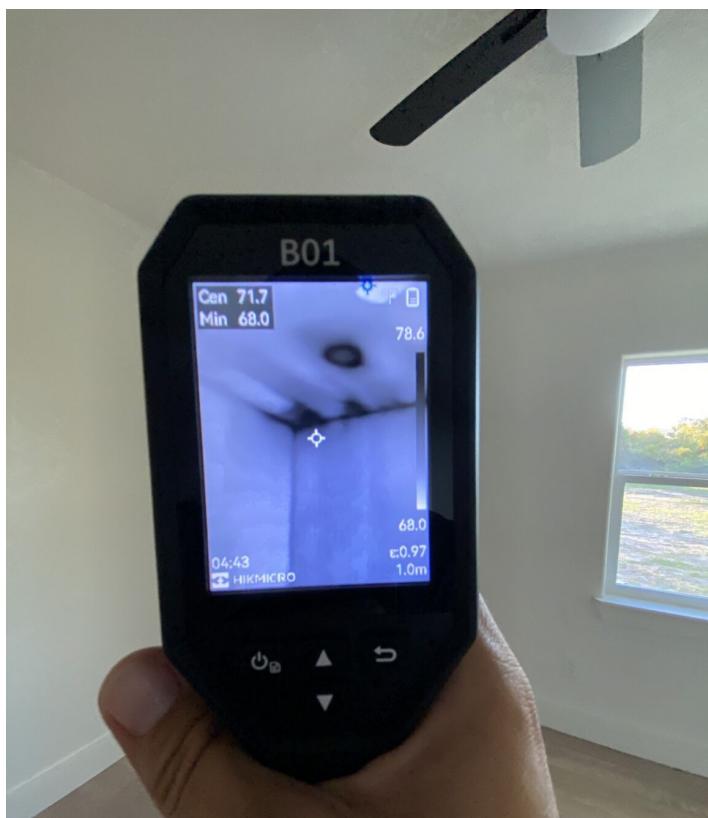
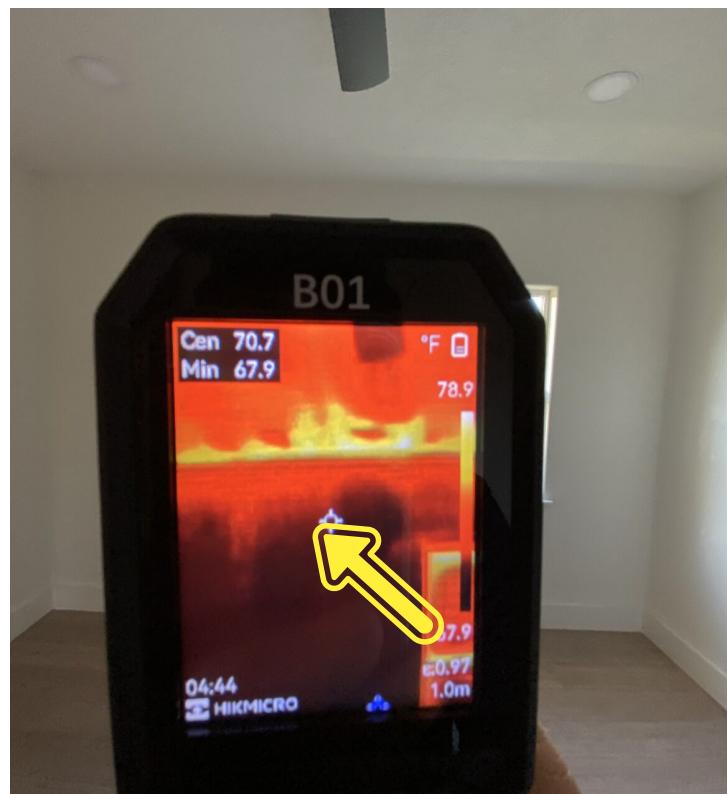
**LOCATION: 2nd Guest Room**

Thermal anomalies were observed in multiple locations of the home, at the time of the inspection. In the inspectors opinion, the anomalies present during the inspection were indicative of potential air infiltration at windows and corner joints. The inspector recommend further review and properly insulating as needed. The following is a report of our findings at the time of the inspection on Monday November 15, 2025.

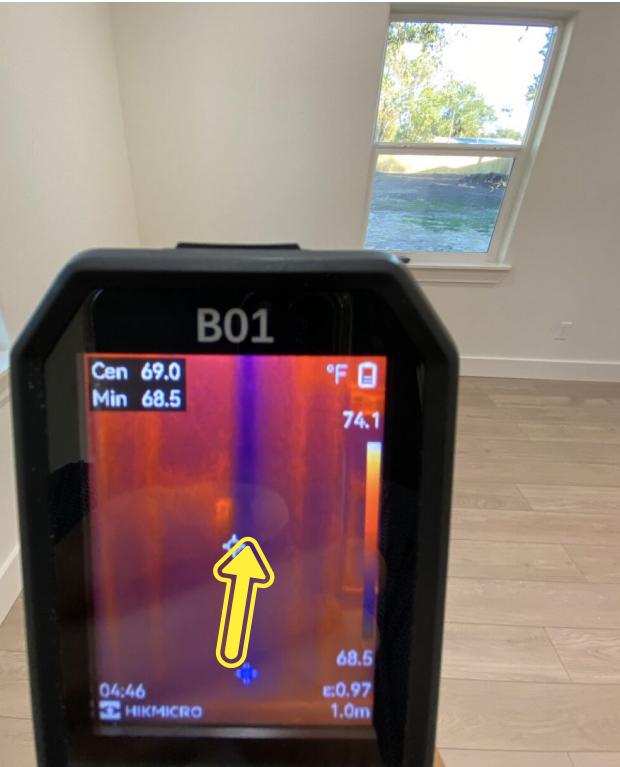
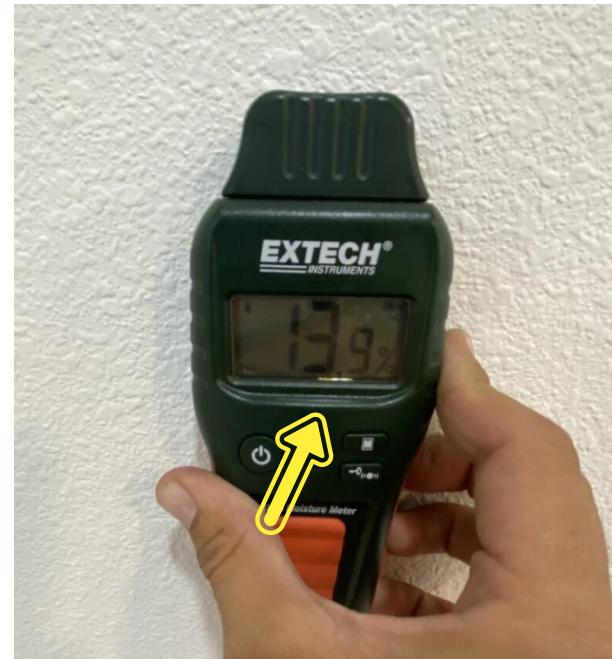
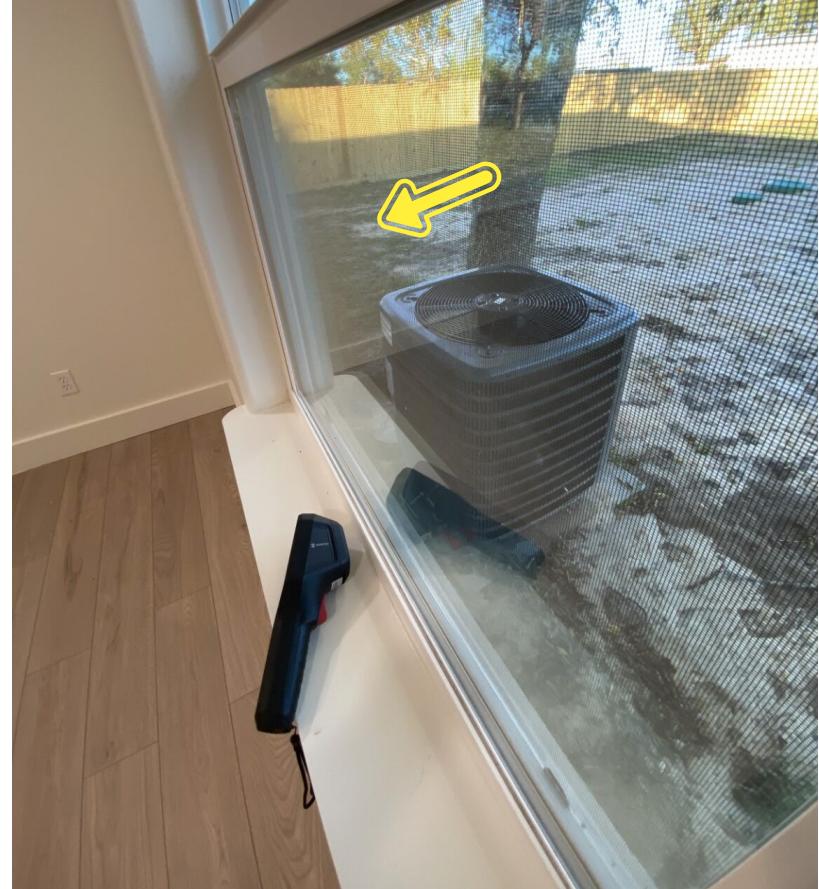
**LOCATION:** Master Bedroom

Thermal anomalies were observed in multiple locations of the home, at the time of the inspection. In the inspectors opinion, the anomalies present during the inspection were indicative of potential air infiltration at windows and corner joints. The inspector recommend further review and properly insulating as needed. The following is a report of our findings at the time of the inspection on Monday November 15, 2025.
