Inspection Report

Property Address:
1234 Masters Cir
Houston TX 77056

PROPERTY INSPECTION REPORT FORM

John Doe	11/25/2025
Name of Client	Date of Inspection
1234 Master Cir, Houston, TX 77056	
Address of Inspected Property	
Amber Diehl TREC # 26115	TREC 26115
Name of Inspector	TREC License #
Name of Sponsor (if applicable)	
TREC License #

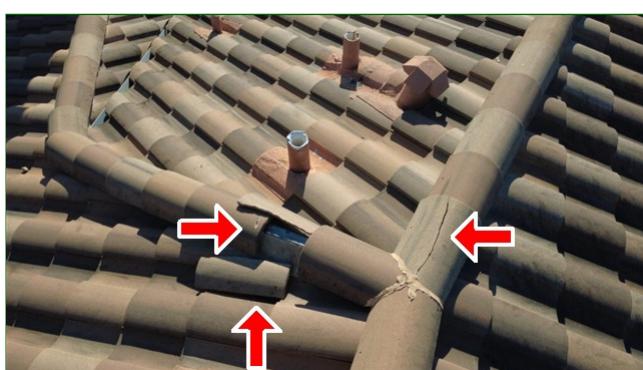
A cracked and missing tile roof covering was observed at the time of the inspection. This is for your information.

C. Item 1 (Picture) Roof, tile covering, cracked & missing

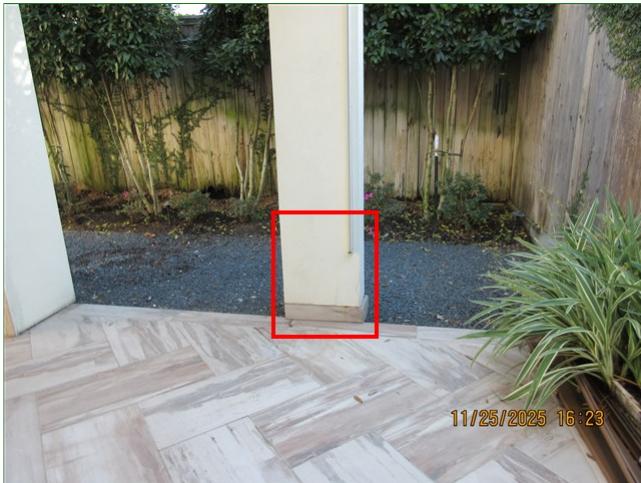
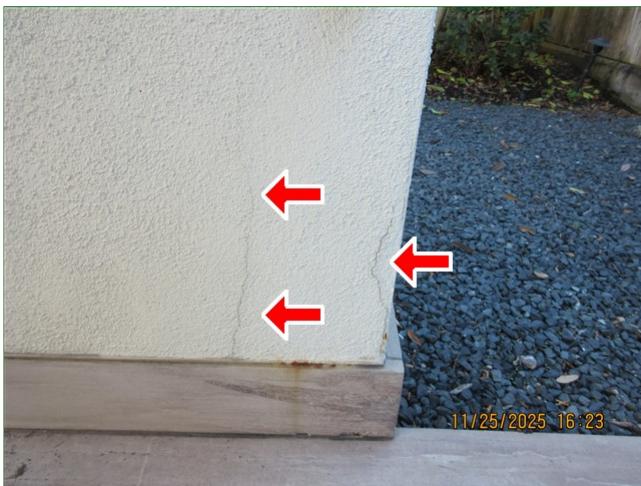
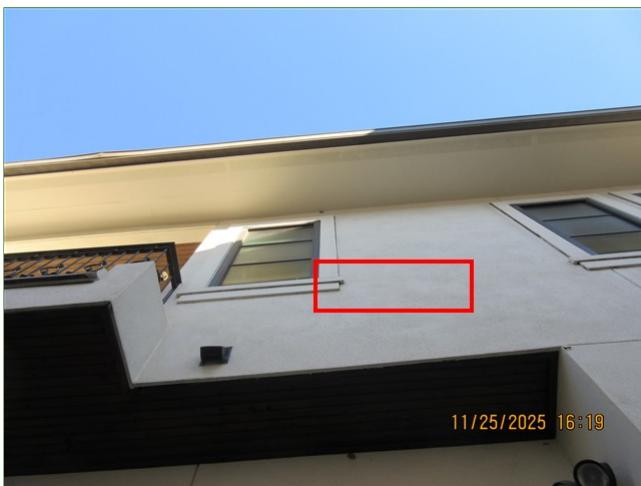
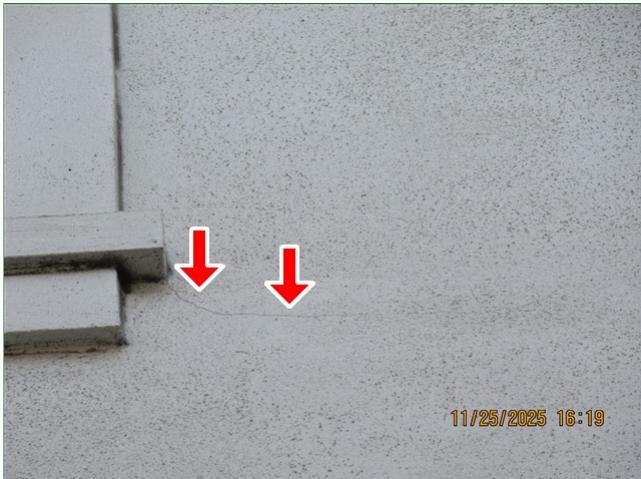
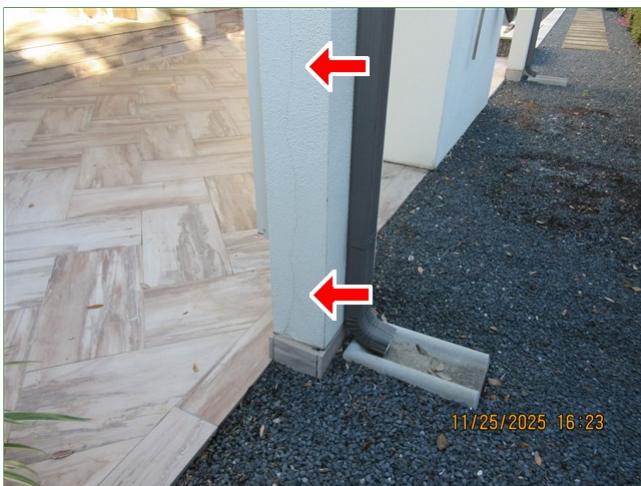
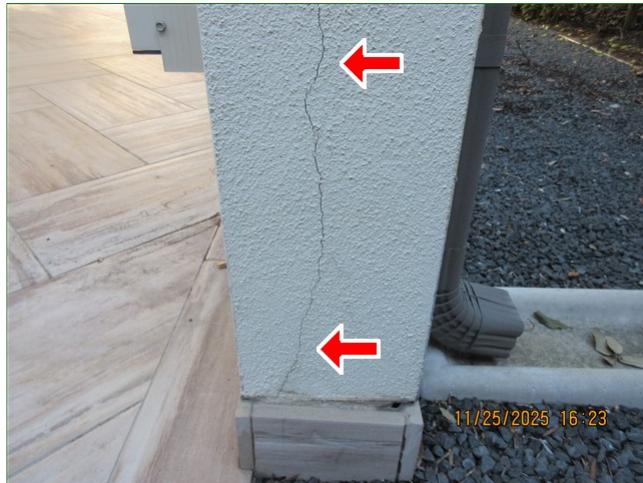
- Multiple hairline cracks were observed in multiple locations of the exterior stucco siding at the time of the inspection. In the inspectors opinion, these cracks were a minor concern at the time of the inspection. If you notice the cracks growing in width or if you are concerned, the inspector recommends further evaluation.
- No kick-out flashing was observed at most of the roof or balcony to wall connections.
- Non standard kick-out flashing installation was observed at the balcony to wall connection on the right side of the home.
- Moisture stains were observed on the exterior stucco siding below a section of gutters at the time of the inspection. The inspector recommends further evaluation and correction.

E. Item 1 (Picture) Back of home, stucco siding, hairline cracks

E. Item 2 (Picture) Back of home, stucco siding, hairline cracks

E. Item 3 (Picture) Right of home, stucco siding, hairline crack

E. Item 4 (Picture) Right of home, stucco siding, hairline crack

E. Item 9 (Picture) Back of home, stucco siding, hairline cracks

E. Item 10 (Picture) Back of home, stucco siding, hairline cracks

Multiple defects were observed in multiple locations of the exterior stucco siding at the time of the inspection. The inspector recommends further evaluation and correction by a qualified contractor if you are concerned. The defects observed are listed below:

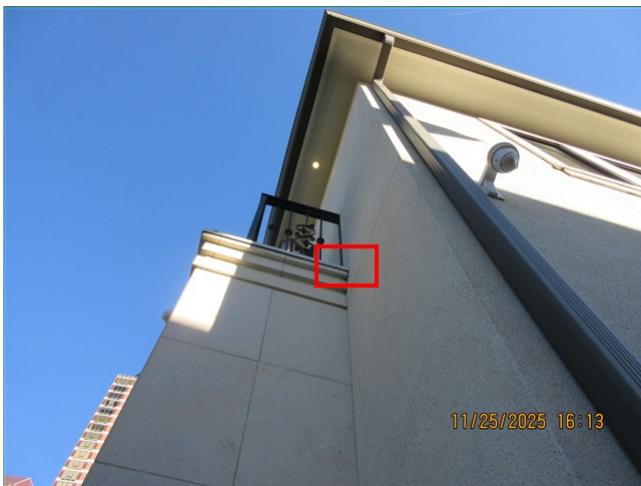
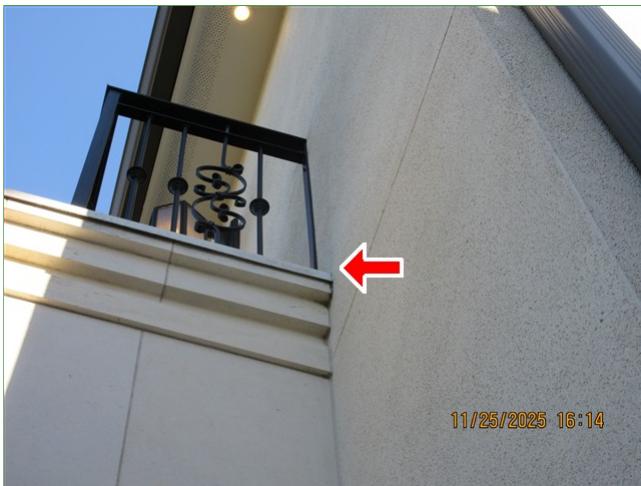
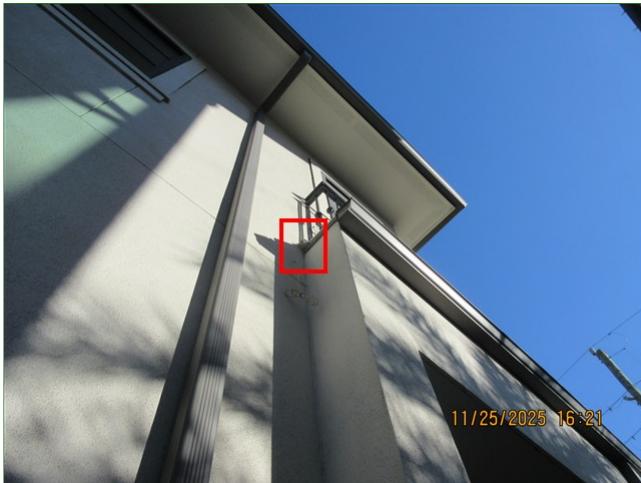
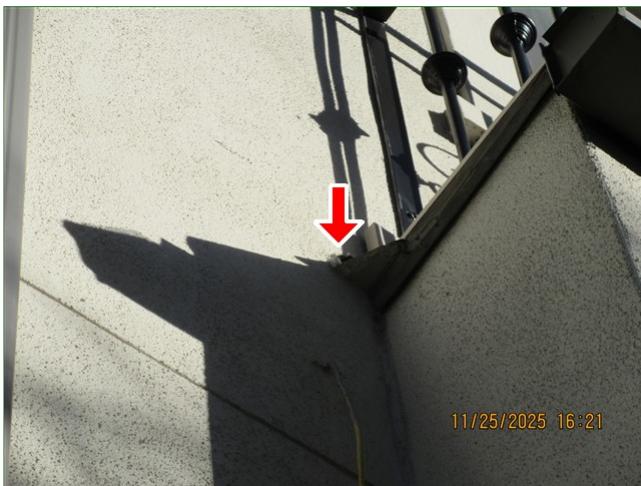
E. Item 5 (Picture) Front of home, balcony to wall connection, no kick-out flashing

E. Item 6 (Picture) Front of home, balcony to wall connection, no kick-out flashing

E. Item 7 (Picture) Right of home, balcony to wall connection, non standard kick-out flashing

E. Item 8 (Picture) Right of home, balcony to wall connection, non standard kick-out flashing

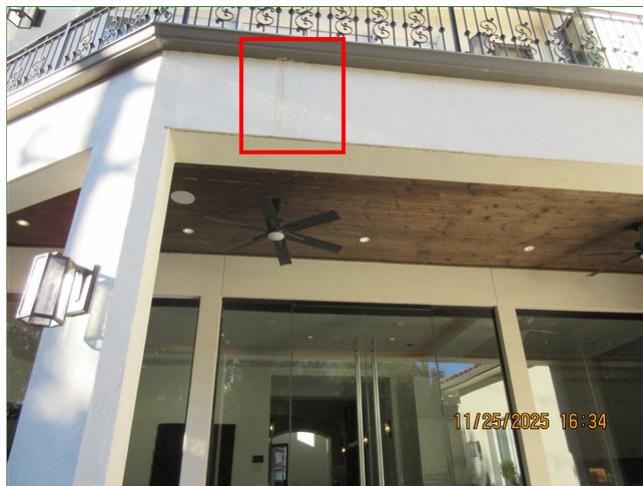
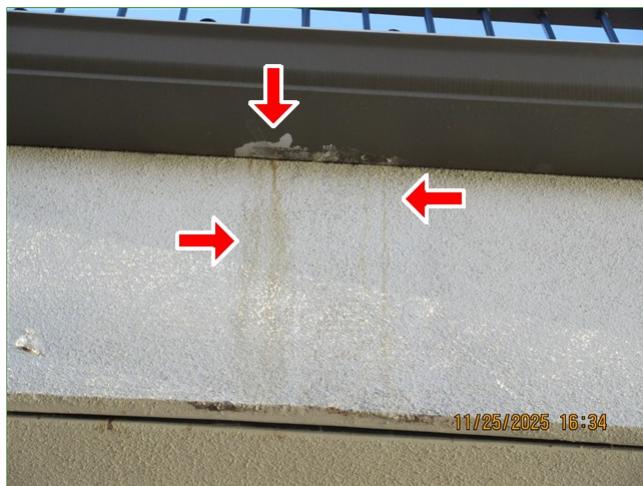
E. Item 11 (Picture) Back of home, stucco siding, moisture stains

E. Item 12 (Picture) Back of home, stucco siding, moisture stains

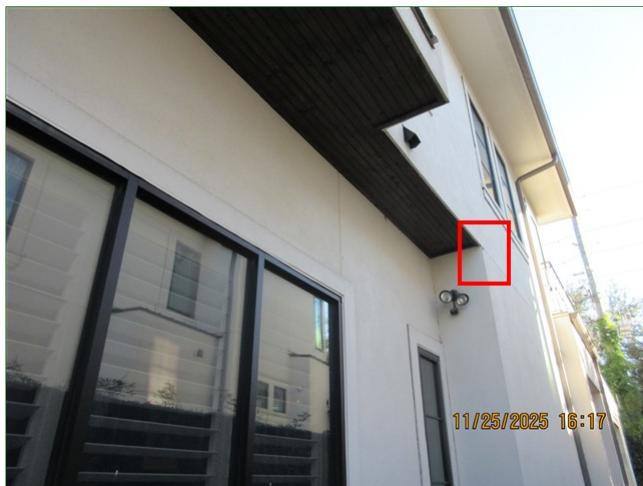
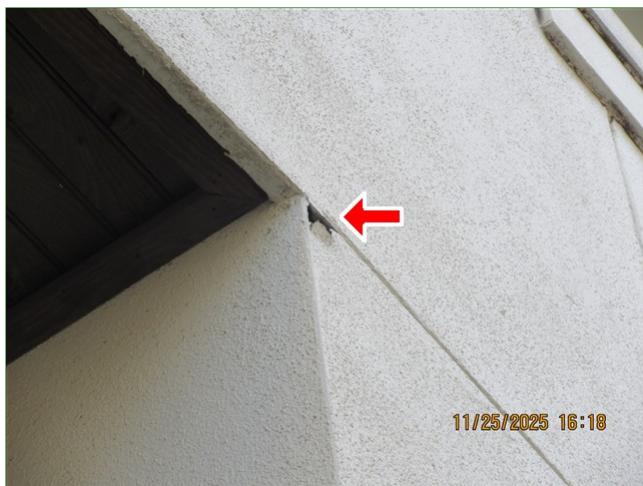
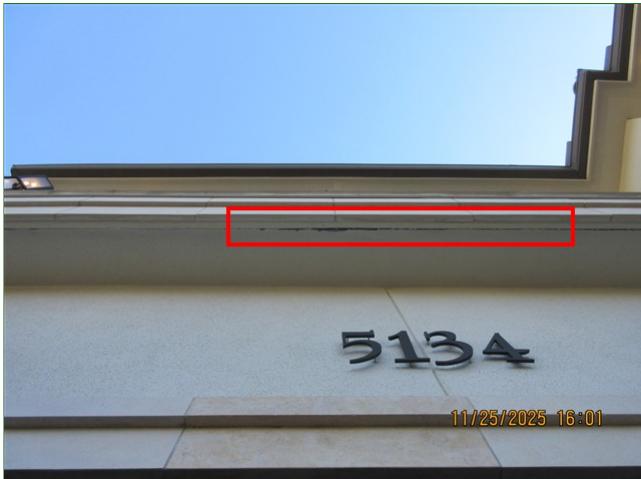
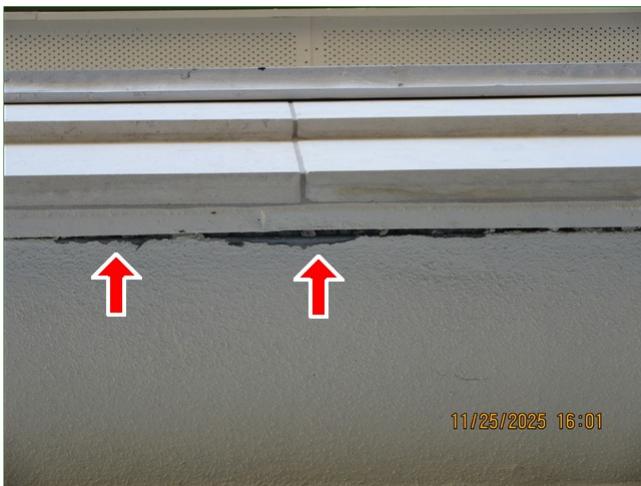
- In the inspectors opinion, evidence of normal wear and tear was observed at the bottom section of the stucco walls. This is for your information.
- A small hole/ damage was observed on the right side. The inspector recommends a qualified contractor repair the small hole.

E. Item 13 (Picture) Right of home, stucco siding, damaged

E. Item 14 (Picture) Right of home, stucco siding, damaged

E. Item 15 (Picture) Front of home, stucco siding, normal wear and tear evidence

E. Item 16 (Picture) Front of home, stucco siding, normal wear and tear evidence

(3) Multiple maintenance defects were observed in multiple locations of the exterior stucco siding at the time of the inspection. The inspector recommends further evaluation and correction by a qualified contractor as part of *routine maintenance*. The maintenance defects observed are listed below:

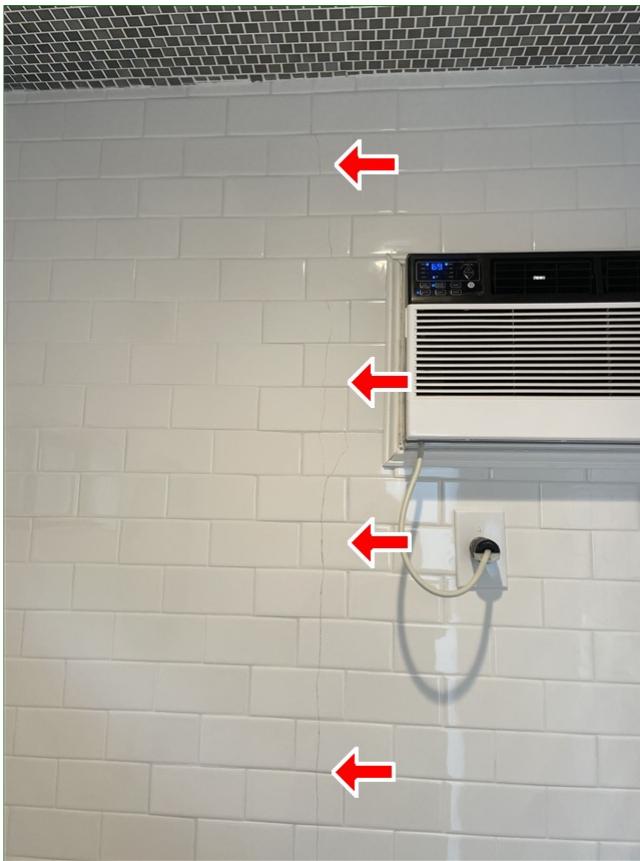
(4) A vertical crack was observed on the tile wall covering in the outside pool bathroom at the time of the inspection. This is for your information.

E. Item 17 (Picture) Outside half bathroom, tile wall covering, cracked

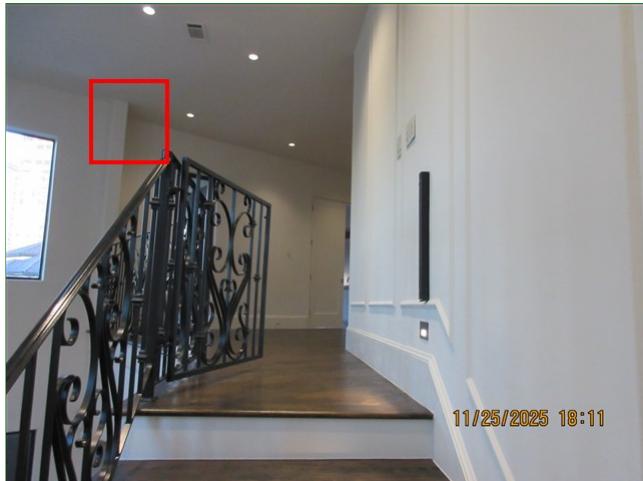
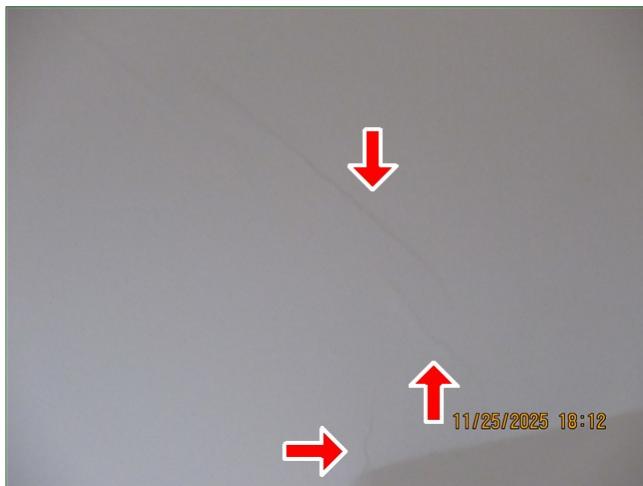
Multiple minor hairline corner cracks were observed on the ceiling at the time of the inspection. In the inspectors opinion these appear to be cosmetic cracks at the time of the inspection. The inspector recommends regular evaluation as part of routine maintenance.

F. Item 1 (Picture) Second story, ceiling, minor hairline cracks

F. Item 2 (Picture) Second story, ceiling, minor hairline cracks

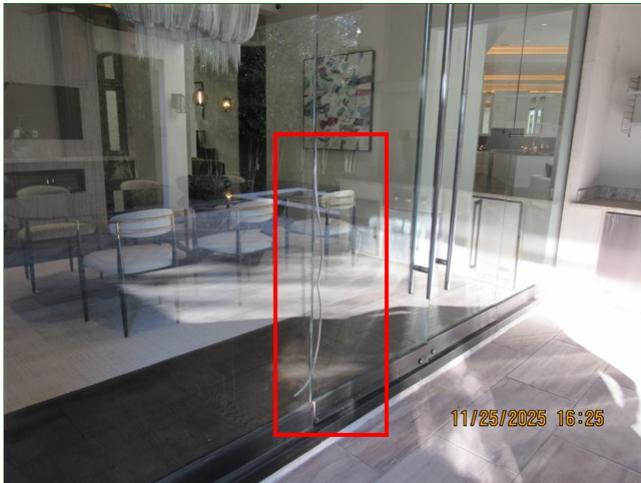
Daylight and loose weather stripping was observed at multiple exterior doors at the time of the inspection. The inspector recommends installing new weather strip in these locations.

G. Item 1 (Picture) Back of home, exterior door, loose weather stripping

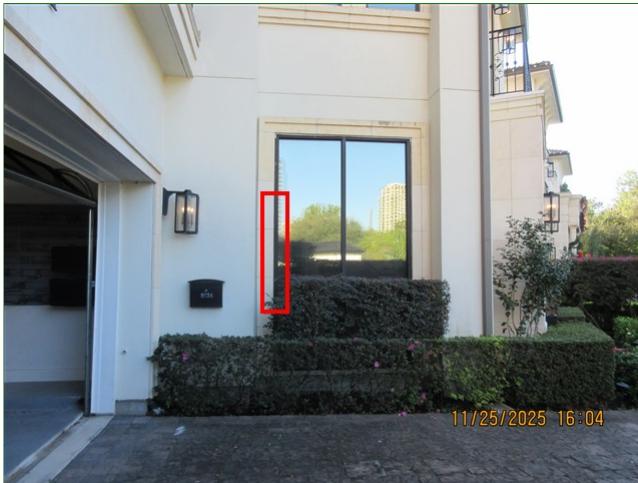
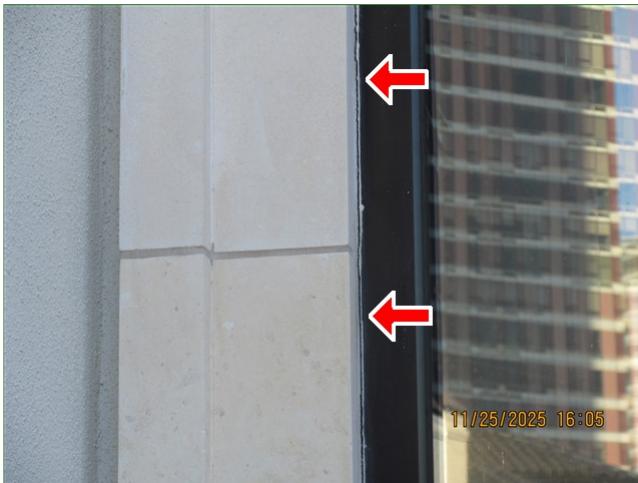
- (1) The inspector did not open or operate any of the casement windows due to a past experience of the casement window not closing at the time of the inspection. This is for your information.
- (2) In the inspectors opinion, evidence of normal wear & tear of the caulk/ sealant was observed at multiple butt joints on all sides of the home. Caulk/ sealant is not a permanent seal. The inspector recommends a qualified contractor make corrections where needed and check all exterior locations with sealant/ caulk at least once a year as part of routine maintenance.

H. Item 1 (Picture) Front of home, window to stone trim butt joint connections, caulk/ sealant, normal wear & tear

H. Item 2 (Picture) Front of home, window to stone trim butt joint connections, caulk/ sealant, normal wear & tear

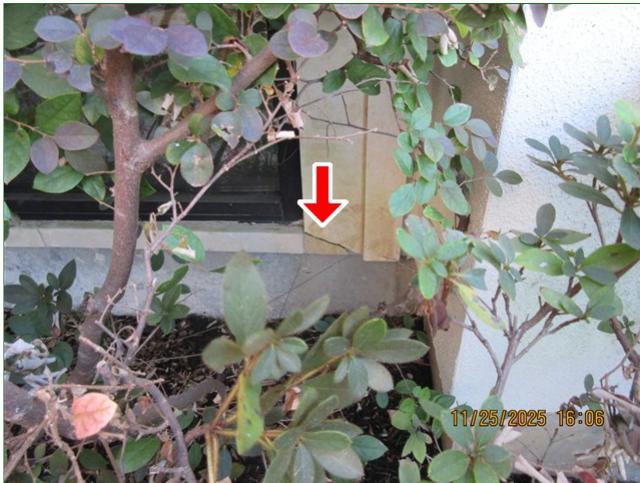
(3) A crack was observed at one of the front window's stone trim pieces at the time of the inspection. This is a cosmetic defect and is for your information.

H. Item 3 (Picture) Front of home, stone window trim, cracked

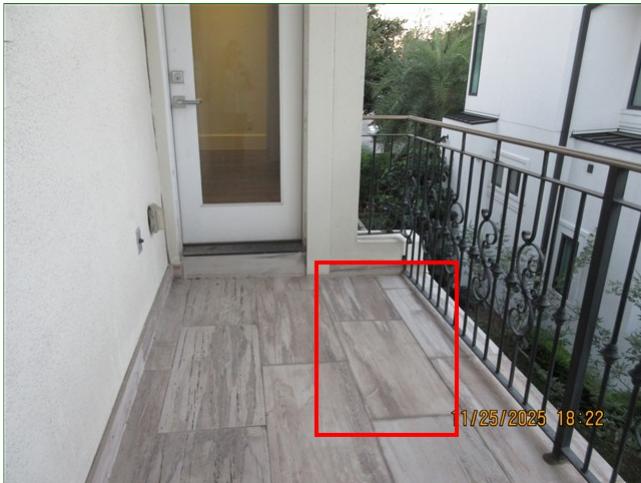
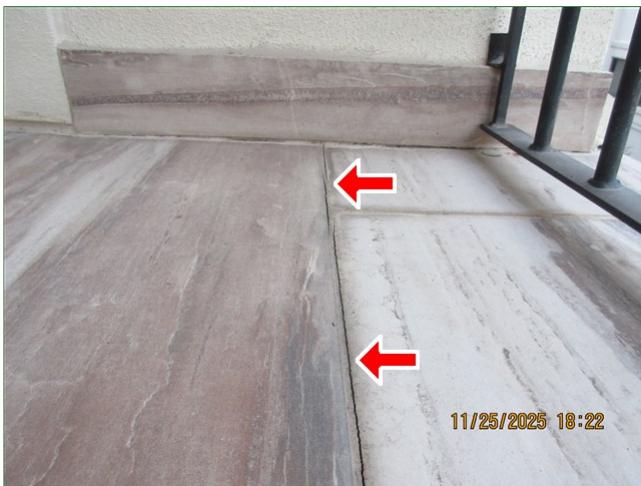
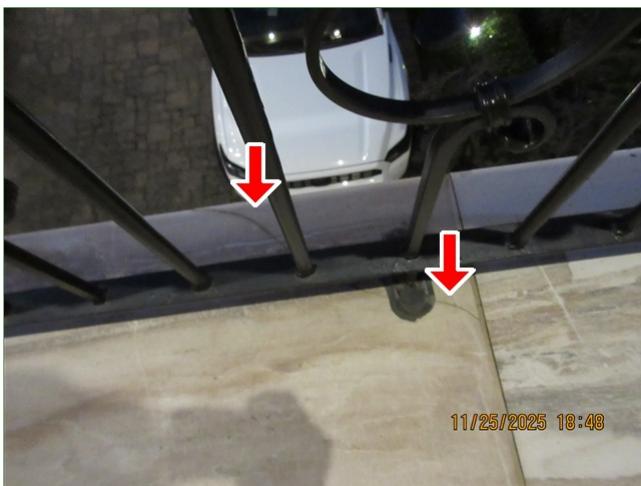
- Loose guard-rails at multiple balconies.
- Some of the tile floor coverings grout/ mortar showed evidence of normal wear & tear at each balcony.
- Cracked tile at a few of the guard-rail connections on the balcony above the garage.

K. Item 1 (Picture) Second story, balcony, tile floor covering, grout/ mortar, normal wear & tear

K. Item 2 (Picture) Second story, balcony, tile floor covering, grout/ mortar, normal wear & tear

K. Item 3 (Picture) Second story, balcony above garage, tile floor covering, cracked

Multiple maintenance defects were observed on the balcony at the time of the inspection. The inspector recommends correction by a qualified contractor as part of routine maintenance. The maintenance defects observed are listed below:

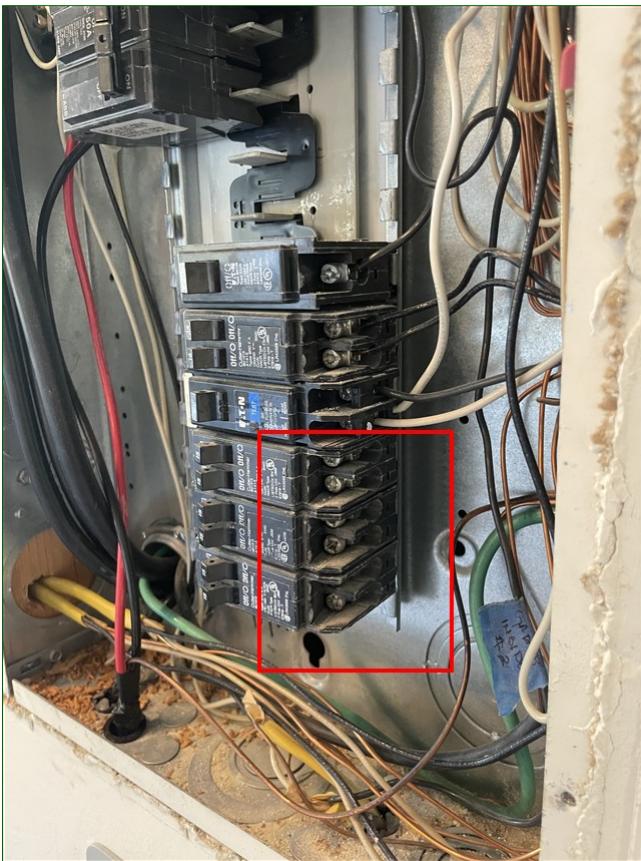
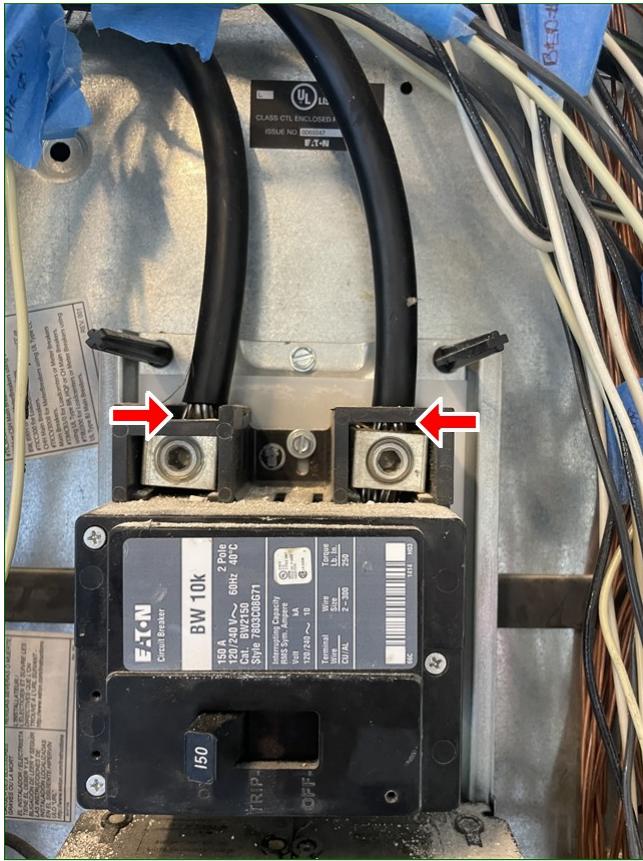
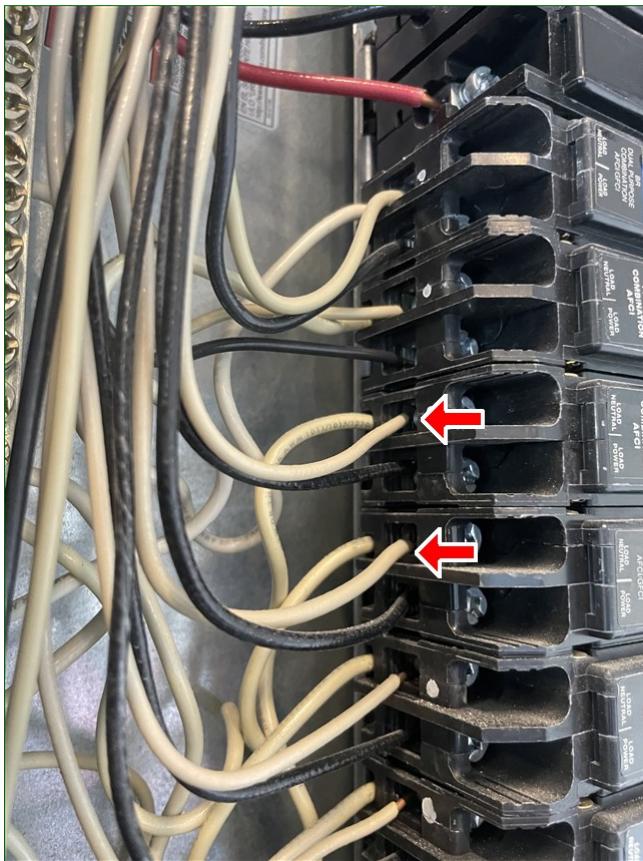
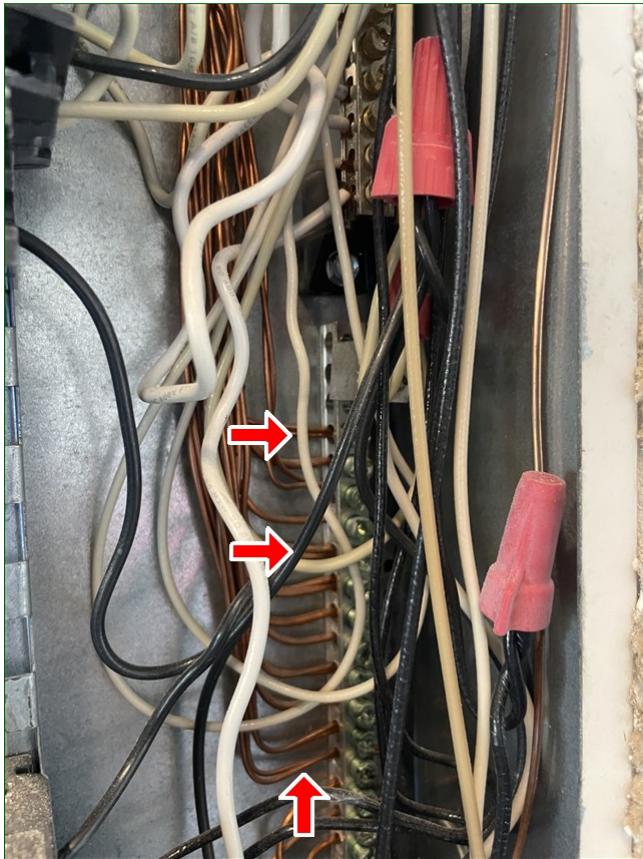
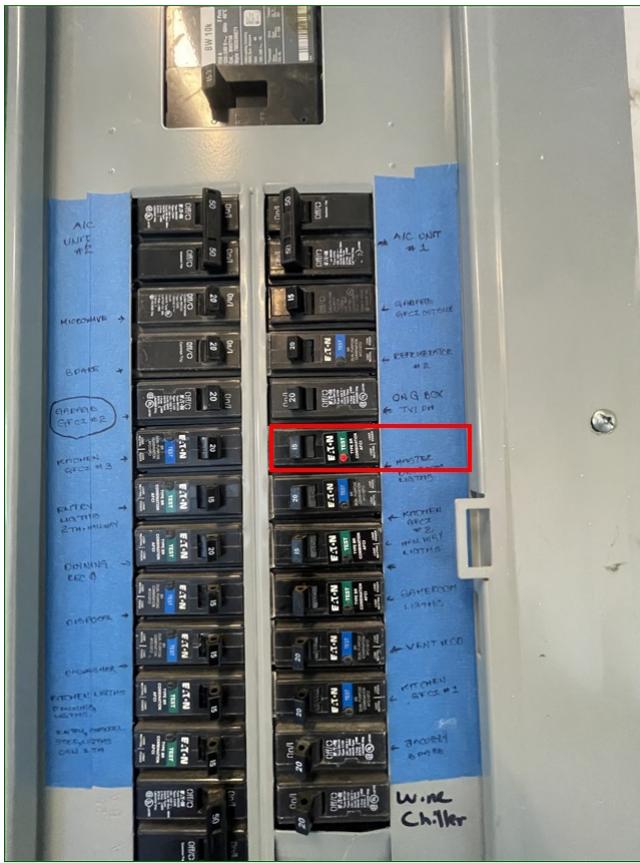
Multiple defects were observed at the main and sub electrical panel boards at the time of the inspection.

- Multiple circuit breakers did not have an electrical distribution wire connected at the time of the inspection. This is for your information.
- Exposed solid aluminum service cable wires.
- Multiple circuit breakers had double tapped neutrals. Typically, Eaton manufacture installation requirements does not allow double tapped neutrals.
- Multiple double tapped neutrals were also observed on the neutral bus bars.
- A red test light was on at one of the AFCI circuit breakers.

A. Item 1 (Picture) Garage, main paperboard, circuit breakers, no wire connected

A. Item 2 (Picture) Garage, main panel board, solid aluminum service cable wires, exposed

A. Item 3 (Picture) Garage, main panel board, double tapped neutrals

A. Item 4 (Picture) Garage, main panel board, neutral bus bar, double tapped

A. Item 5 (Picture) Garage, main panel board, AFCI breaker, red test light

The inspector recommends further evaluation by a qualified electrician. The defects observed are listed below:

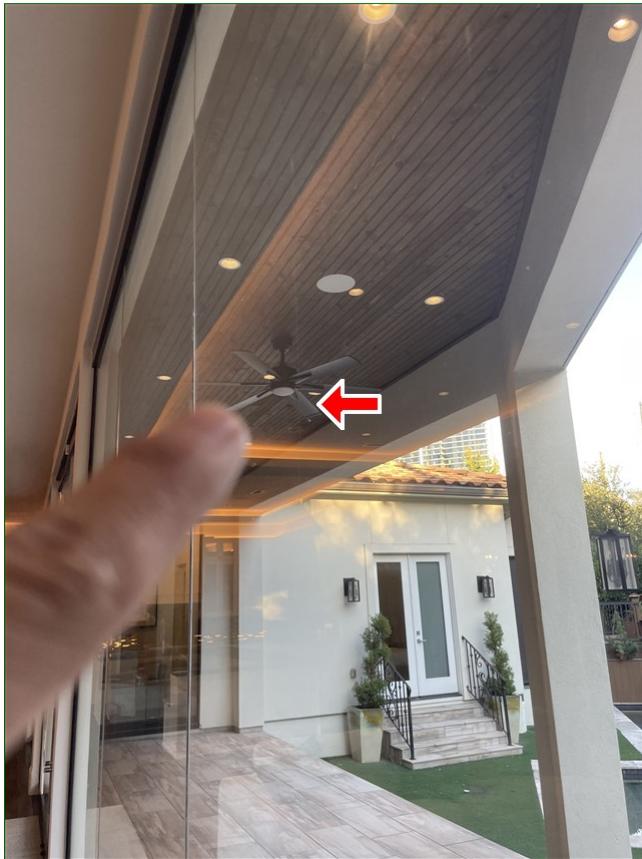
(2) An exterior fan did not operate at the time of the inspection. This is for your information.

B. Item 1 (Picture) Back of home, exterior fan, not operating

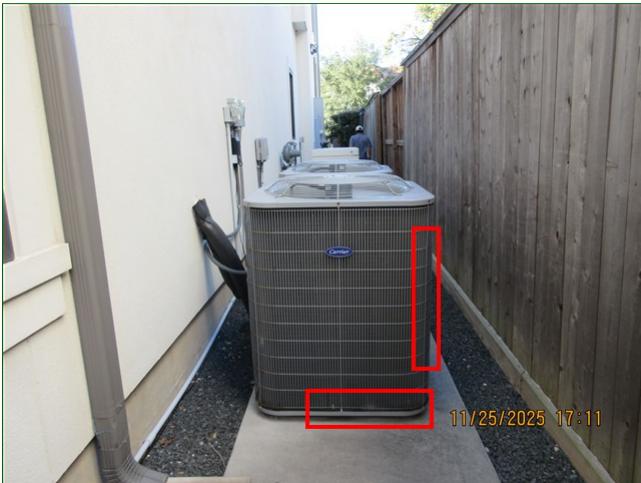
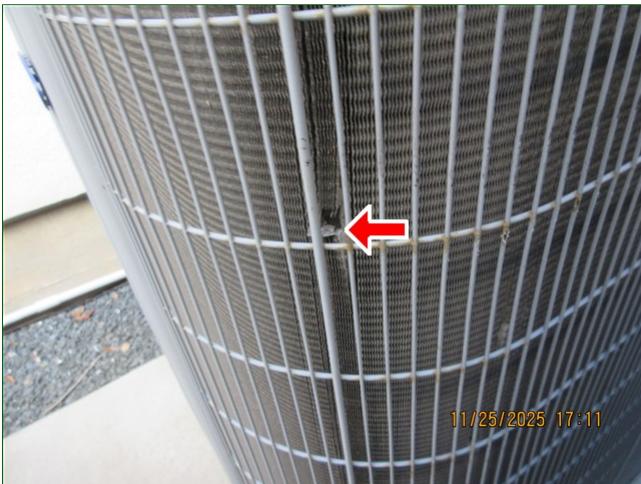
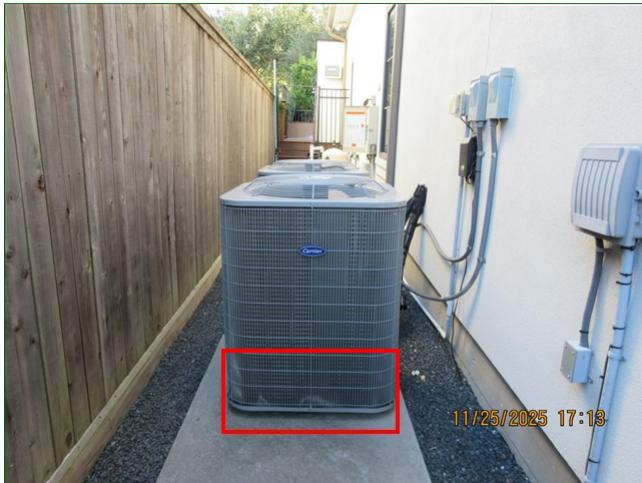
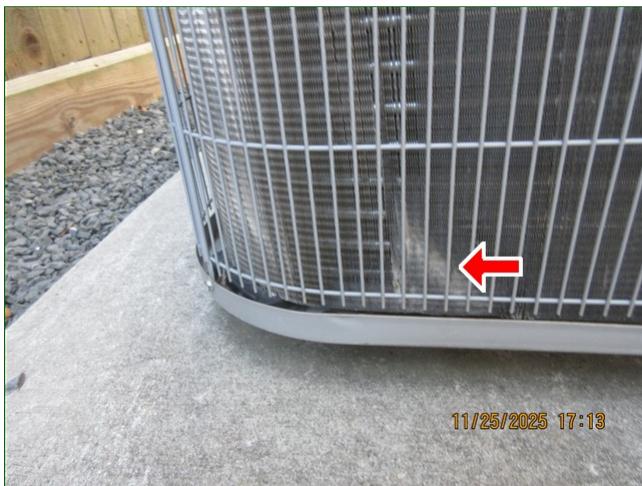
(1) Damaged condenser coils were observed at the time of the inspection. This may decrease the service life of the air condenser unit. This is for your information.

B. Item 1 (Picture) Left of home, condenser coils, damaged

B. Item 2 (Picture) Left of home, condenser coils, damaged

B. Item 3 (Picture) Left of home, condenser coils, damaged

B. Item 4 (Picture) Left of home, condenser coils, damaged

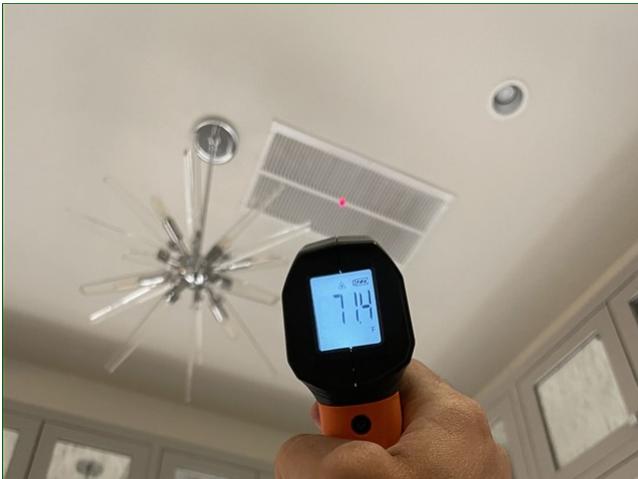
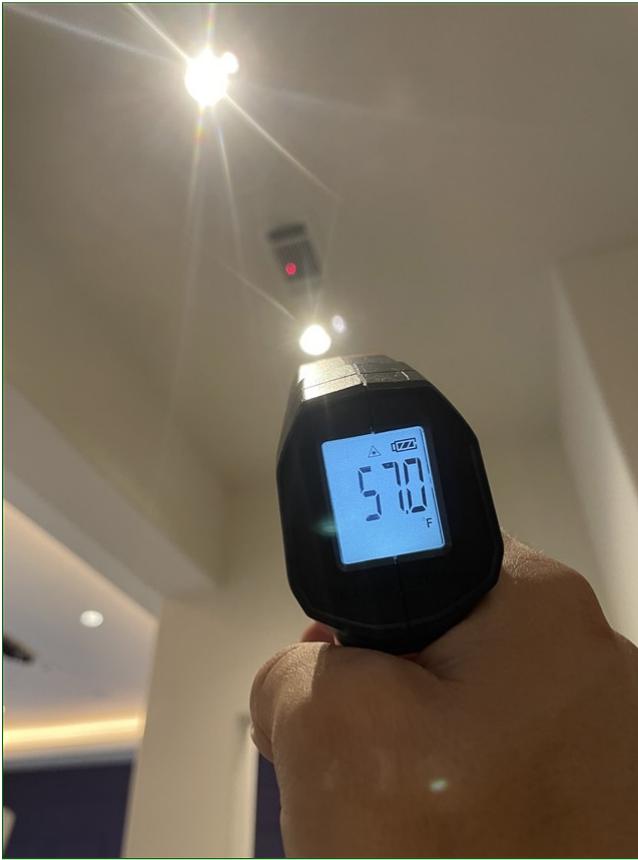
(2) The A/C supply and return vents were tested with a thermo- gun to determine if the difference in temperatures of the supply and return air are between 14 degrees and 22 degrees fahrenheit, which indicates that the unit is cooling as intended. The A/C temperature reading taken at the time of the inspection indicated a sufficient temperature difference at the time of the inspection. This is for your information.

B. Item 5 (Picture) Common area, HVAC return vent, temp. reading

B. Item 6 (Picture) Common area, A/C supply vent, temp. reading

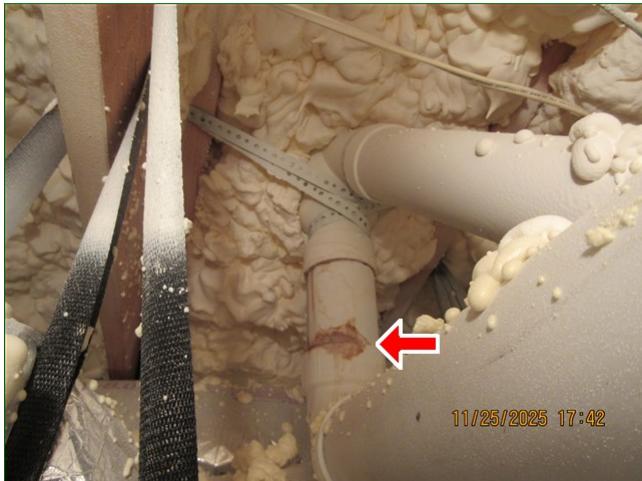
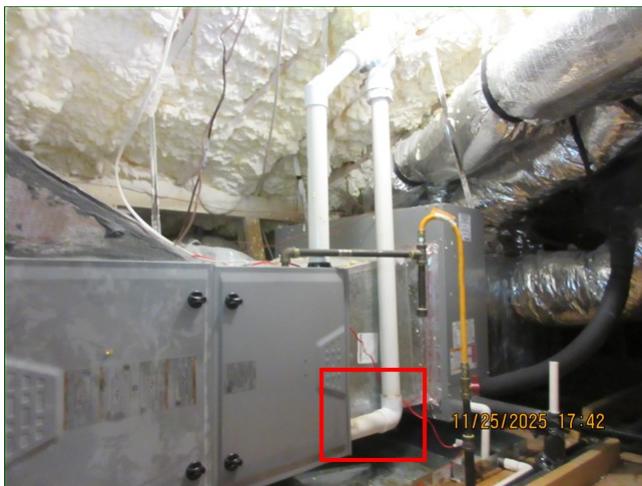
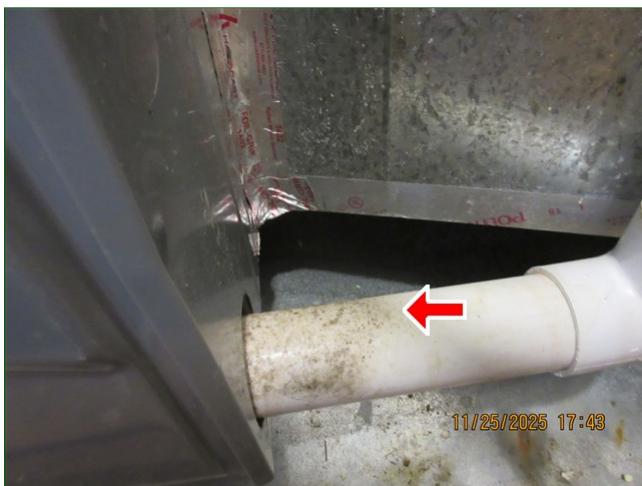
Multiple defects were observed at both of the attic HVAC units and their components at the time of the

- In the inspectors opinion, potential organic growth was observed on one of the attic HVAC units. The inspector recommends further evaluation and a *routine* cleaning of both of the HVAC systems and ducts.
- Staining/ discoloration was observed at one of the furnace gas flue vent stacks.

C. Item 1 (Picture) Attic, furnace gas flue vent stack, staining/ discoloration

C. Item 2 (Picture) Attic, furnace vent pipe, potential organic growth

C. Item 3 (Picture) Attic, furnace vent pipe, potential organic growth

inspection. The inspector recommends further evaluation by a qualified HVAC technician. The defects observed are listed below:

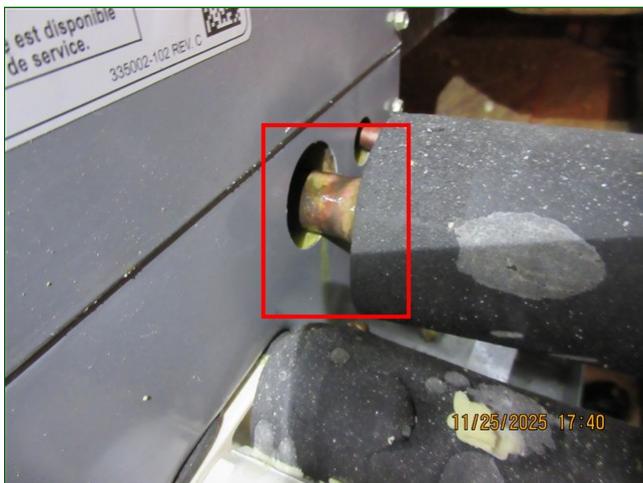
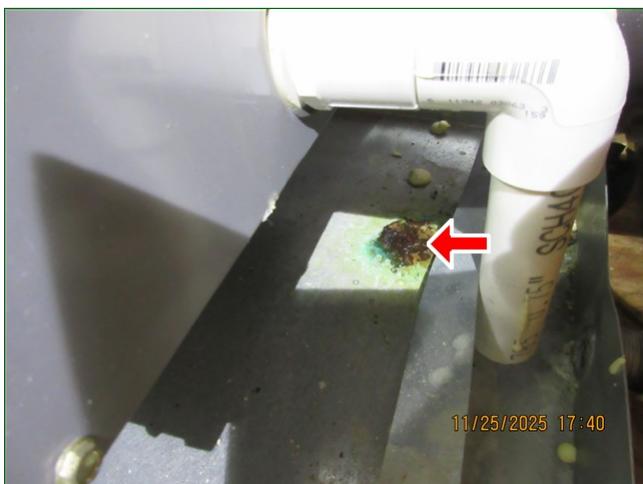
Moisture stains were observed in the HVAC's drip pans at the time of the inspection. A small drip leak was observed at the refrigerant line connection at the time of the inspection. This is for your information.

D. Item 1 (Picture) Attic, HVAC refrigerant line, small drip leak

D. Item 2 (Picture) Attic, HVAC refrigerant line, small drip leak

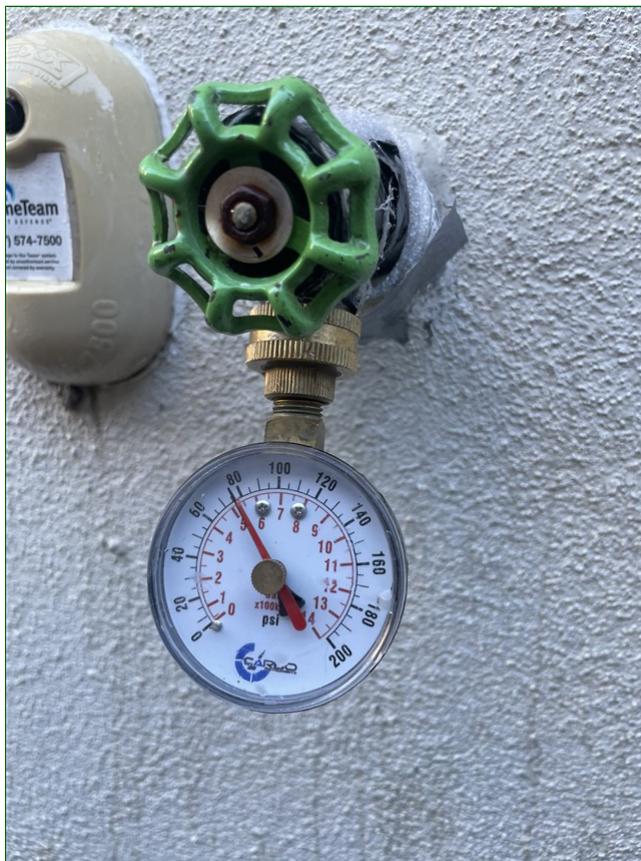
(1) The water pressure was about 75psi at the time of the inspection. The minimum psi for residential plumbing supply is 40psi, while the maximum is 80psi. This is for your information.

A. Item 1 (Picture) Exterior hose spigot, water pressure, about 75psi

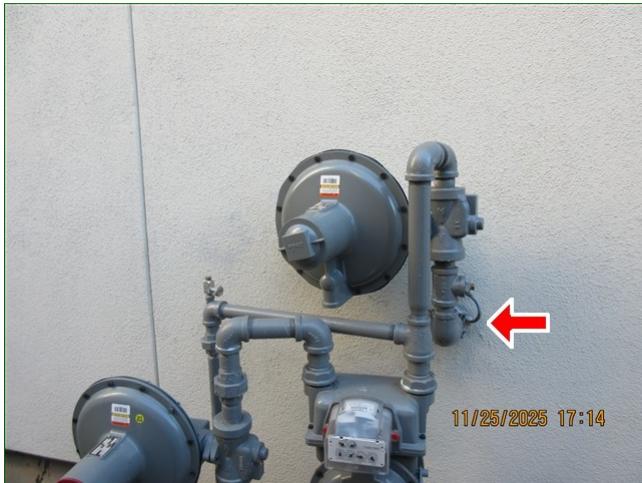
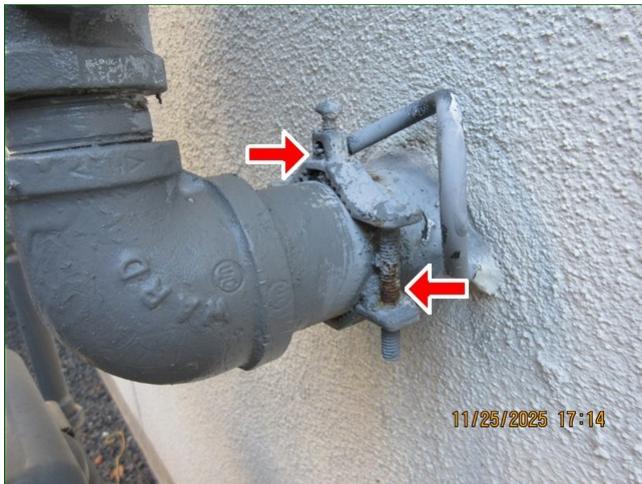
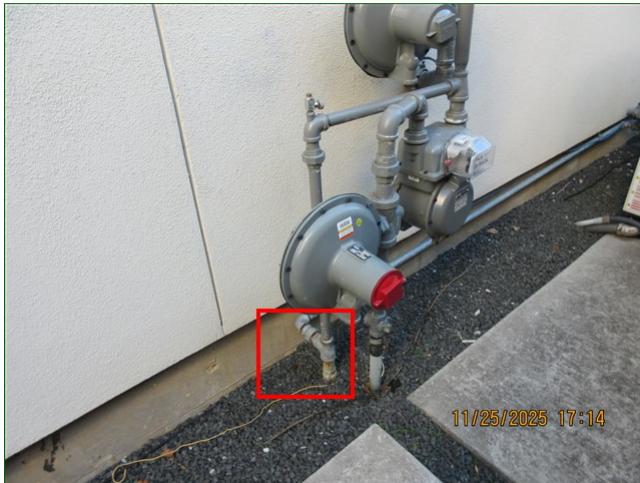
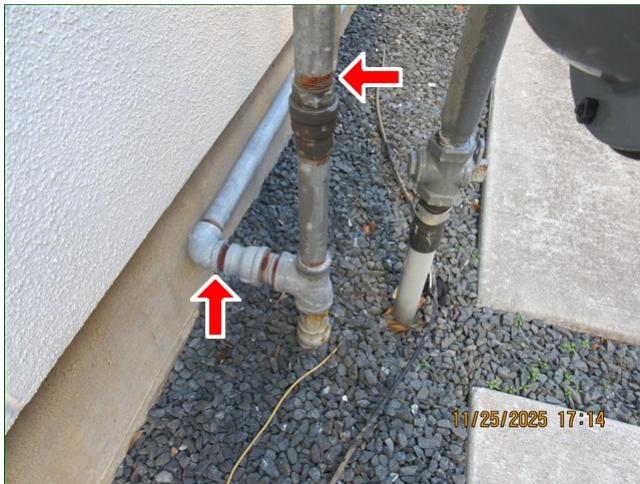
Rust and paint were observed on the gas supply's bonding clamp at the time of the inspection. This may cause resistance in the electrical bonding wires. Rust was also observed at multiple gas supply pipe connections at the time of the inspection. The inspector recommends further evaluation by a qualified specialist to determine if immediate attention is required.

E. Item 1 (Picture) Left of home, gas meter, supply line bonding clamp, rusted and painted

E. Item 2 (Picture) Left of home, gas meter, supply line bonding clamp, rusted and painted

E. Item 3 (Picture) Left of home, gas meter, supply line connections, rust

E. Item 4 (Picture) Left of home, gas meter, supply line connections, rust

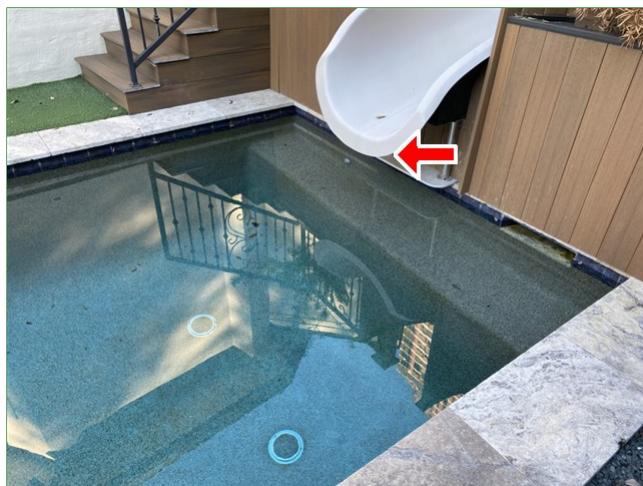
The pool's water slide accessory did not function at the time of the inspection. This is for your information.

D. Item 1 (Picture) Pool, water slide, not functioning

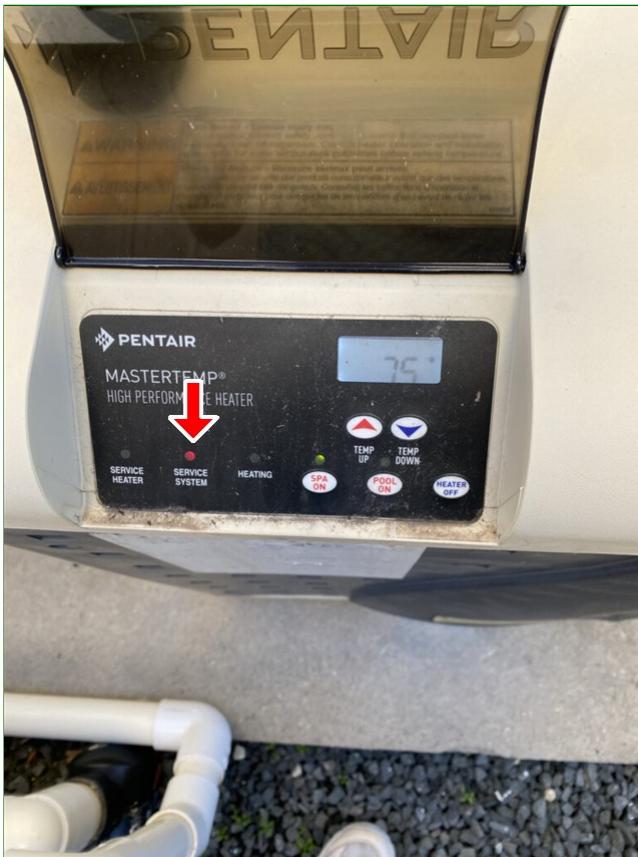
The pool and spa's heater "service system" light was on and the water did not warm up at the time of the inspection. The inspector recommends further evaluation and correction by a qualified professional.

G. Item 1 (Picture) Pool & spa heater, service system light on

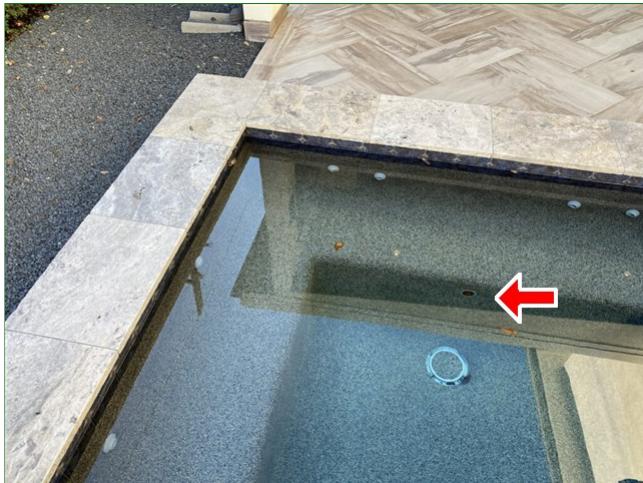
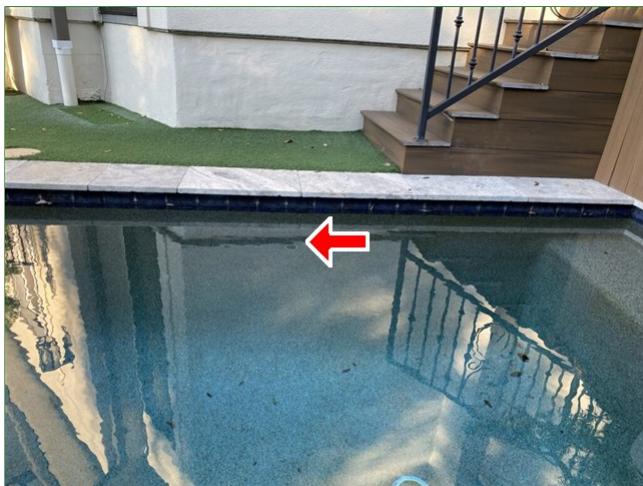
Only 1 pool light functioned at the time of the inspection. The remaining pool lights were not functioning and appeared to have rust built up behind the light cover at the time of the inspection. The inspector recommends further evaluation and correction by a qualified professional.

T. Item 1 (Picture) Hot tub, light, not functioning & possible rust build up

T. Item 2 (Picture) Pool light, not functioning & possible rust build up
