# Inspection Report

**Property Address:**  
1234 Masters Cir  
Baytown TX 77523

# PROPERTY INSPECTION REPORT FORM

John Doe	11/15/2025
Name of Client	Date of Inspection
1234 Masters Clr, Baytown, TX 77523	
Address of Inspected Property	
Amber Diehl TREC # 26115	TREC 26115
Name of Inspector	TREC License #
Name of Sponsor (if applicable)	
TREC License #

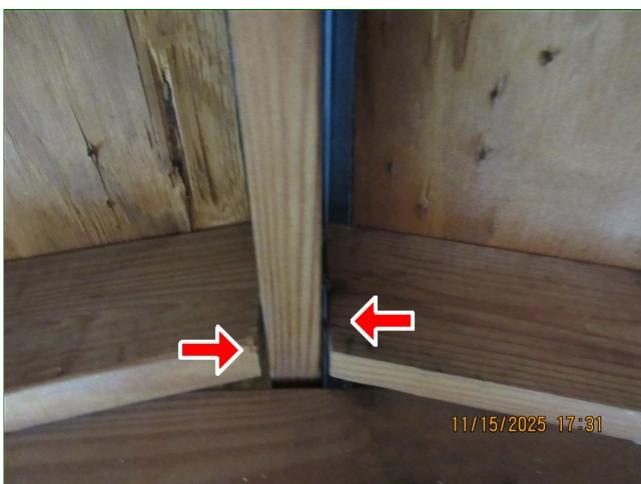
D. Item 2 (Picture) Attic, rafters connection to ridge board, separated

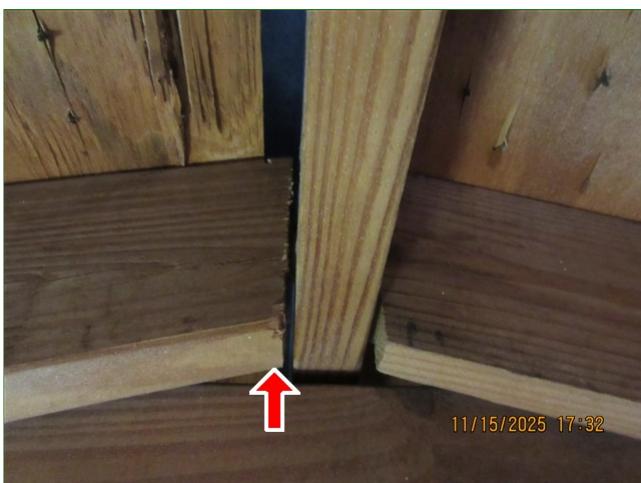
D. Item 3 (Picture) Attic, rafters connection to ridge board, separated

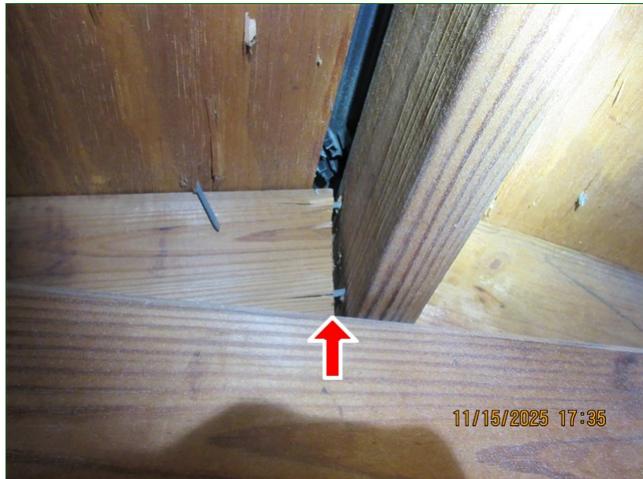
D. Item 4 (Picture) Attic, rafters connection to ridge board, separated

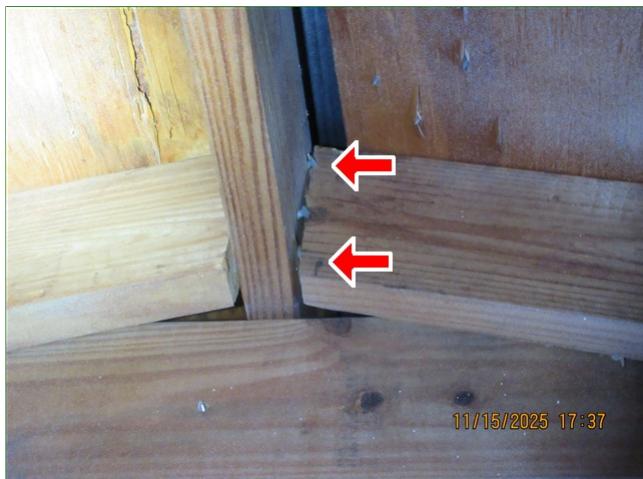
D. Item 5 (Picture) Attic, rafters connection to ridge board, separated

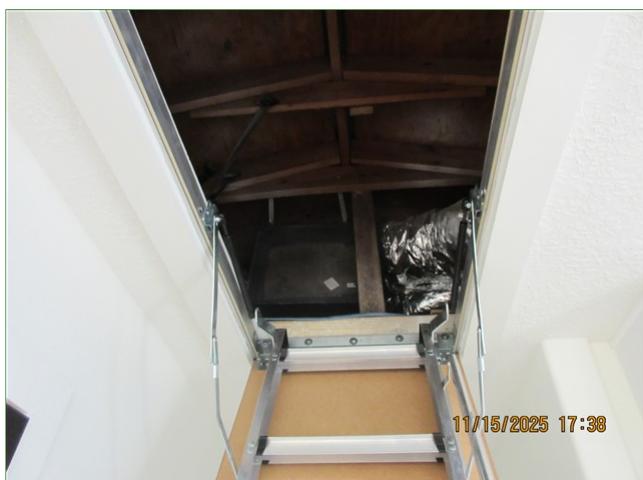
D. Item 6 (Picture) Attic, access, very limited

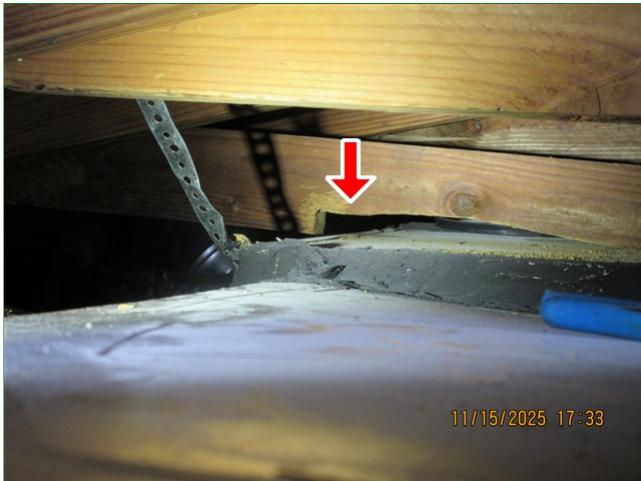
D. Item 7 (Picture) Attic, structural load bearing members, cut

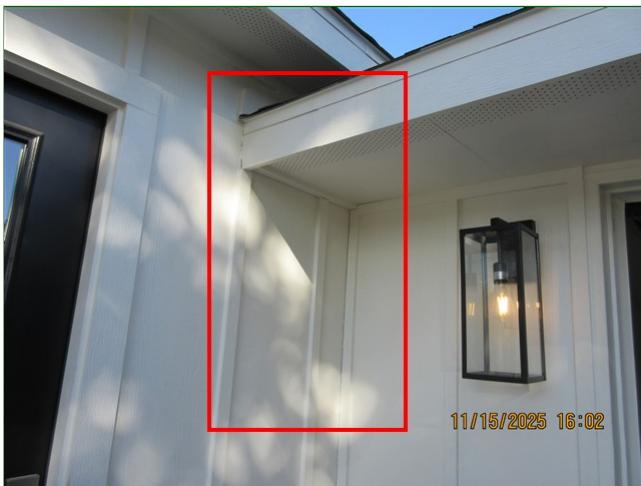
E. Item 2 (Picture) Right of home, roof to wall boards connections, separated caulk/ sealant

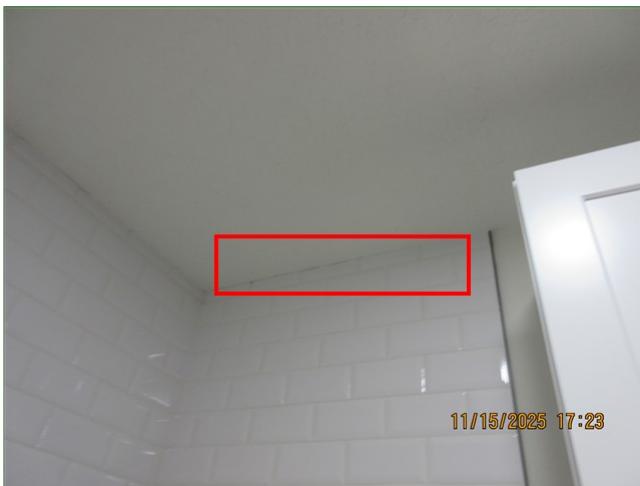
E. Item 8 (Picture) Guest bathroom, tile wall, poor caulk/ sealant work

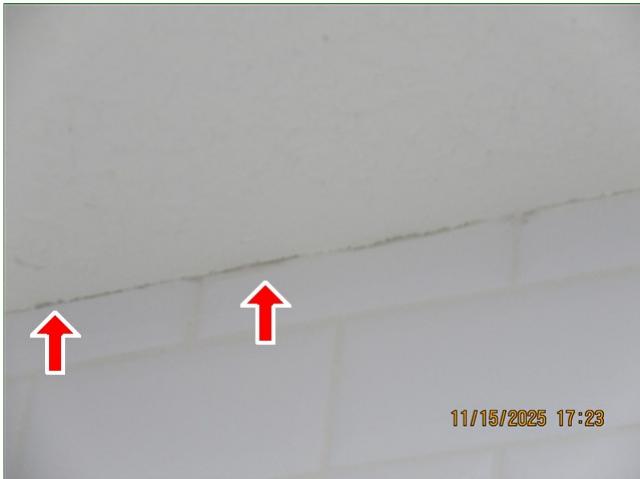
E. Item 9 (Picture) Guest bathroom, tile wall, poor caulk/ sealant work

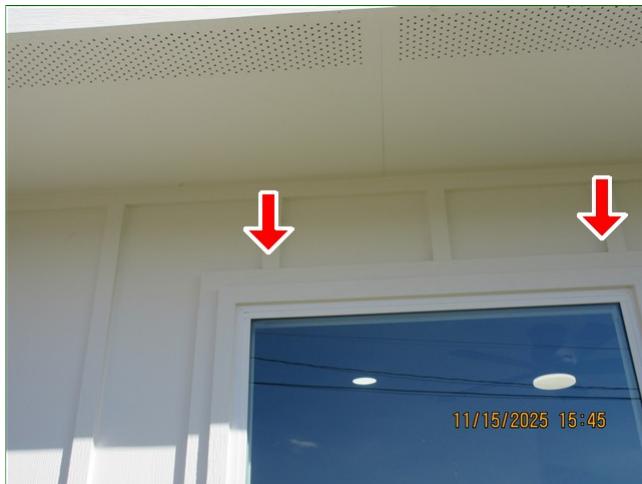
E. Item 12 (Picture) Front of home, cement fiber siding & window butt joints, no flashing

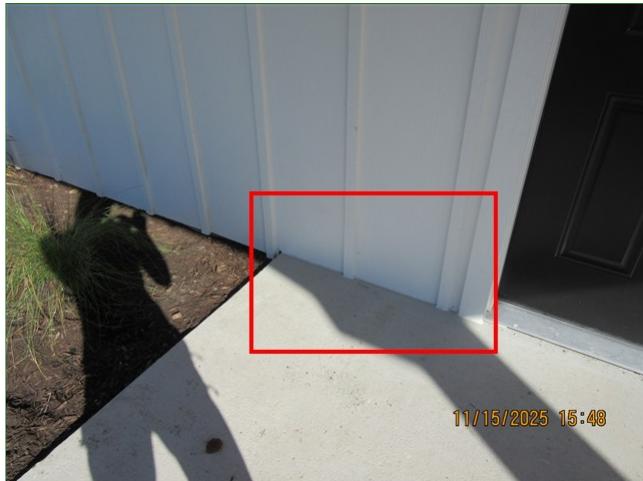
E. Item 13 (Picture) Front of home, cement fiber siding, in direct contact with concrete

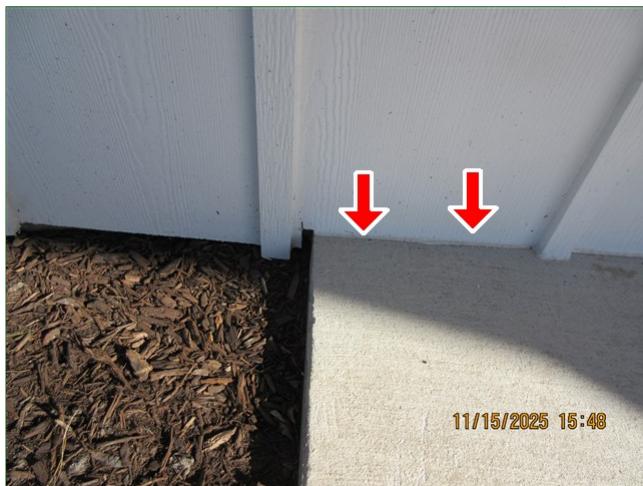
E. Item 14 (Picture) Front of home, cement fiber siding, in direct contact with concrete

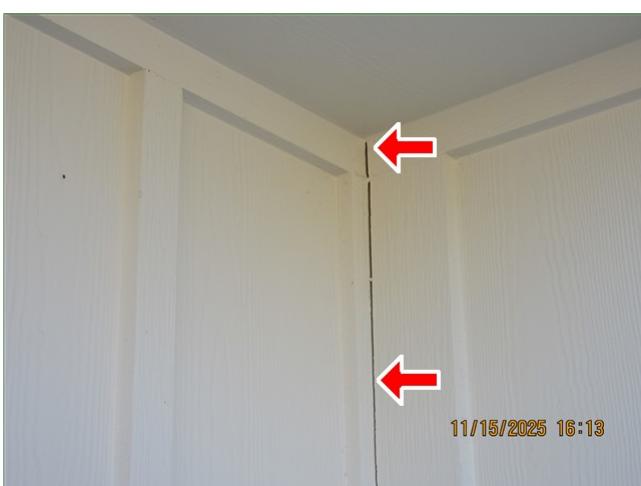
E. Item 18 (Picture) Back of home, siding butt joint, separated

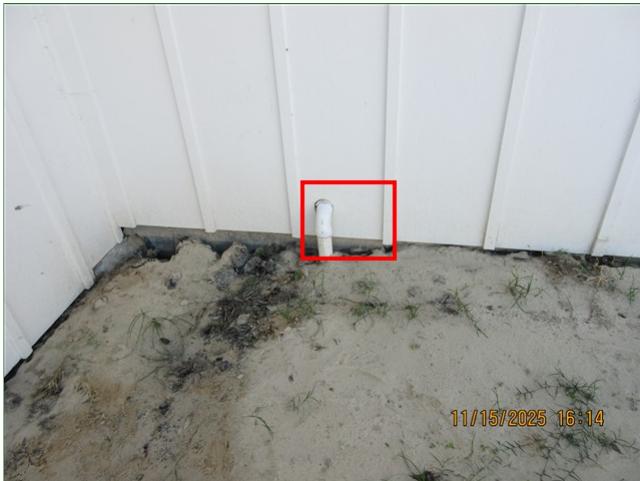
E. Item 19 (Picture) Back of home, through wall termination, no flashing

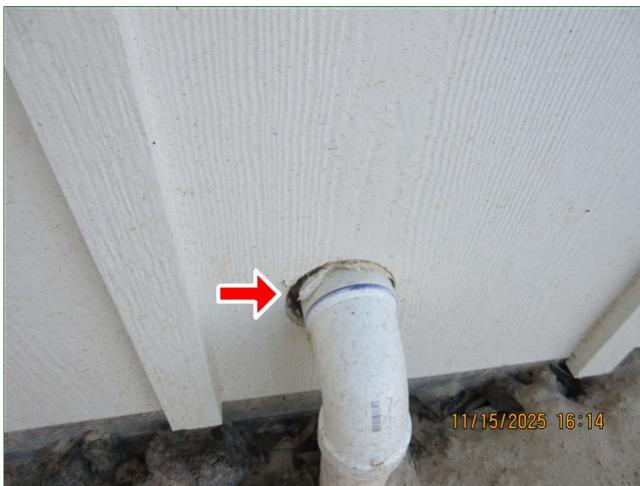
E. Item 20 (Picture) Back of home, through wall termination, no flashing

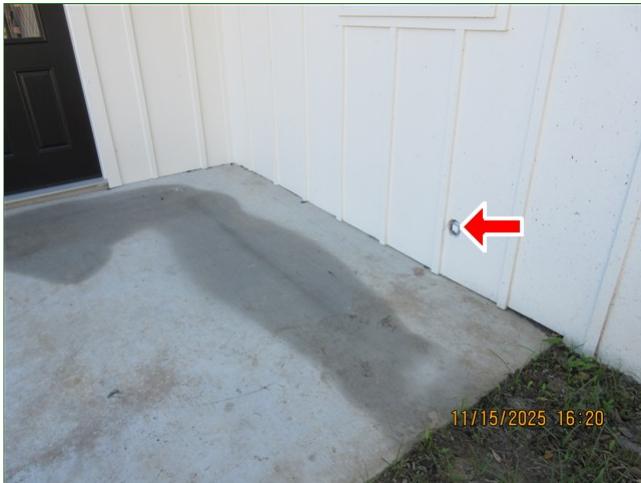
E. Item 24 (Picture) Back of home, through wall termination, no flashing, possible 2 layers of exterior siding

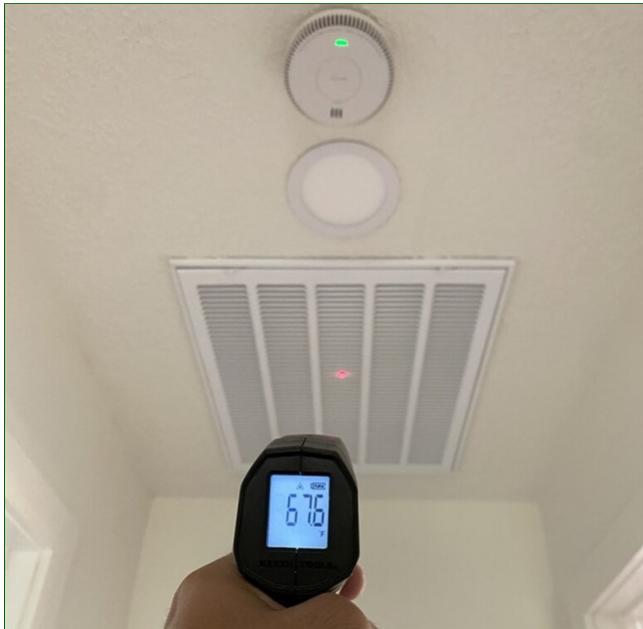
The A/C supply and return vents were tested with a thermo- gun to determine if the difference in temperatures of the supply and return air are between 14 degrees and 22 degrees fahrenheit, which indicates that the unit is cooling as intended. The A/C temperature reading taken at the time of the inspection indicated a sufficient temperature difference at the time of the inspection. However, there were a few supply vents that did not seem to blow as cool at the time of the inspection. This is for your information.

B. Item 1 (Picture) Hallway, HVAC return vent, temp. reading

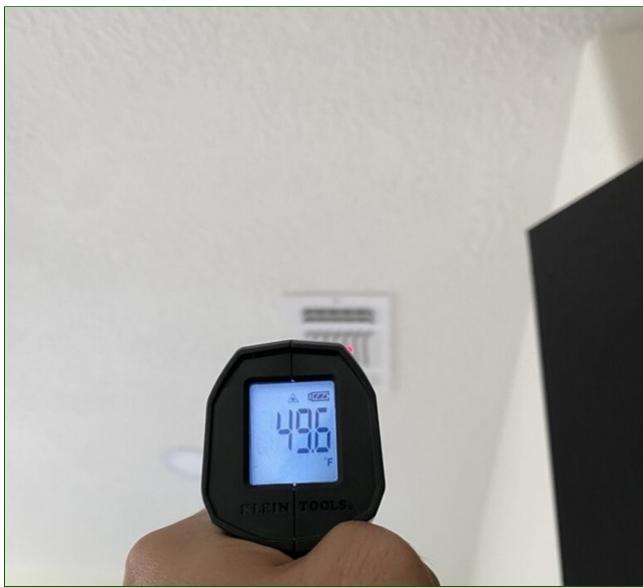
B. Item 2 (Picture) Master bedroom, HVAC supply vent, A/C supply temp. reading

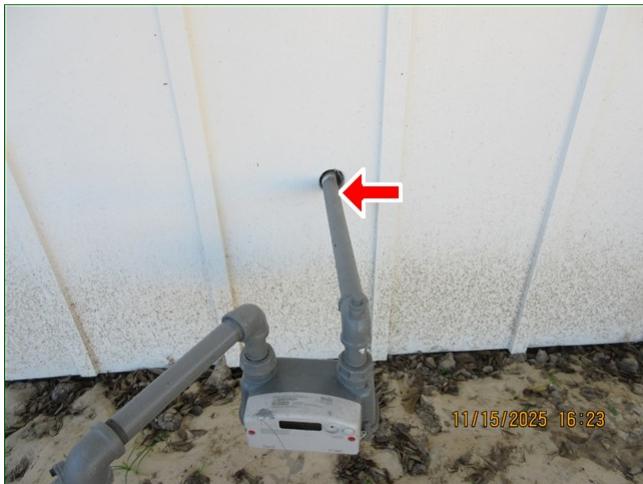
E. Item 2 (Picture) Back of home, gas meter, no electrical bonding wired connection clamp
